Chichester City Council

PROP2026/9 - MARKET CROSS CONDITION REPORT

**CONDITION REPORT
FOR
THE MARKET CROSS,
CHICHESTER, WEST SUSSEX**

November 2025

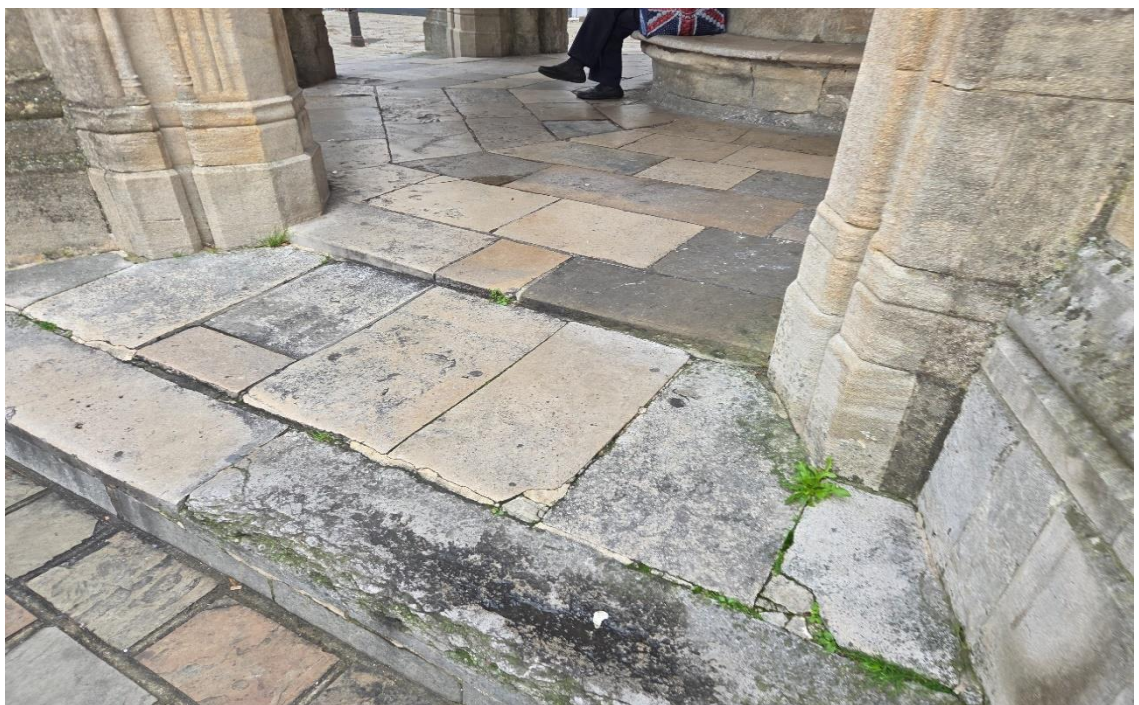
1. View of stone base to south elevation.

The surface of the stone across the whole floor has been worn generally smooth and shiny through centuries of foot traffic, though of course individual slabs have been replaced over time and different stone types and stone from different sources have been used, which has resulted in a non-uniform appearance in terms of colour, finish, durability and condition. A small number of individual slabs are in poor condition and require minor repair in the form of stone indents. There is some minor vegetation growth in some joints which should be

removed. There are a lot of eroded or empty joints to more or less all elevations and these joints should be raked out and repointed in a carefully specified lime mortar mix. The whole nosing area to the right hand step to the south elevation is heavily cracked and we would recommend the damaged section is cut out and replaced. Depending on the extent of failure it may be the whole stone will have to be replaced.

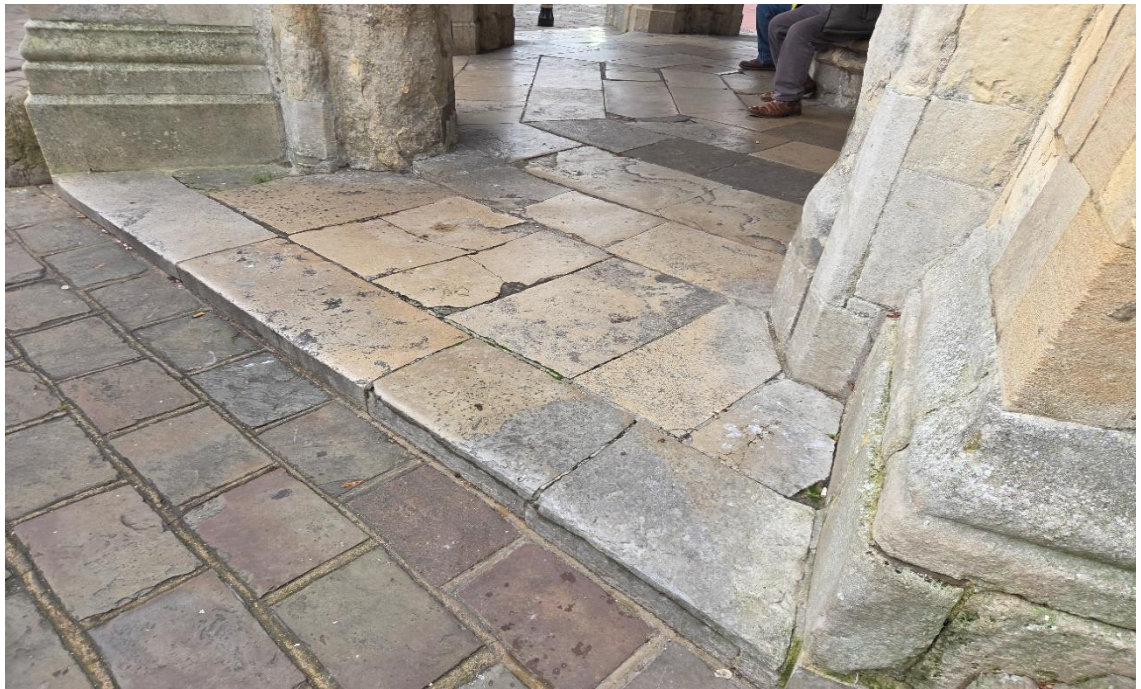
2. North east elevation with no shallow steps, the floor instead sloping down and out.

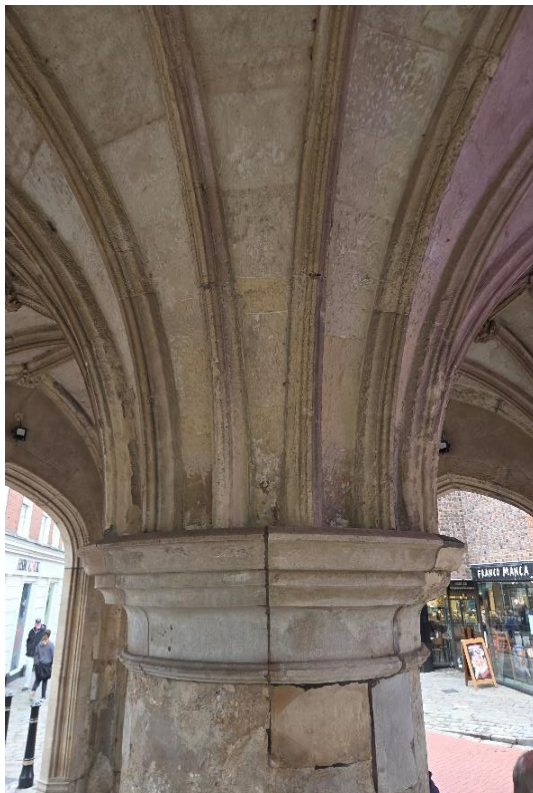
3. View of the stone shaft, vault rib springer and vault ribs above.

We would recommend some repointing work where joints are eroded or void and some light defrassing to delaminating areas and application of protective shelter coats. The column pilasters are generally in poor visual condition with extensive erosion, damage and inappropriate cement repair all evident. We would recommend consideration be given to replacing cement repairs with lime mortar. Various old small fixings such as screws to the inner face of the outer walls of the monument should be removed as they are unsightly.

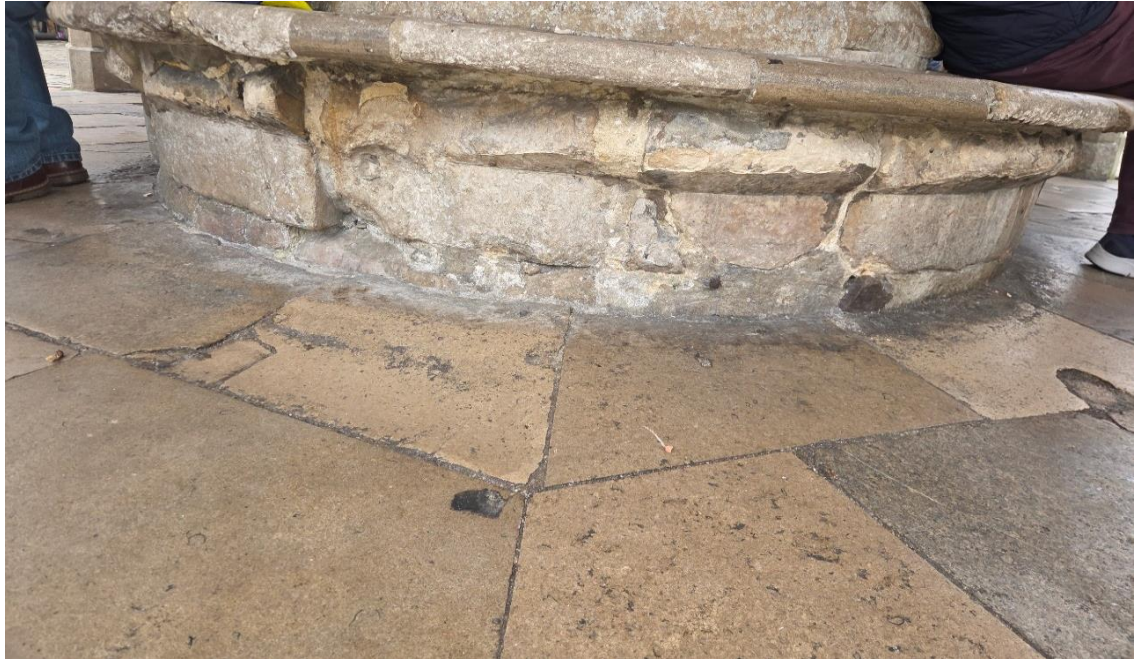
4. There has been loss of stone and delamination to the stone base beneath the seat.

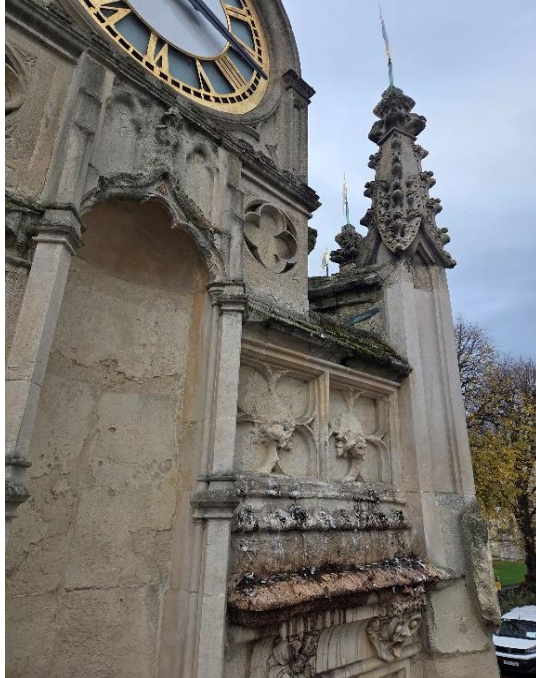
9. The significant guano to the cornice is evident.

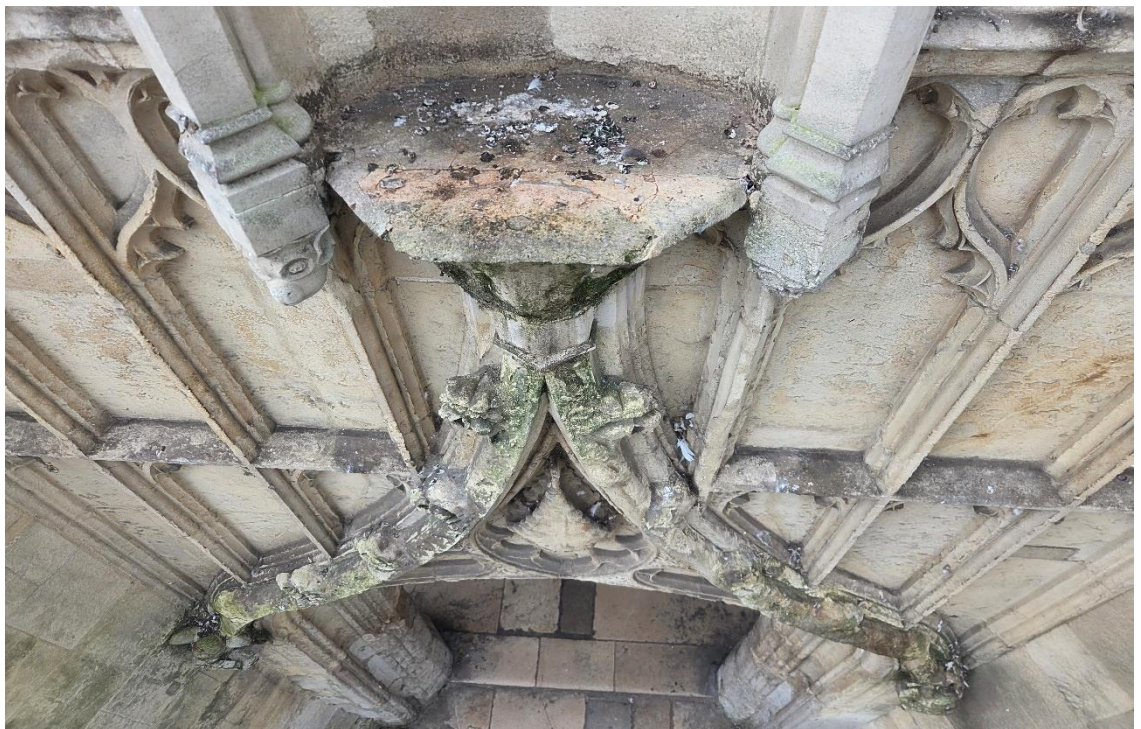
10. Cracking and guano to niche base to north elevation.

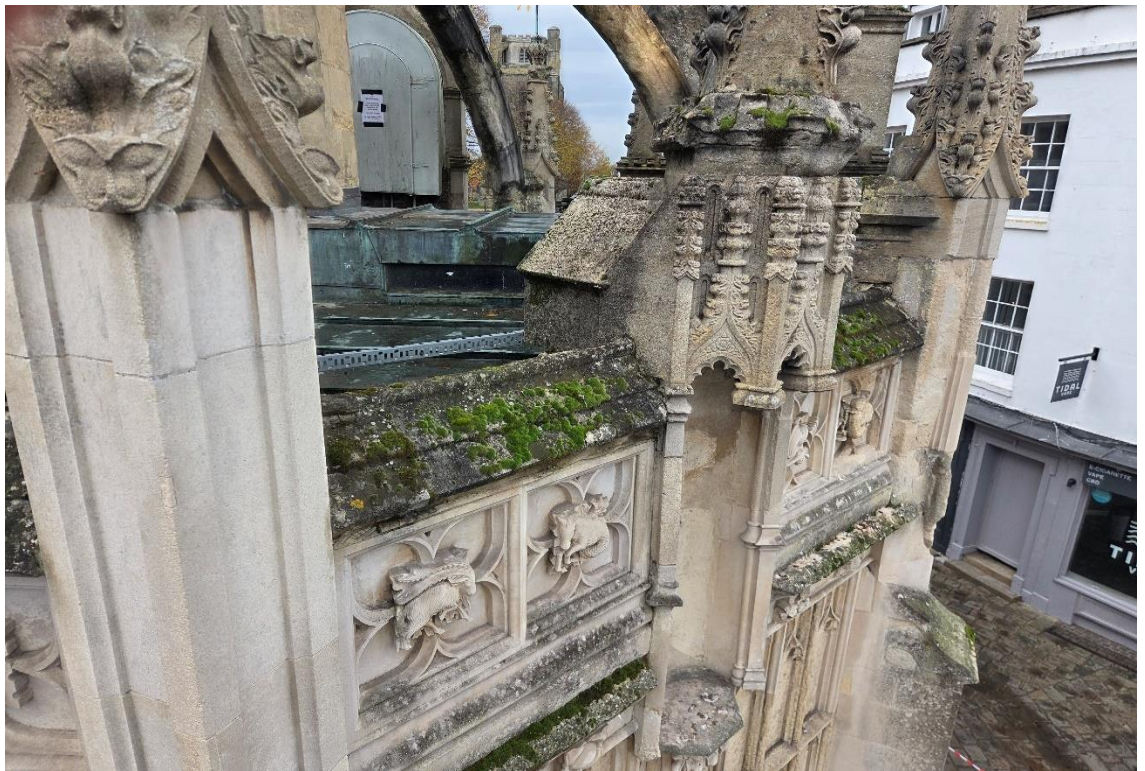
11. Moss growth and dark weathering staining to the top of the parapet wall.

There is moss growth and dark dirt and weathering staining to the top of the parapet wall and to cornices below, all of which should be carefully cleaned off. The right hand side of the frieze panel is heavily eroded and cracked, and there are a number of unsightly indents to the cornice above the frieze. One of the pinnacle columns is heavily eroded and some cracking is present. Two motifs to the stone band to the right hand side are heavily eroded as are both the angels at the bases of the hood mould both sides. The cracking should be carefully raked out and infilled with a lime mortar of a strength just inferior to the stone. The unsightly repairs should be checked and ideally replaced with stone that matches more closely that of the cornice. Carefully specified and selected shelter coats should be applied to the eroded areas in particular to help protect them.

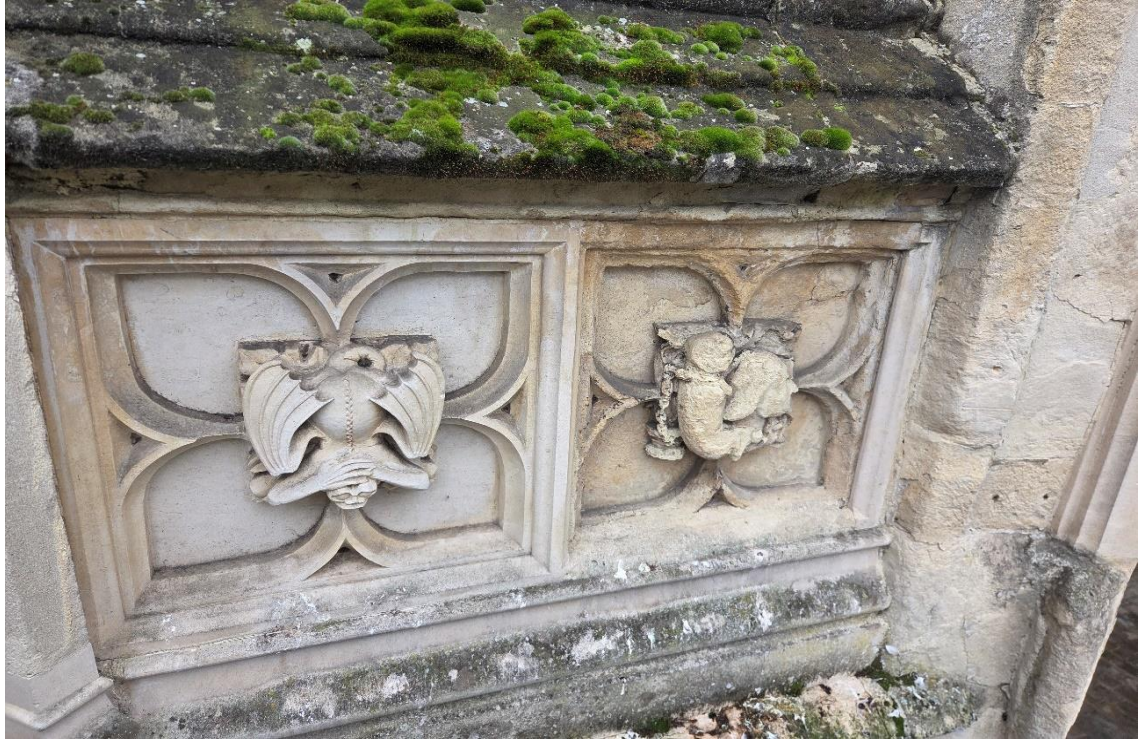
12. Heavy erosion to the right hand frieze panel.

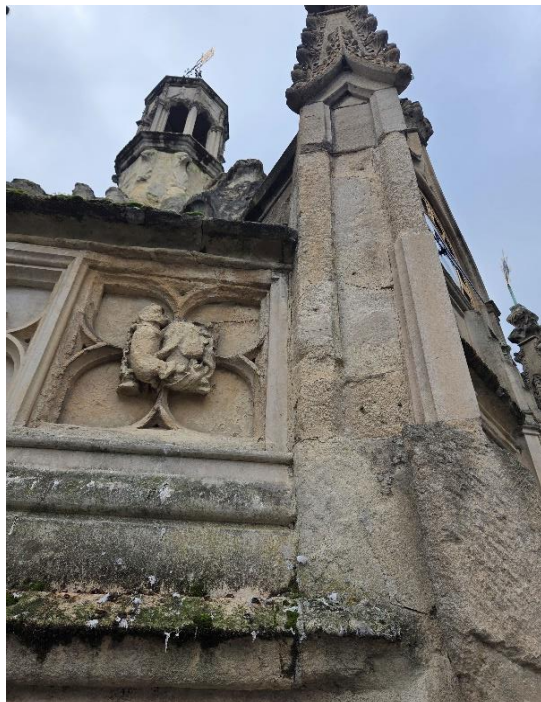
13. Quite significant erosion to the pinnacle shaft to the right of the eroded frieze panel.

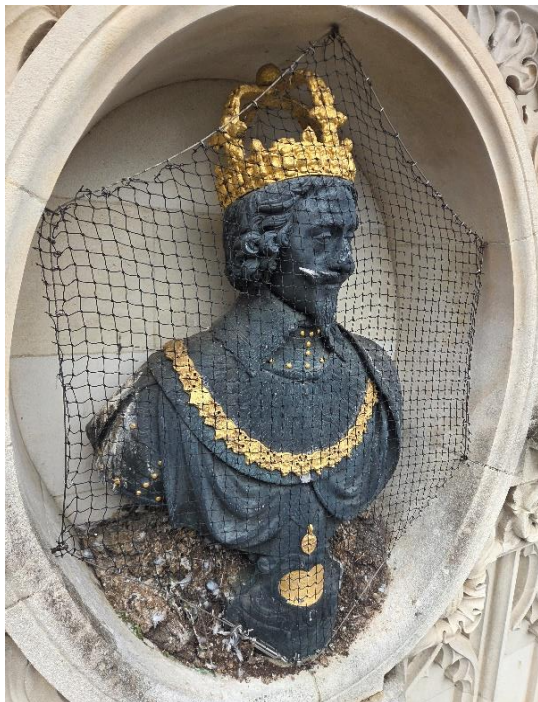
18. The guano build up around the base of the bust is very significant.

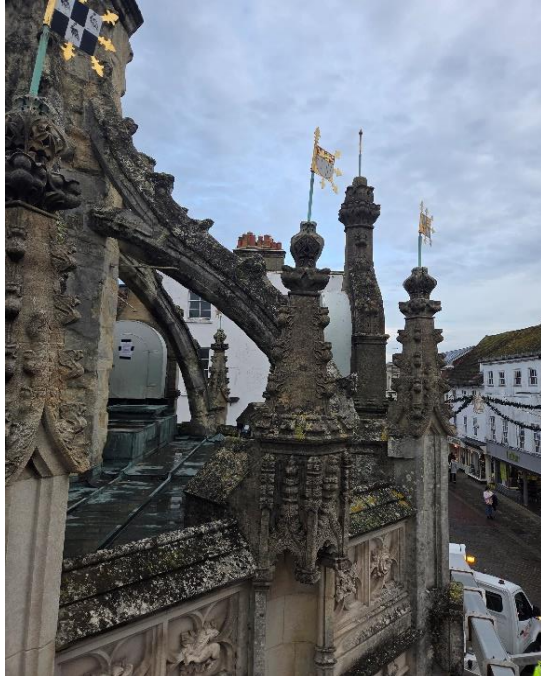
20. There is a lot of moss and lichen staining to the top of the parapet wall.

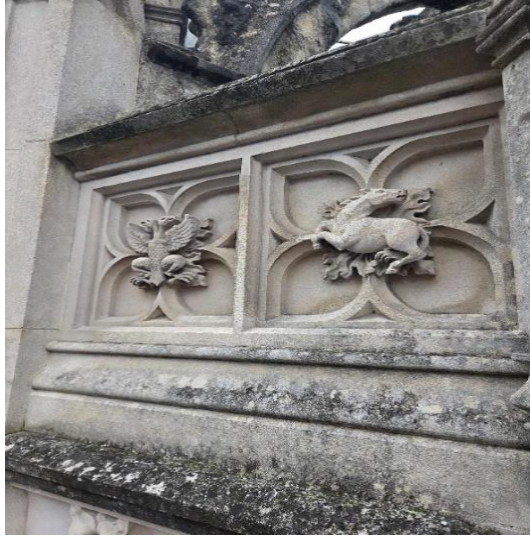
22. Further weather staining to the cornice.

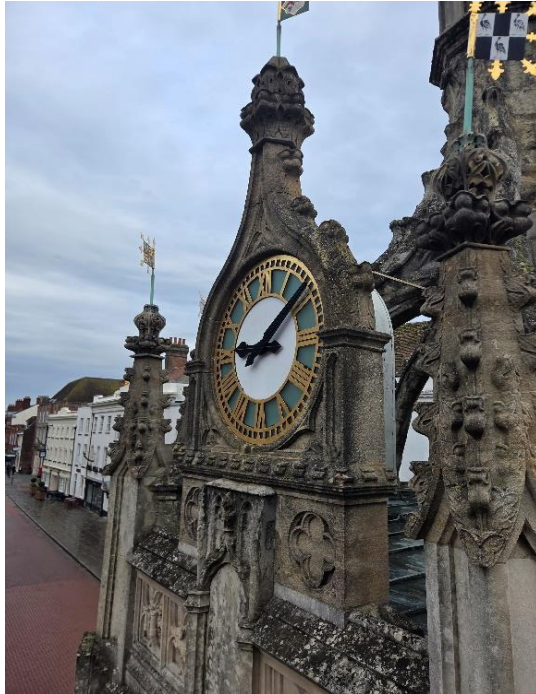
24. The stone is weather stained and covered in lichen.

The stonework is in generally good condition, mainly because so much of it has been replaced in modern times. There is general weather staining and lichen to various elements across the piece and the affected areas should be cleaned using a light non-abrasive steam based method such as Dof. There does not seem to be any mortar in the joint at the base of the pinnacles so these joints should be prepared and then pointed in a lime mortar.

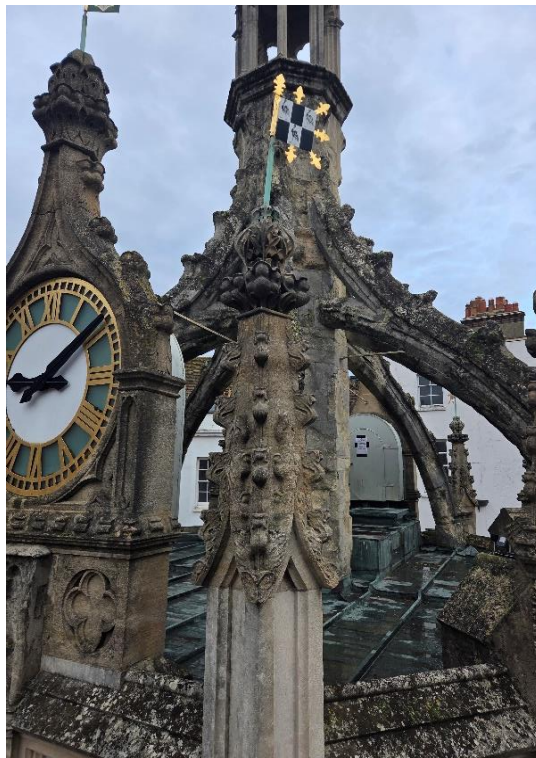
25. The Clipsham stone has not been a good colour match for the Caen and Portland stone.

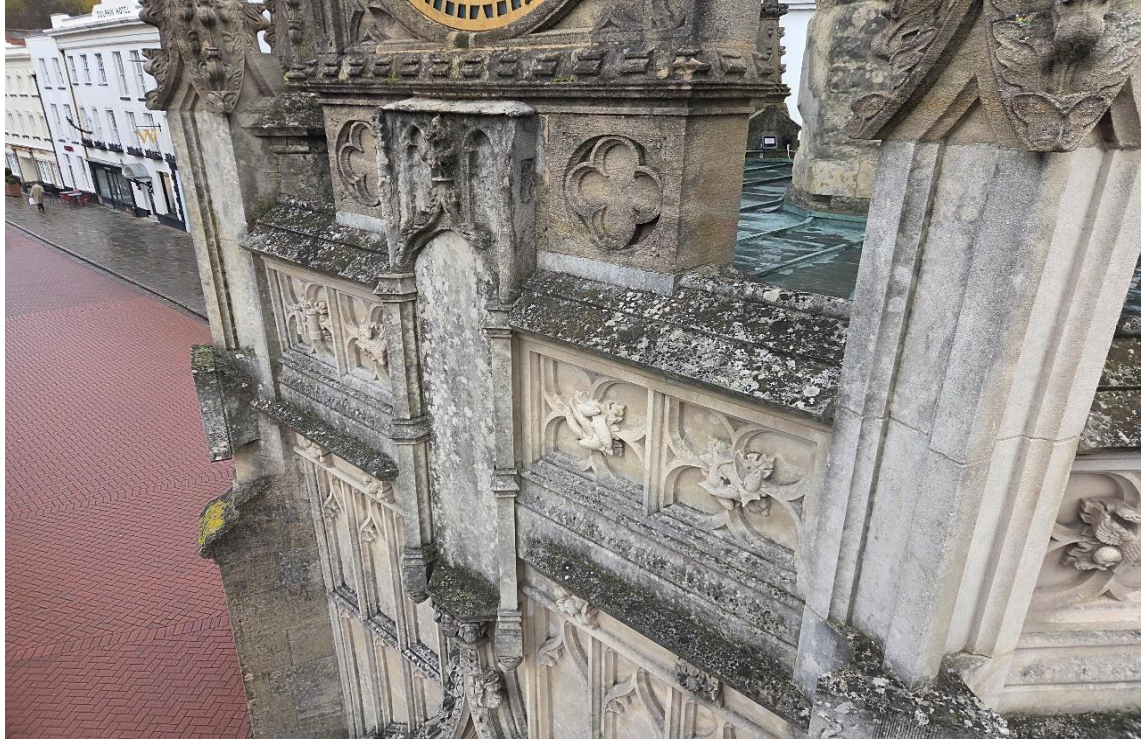
26. The detailing to the stone remains crisp but there is staining across the face.

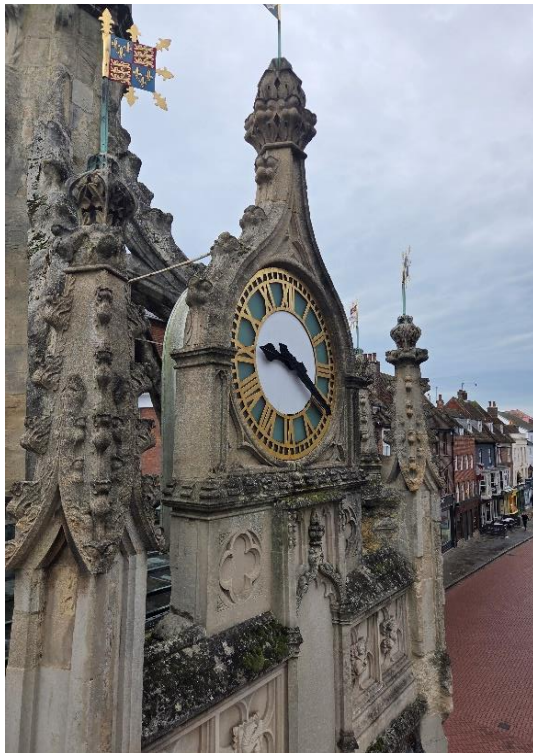
31. As for other elevations there was much weather staining to the elevation.

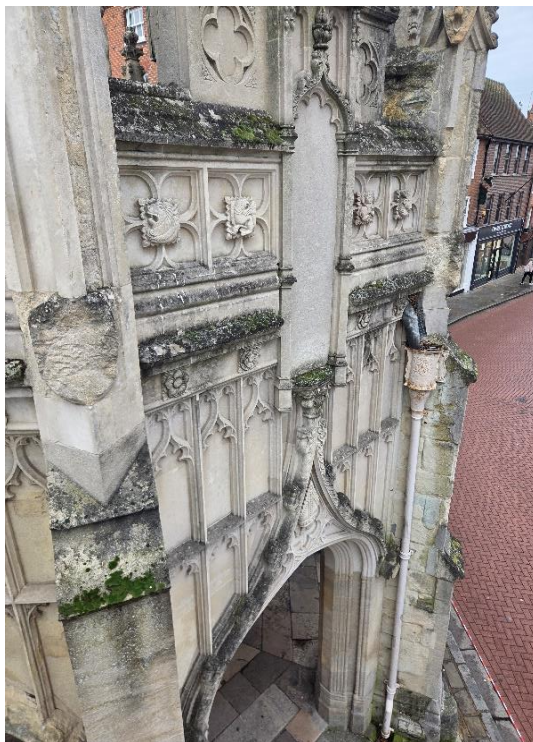
33. The shield at the base of each corner pinnacle column was missing or eroded.

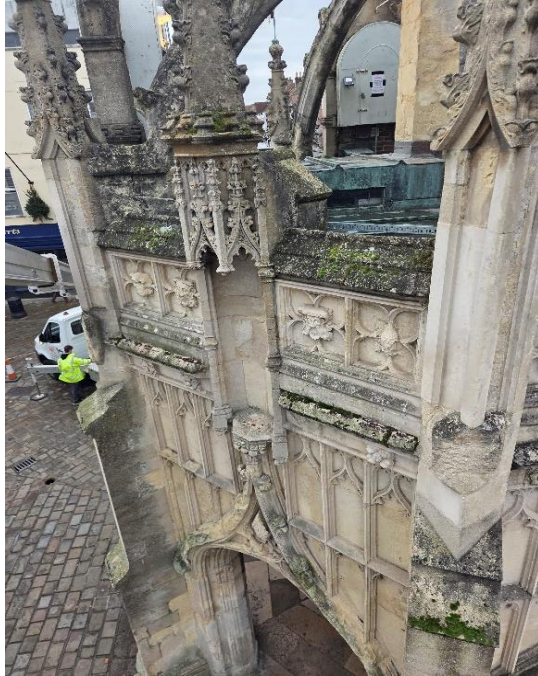
35. Moss growth is evident to the top of the parapet wall and to other sloping surfaces.

There was weather staining and moss growth to the top of the parapet wall, the cornice, the base of a pinnacle, over the niche and elsewhere. The parapet wall capping has been repaired in the past but areas of the surface have cracked off and further this timer suitable mortar repairs are required. The shields at the base of the pinnacles are either wholly eroded, have fallen off or perhaps have been crudely removed in the past as form the west elevation. Two motifs to the frieze have eroded back and one boss to the stone band is missing. It would be a purely philosophical question as to whether the council would want to reinstate the missing elements. There is minor cracking noted, and cracking and delamination to the top of the parapet wall on its inner face. There are small holes in the stonework forming the base of the buttresses. The cracking should be carefully raked out and the cracks and the small holes in the buttress bases all infilled with lime mortar that is slightly weaker than the stone.

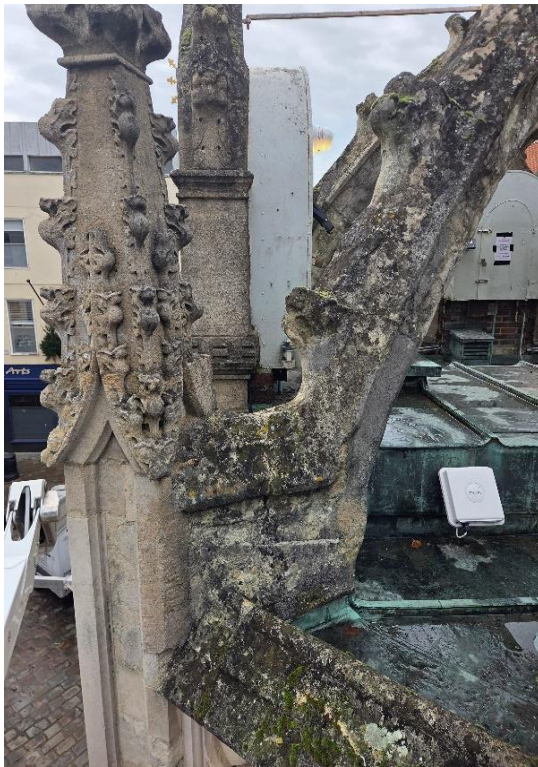
36. Significant open joint at base of flying buttress to rear of pinnacle shaft.

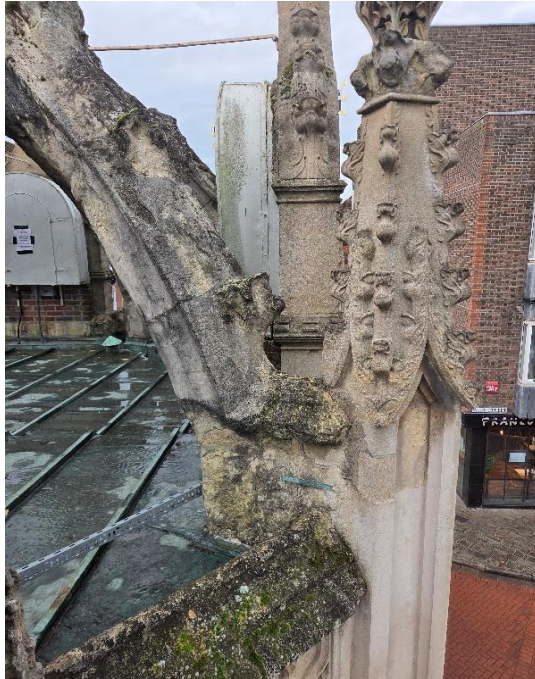
37. Copper cramp evident to stone between base of flying buttress and base of pinnacle.

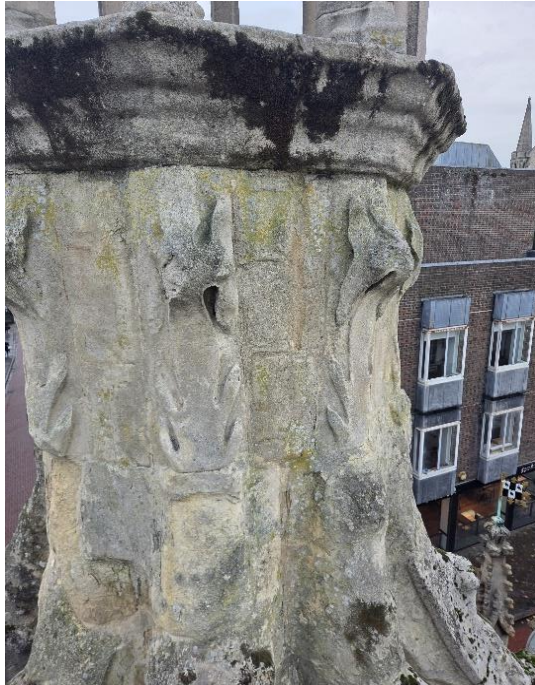
38. Top of central shaft with stone detail on each angle heavily eroded, possibly acanthus.

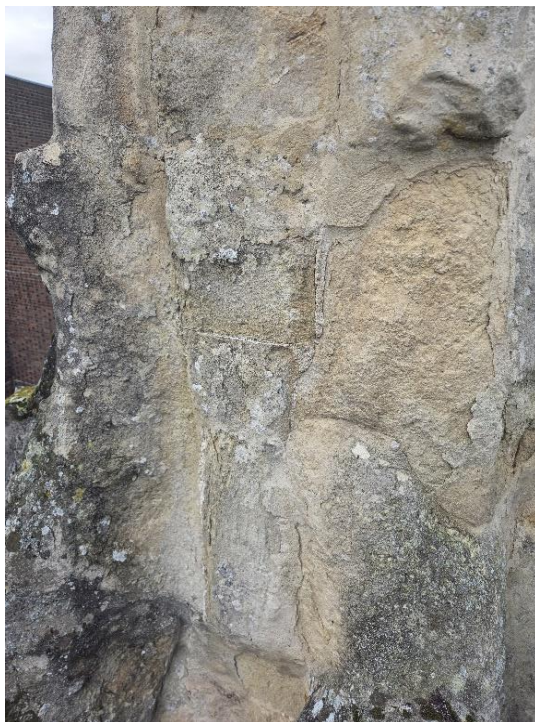
39. View of delamination to face of stonework above where flyers are jointed in.

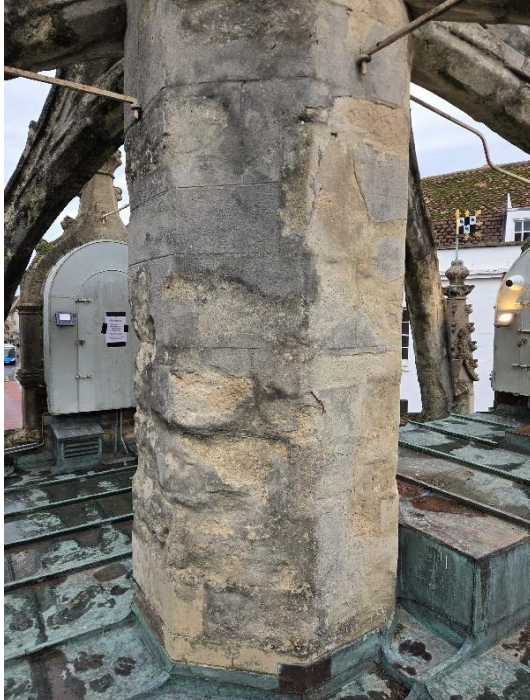
40. This view shows both the delamination of the stone face and old cement repairs.

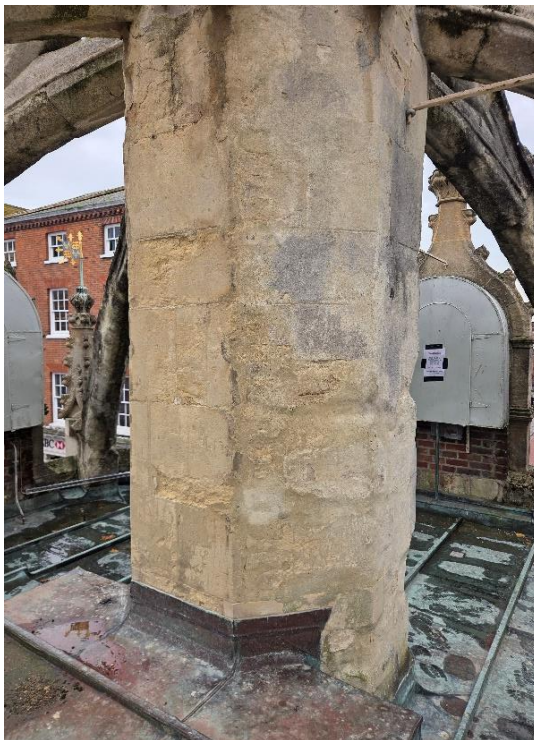
41. This view shows that the cement repairs are to be found to only some of the faces.

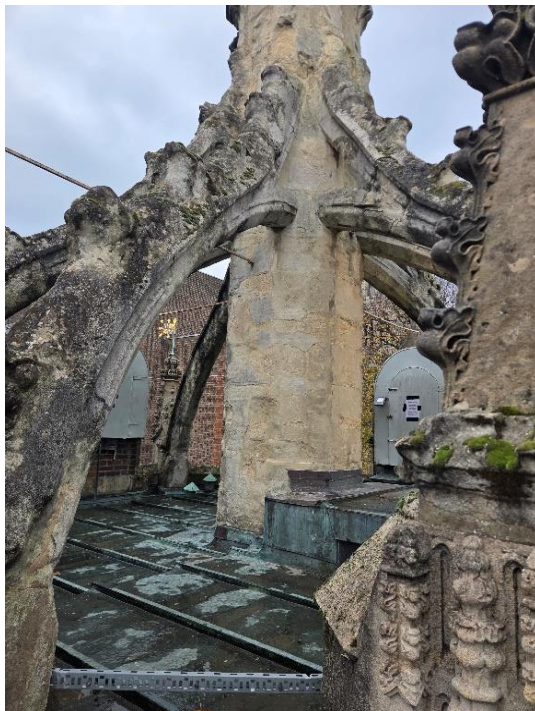
42. The upper faces of the flyers are encrusted with moss, lichen and weather staining.

All crockets are severely eroded and there is a heavy layer of lichen and weather staining, mainly to the upper surfaces. There is some surface delamination present such as to the top of the bases of the flyers. Old discoloured cement repairs, mostly in the form of face filling, are evident to the upper surfaces, and some joints are beginning to open up in areas, including specifically the joint at the top of the base to the north east elevation. A flyer to the north elevation has a failing mortar repair. The staining to the top of the flyers is unsightly but not really causing any deterioration. Due to their location a view of them is restricted and it is likely if they were cleaned a very patchy appearance would be the result due to the numerous cement repairs undertaken in the past. Therefore we do not suggest the flyers are cleaned and only that any cracks or open joints are raked out and filled with lime mortar.

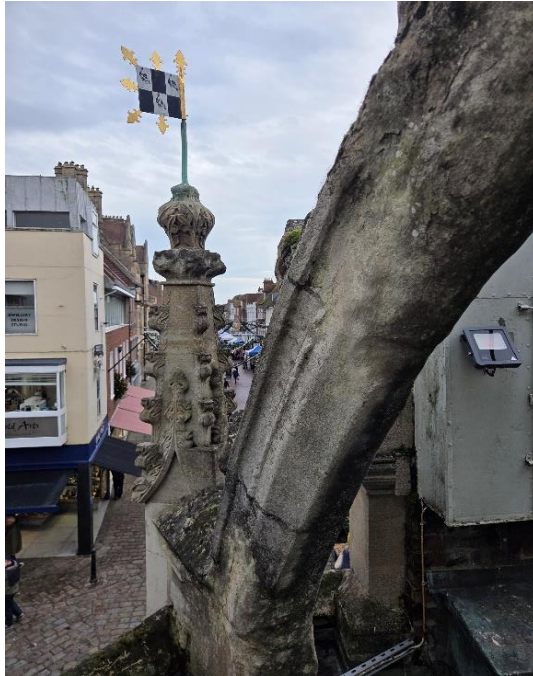
43. The fluted underside of the flyers is heavily eroded in areas and has lost distinction.

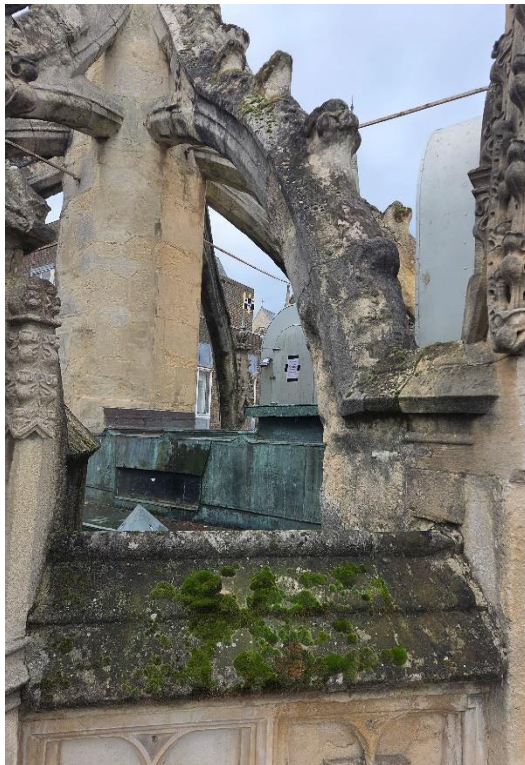
44. The crockets are all so heavily eroded their detail can not be understood.

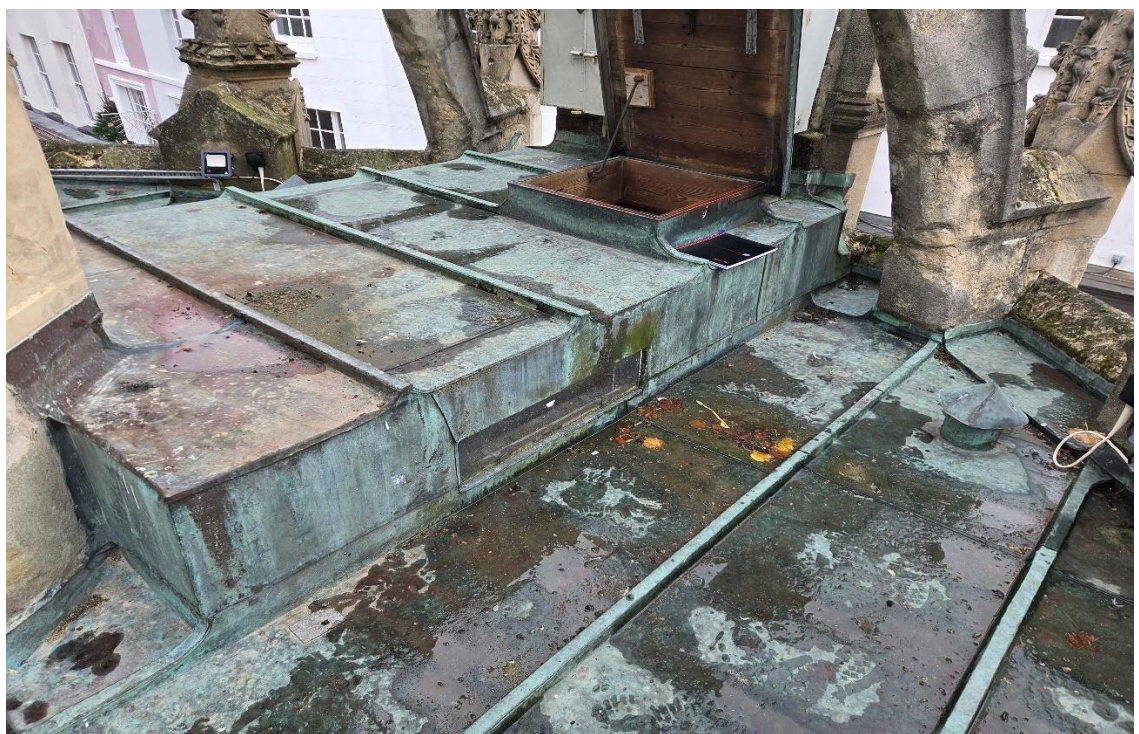
There are three old small patch repairs to the copper sheet which have been undertaken in a Flashband-type material but seem to be holding. However, there is a hole in the copper to the sheet on the raised platform nearest the central shaft where water is ponding, and this has led to water ingress beneath and decay of the timber deck. The hole has been recently temporarily sealed with mastic by the council pending a permanent repair, which will entail replacement of the whole sheet affected. There was a section of flashing to the base of a flyer where the mortar to the top of the joint had failed and required repointing, and another section of flashing was slightly displaced and required reinstatement.

46. The water ponding to the roof sheet nearest the shaft is where there has been a leak.

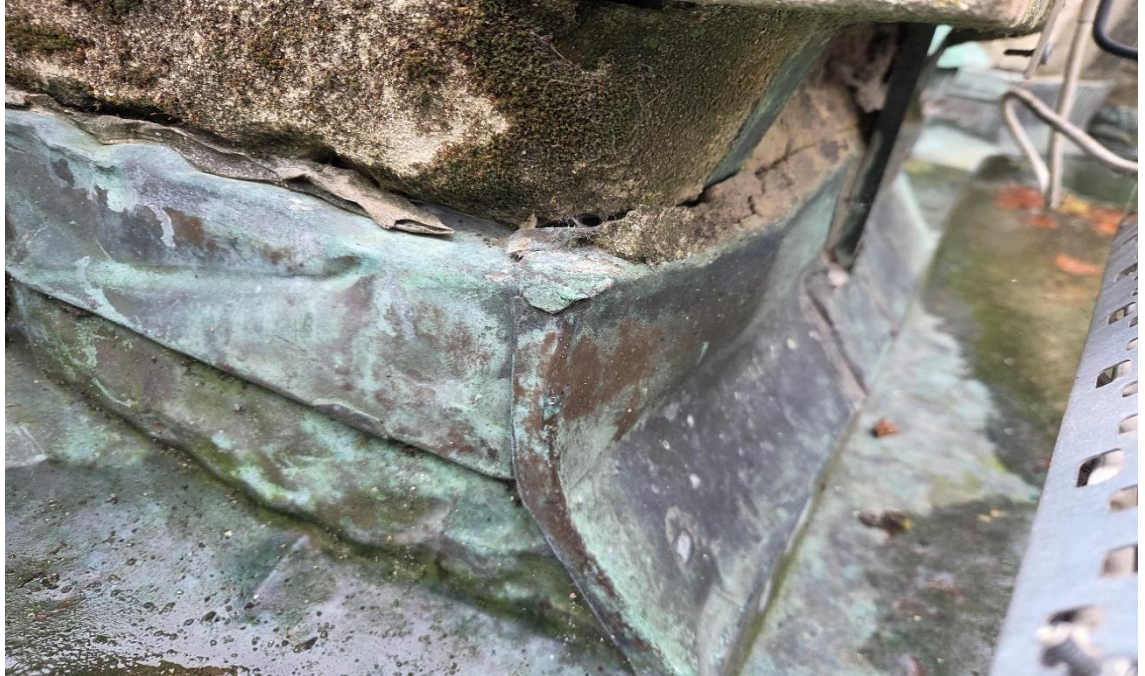
47. To the base of one flyer the mortar joint to the top of the copper flashing was failing.

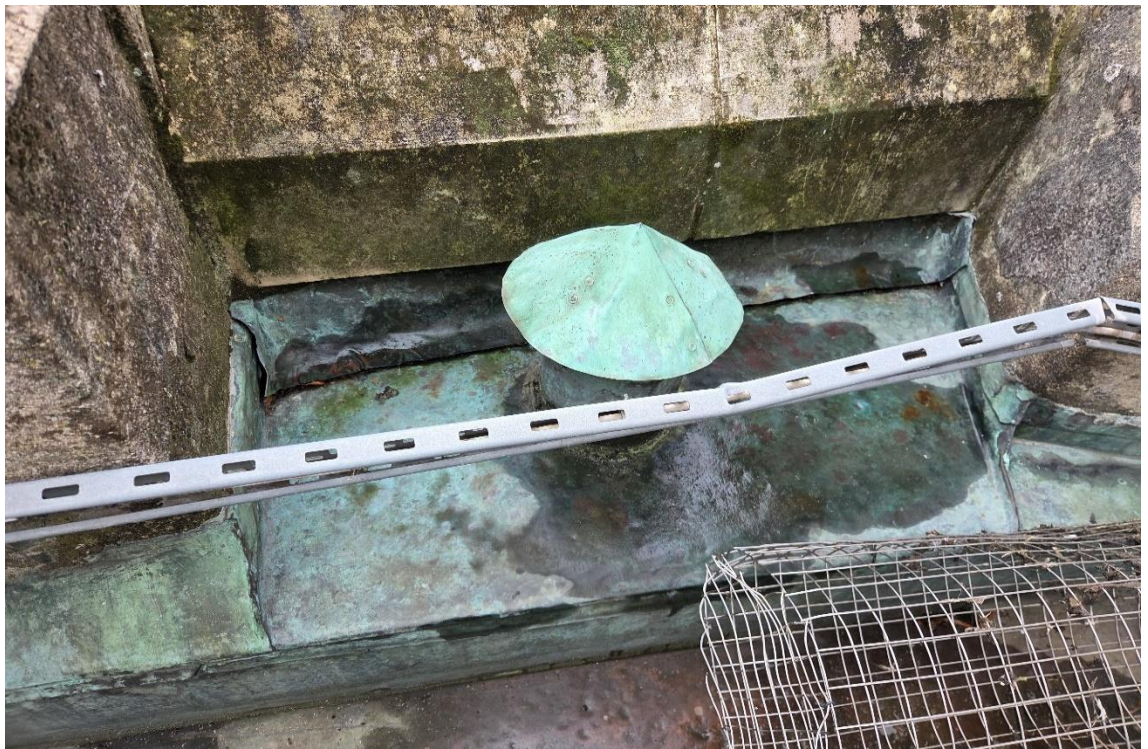
48. A section of copper flashing on the inner face of the parapet wall was displaced.

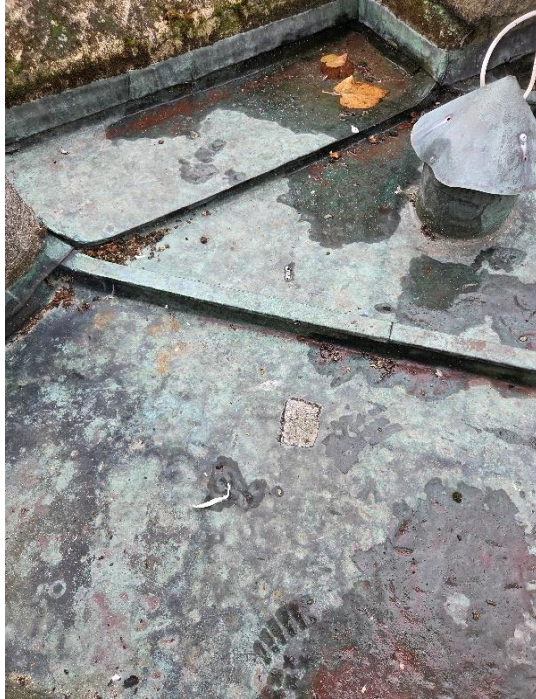
49. Including the one in this photo there were three small patch repairs to the copper roof.

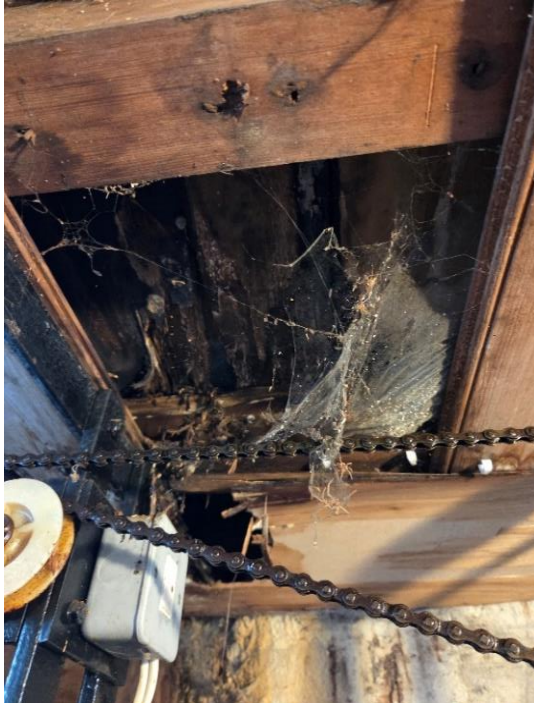
original timber. There is a further area of decay to the roof deck just into the void from the clock enclosure and this seems to correspond with the repair patch near the raised platform. It is believed to be historic and the timber deck is dry but the strength of the timber has been compromised by the decay. When roof repairs are undertaken to the raised platform this area should be addressed too, but the historic tongue and groove ceiling boards should of course be retained.

51. Decay to roofing deck over clock mechanism where boards are missing.

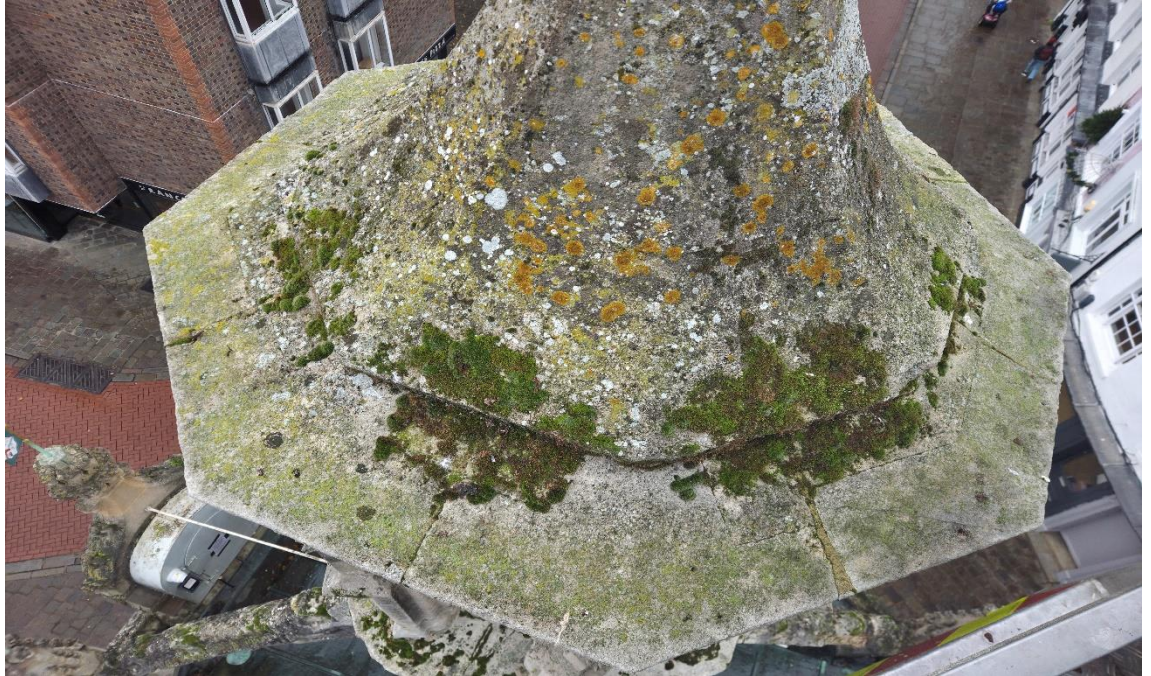
55. Closer view of moss and lichen encrusted stone roof to cupola.

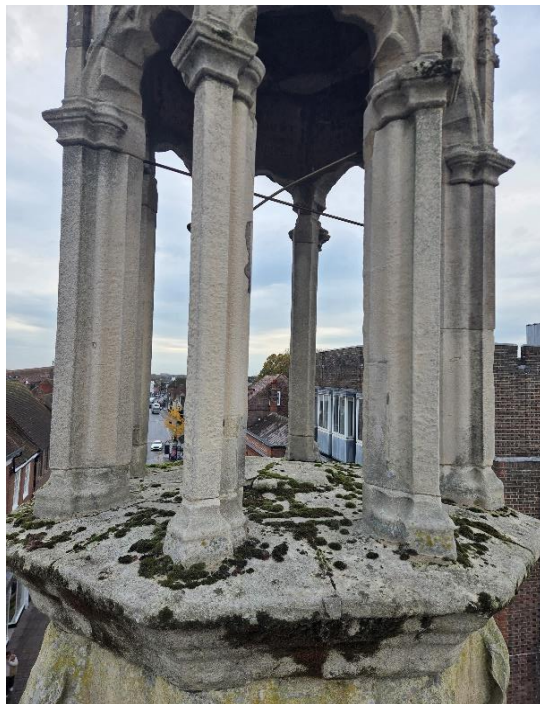
There is significant erosion of the detail of the piers, panels and cusps. The mortar joints to the base and tops of the piers have worn away and we do recommend that the joints are repointed in lime. One of the stiffening rods has come out of its eyelet at one end while the other is curved, and the displaced one should surely be reinstated. These rods should be checked by a structural engineer to ensure they are still performing their function.

56. The piers are heavily eroded and there is much moss cover on the base.

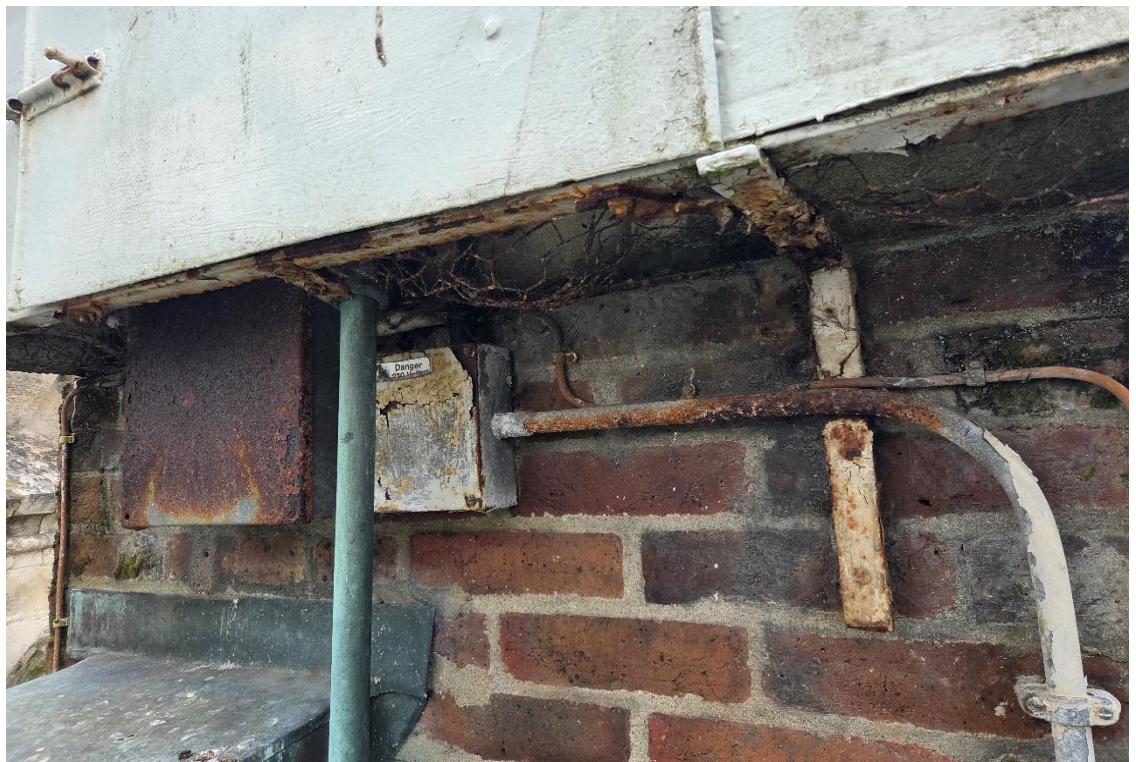
59. This photo shows the corrosion to the support brackets beneath the clock casing.
