CHICHESTER CITY CENTRE PAVEMENTS

Options Study on Maintenance and Replacement

March 2021

TECHNICAL NOTE

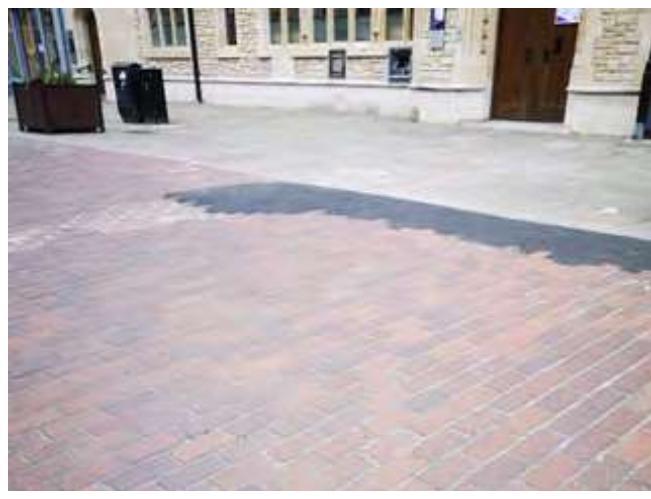
Figure 6.1: Temporary repairs to block paving with asphalt (utilities)

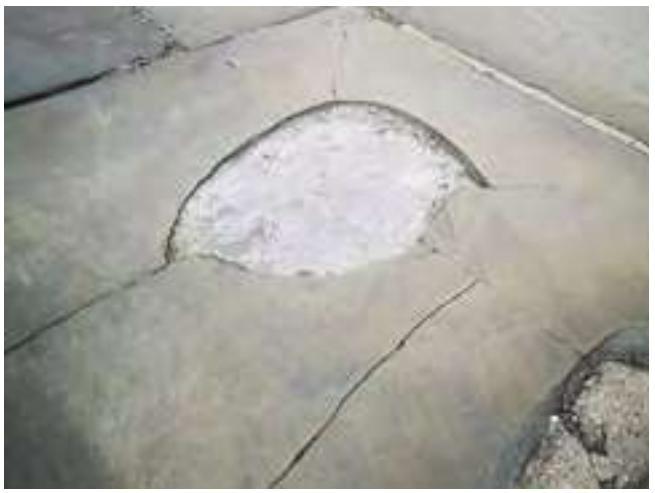
6.2.26 Figure 6.2 indicates a repair made to a broken paving slab. The slab appears to have been repaired by filling the cavity with concrete, and not levelling off the surface or replacing the broken slab, leaving a potential trip hazard. Although the repair potentially addresses a larger hazard, it replaces it with a smaller one rather than eliminating the problem. It is not possible to determine why the surface has not been levelled. Equally, the reinstatement does not uphold the aesthetic standard of the pavement. It appears that without a more formalised process of subsequent inspections of workmanship quality for repairs under the Safety Plus process, this type of issue may re-occur.

Figure 6.2: Broken slabs repaired with concrete

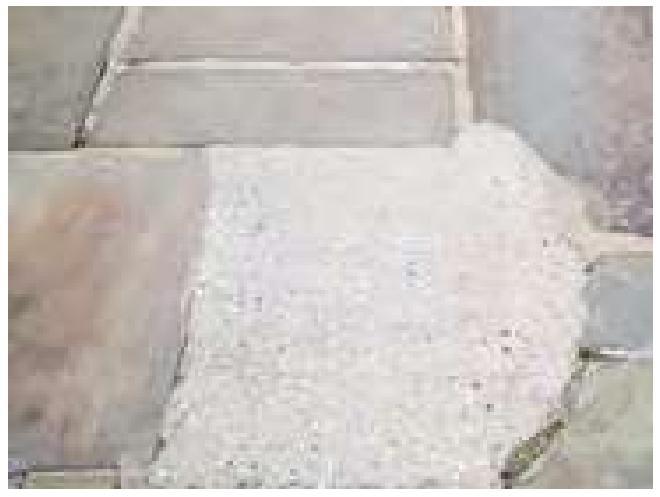
Figure 6. 3: Slab infill with concrete

6.2.27 Figure 6.3 shows a similar repair, where the broken slab has been removed and the entire cavity has been filled with concrete. In this case, the concrete surface is flush. However, the aesthetics of the repair are extremely poor.

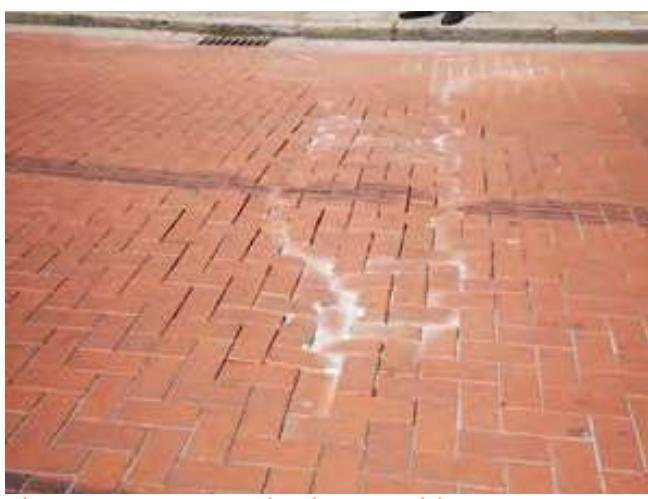
Figure 6. 4: Block paving irregularities

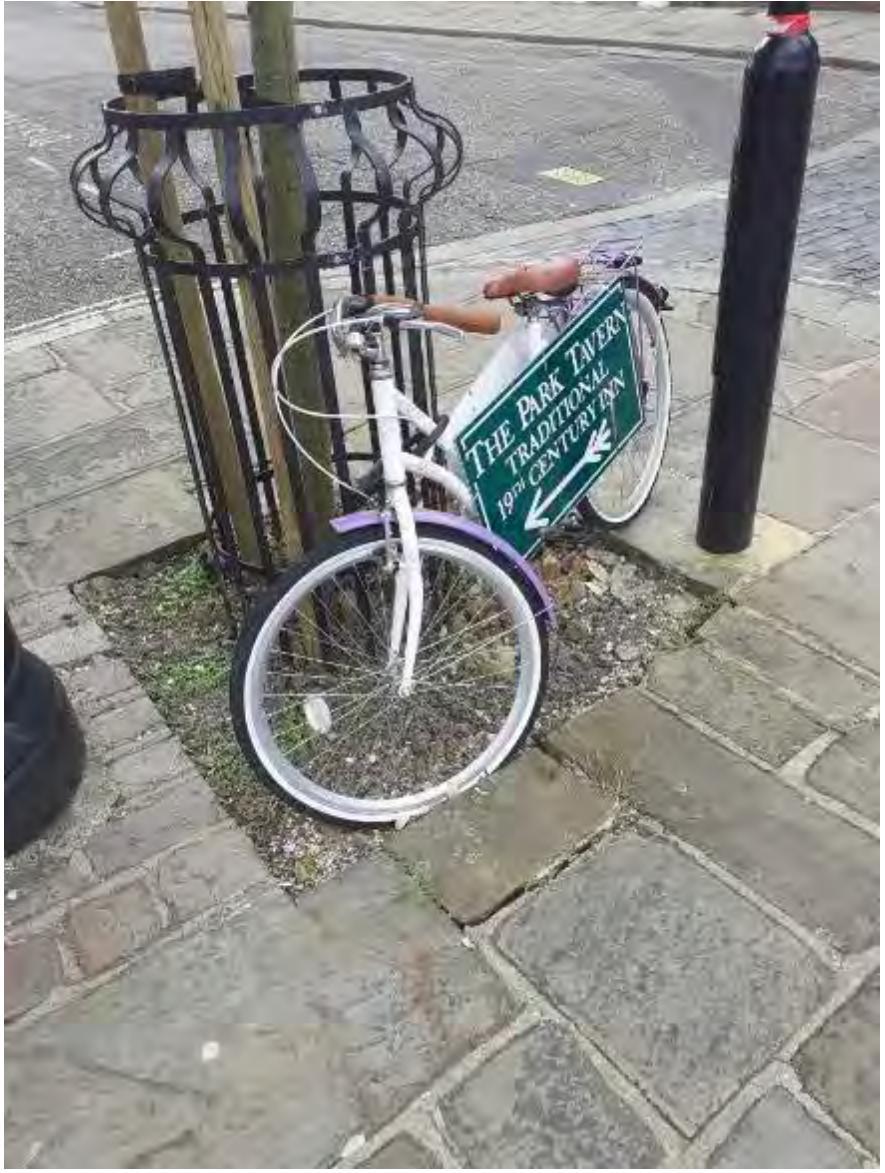
Lack of proper edgings or tree pit protection. Inappropriate street clutter / advertising

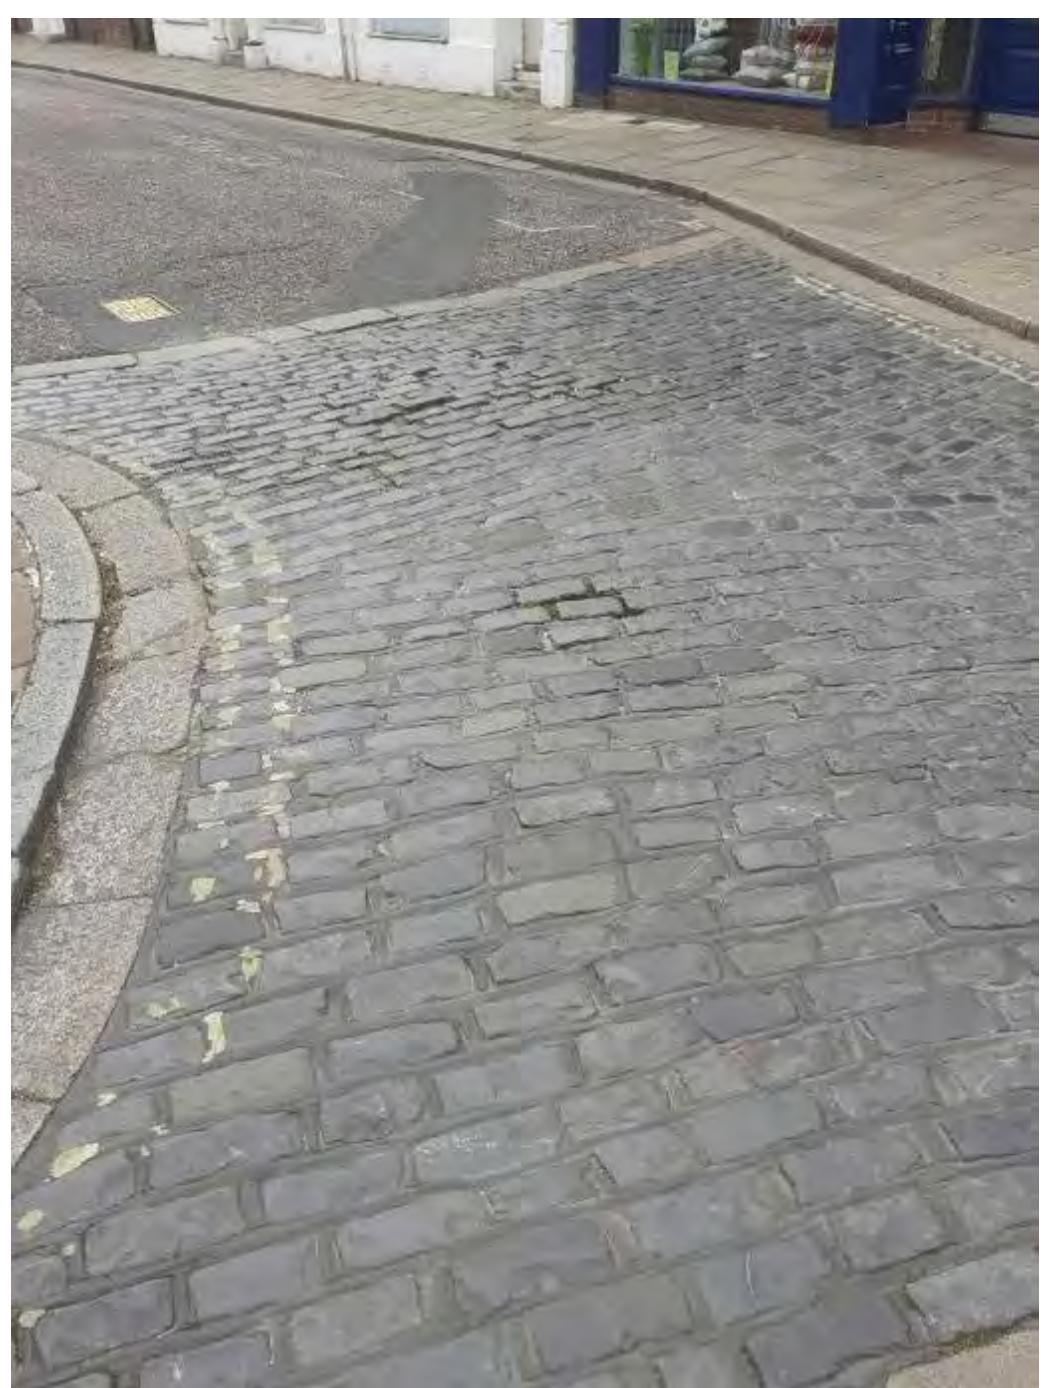
Mortar joints / grouting beginning to fail. Yellow lines ineffective (and inappropriate, perhaps use zonal restrictions) Kerbs and channel failing.

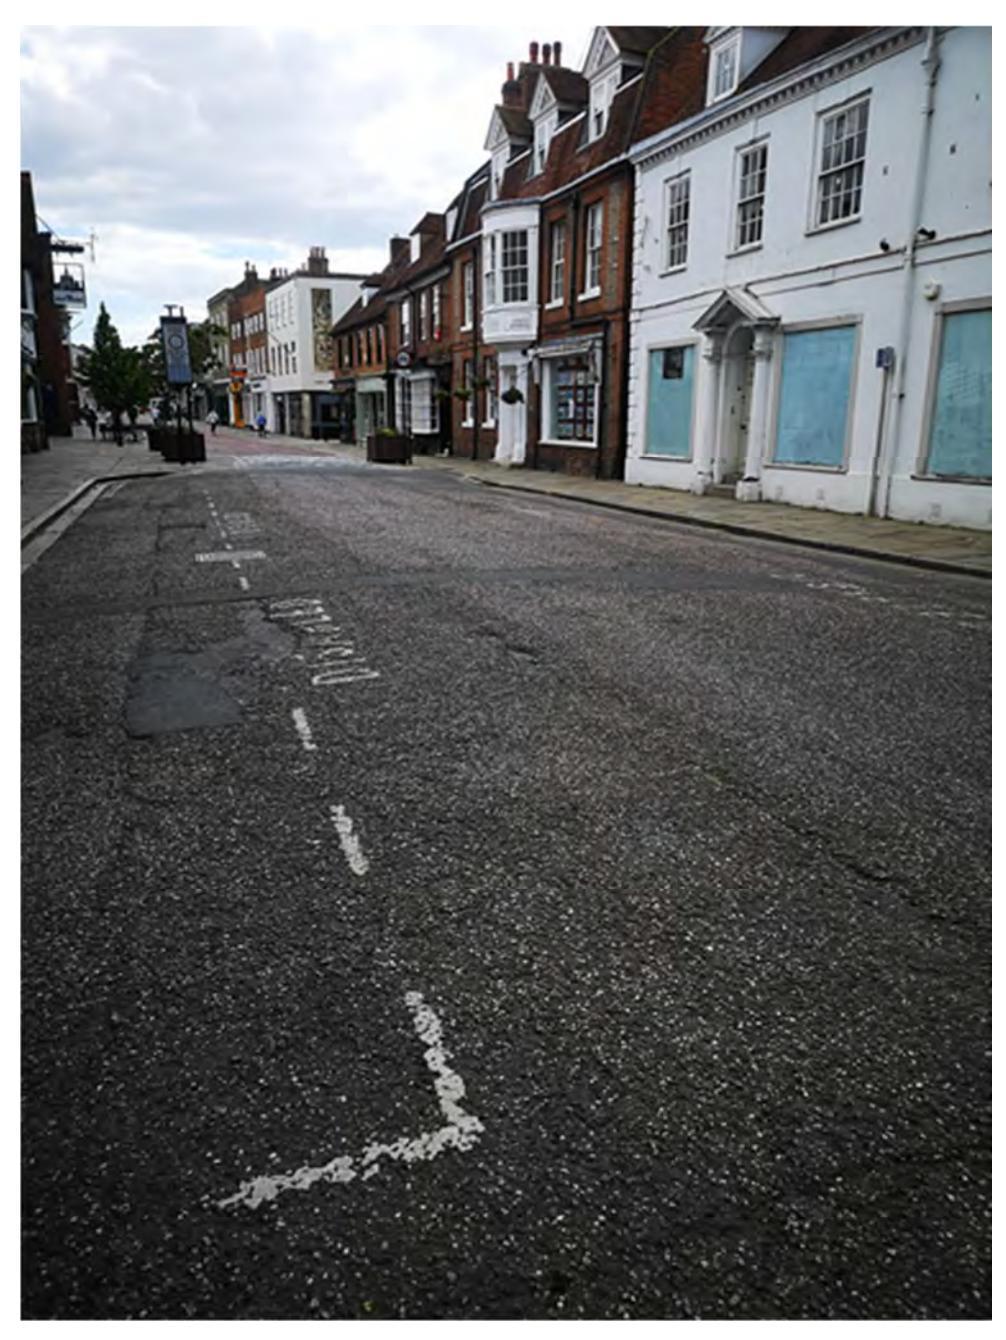
After the gateway there a car parking zone for disabled drivers that is approximately 30 m long and is currently surfaced with asphalt. The asphalt appears to be a very aged hot rolled asphalt containing gravel aggregate. The joints are quite open and there appear to be some failed asphalt patches. The gravel aggregate is well polished and is unlikely to be providing good skidding resistance (although the slow speed of vehicles in this area will mitigate this to a large degree).

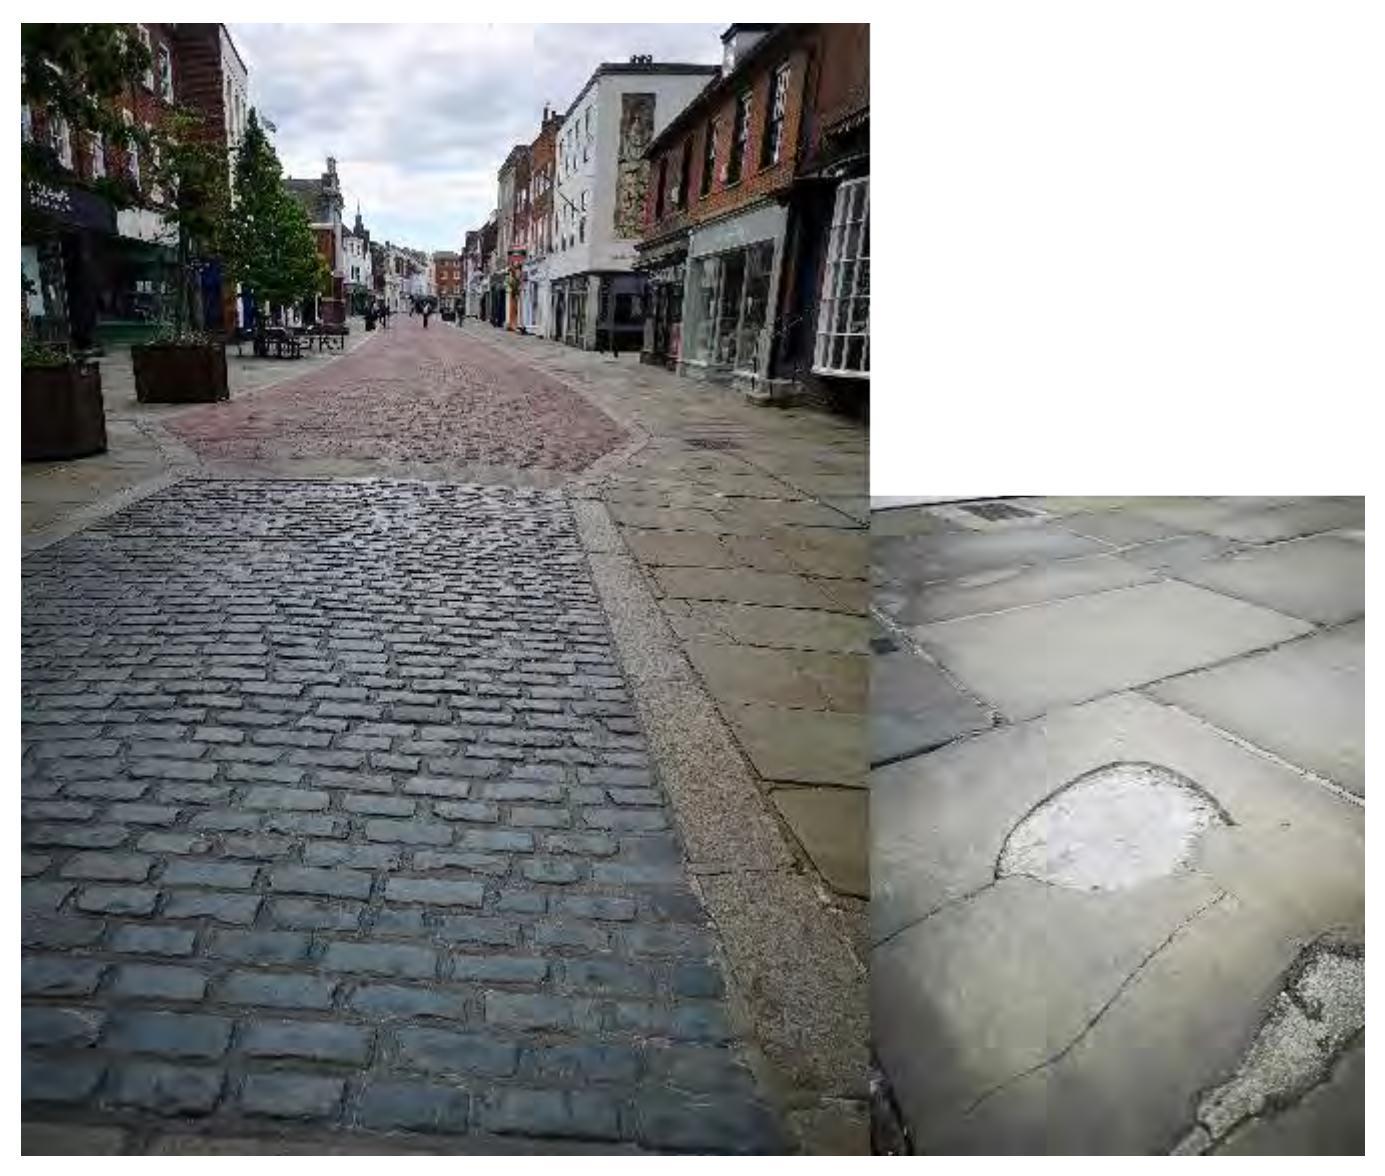
The footways comprise York stone paving slabs of random size and laying pattern in a rigid surface¹, with varying width along the length of North Street. Many of the slabs are cracked and damaged, likely through vehicle overrun. The mortar joints have plucked out and numerous slabs are then beginning to rock and move due to the lack of restraint. Missing mortar also allows the ingress of moisture causing wash out of the structural layers below the slabs. In some instances, the cracked surface of the slab has spalled away leaving a depression.

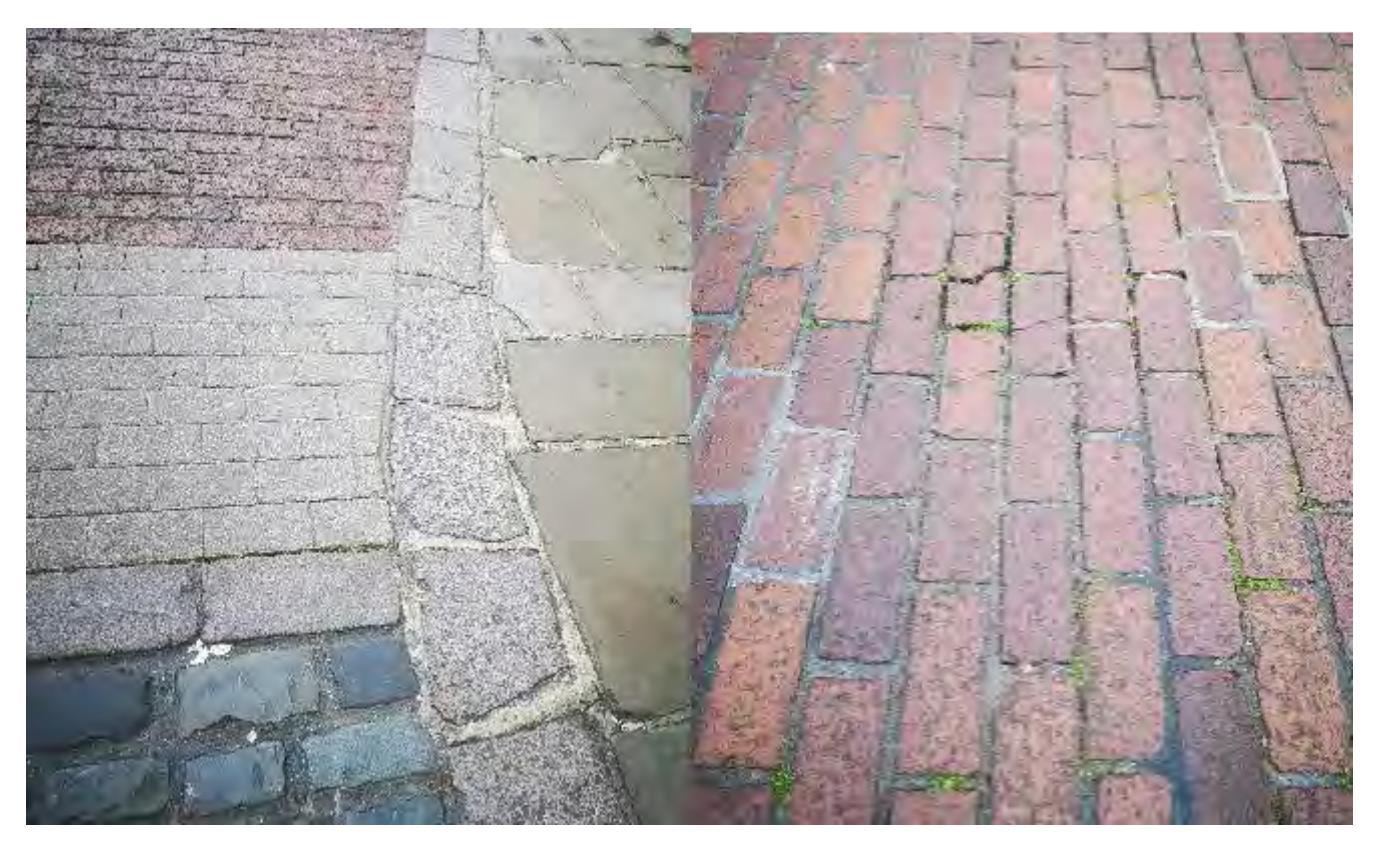
The second gateway at the start of the main pedestrian zone has natural stone paviors in a rigid surface construction. Both of the gateway features have very wide mortar joints around the individual natural stone elements. The second gateway is followed by a strip of concrete paviors in a flexible surface construction (i.e. no mortar in the joints).

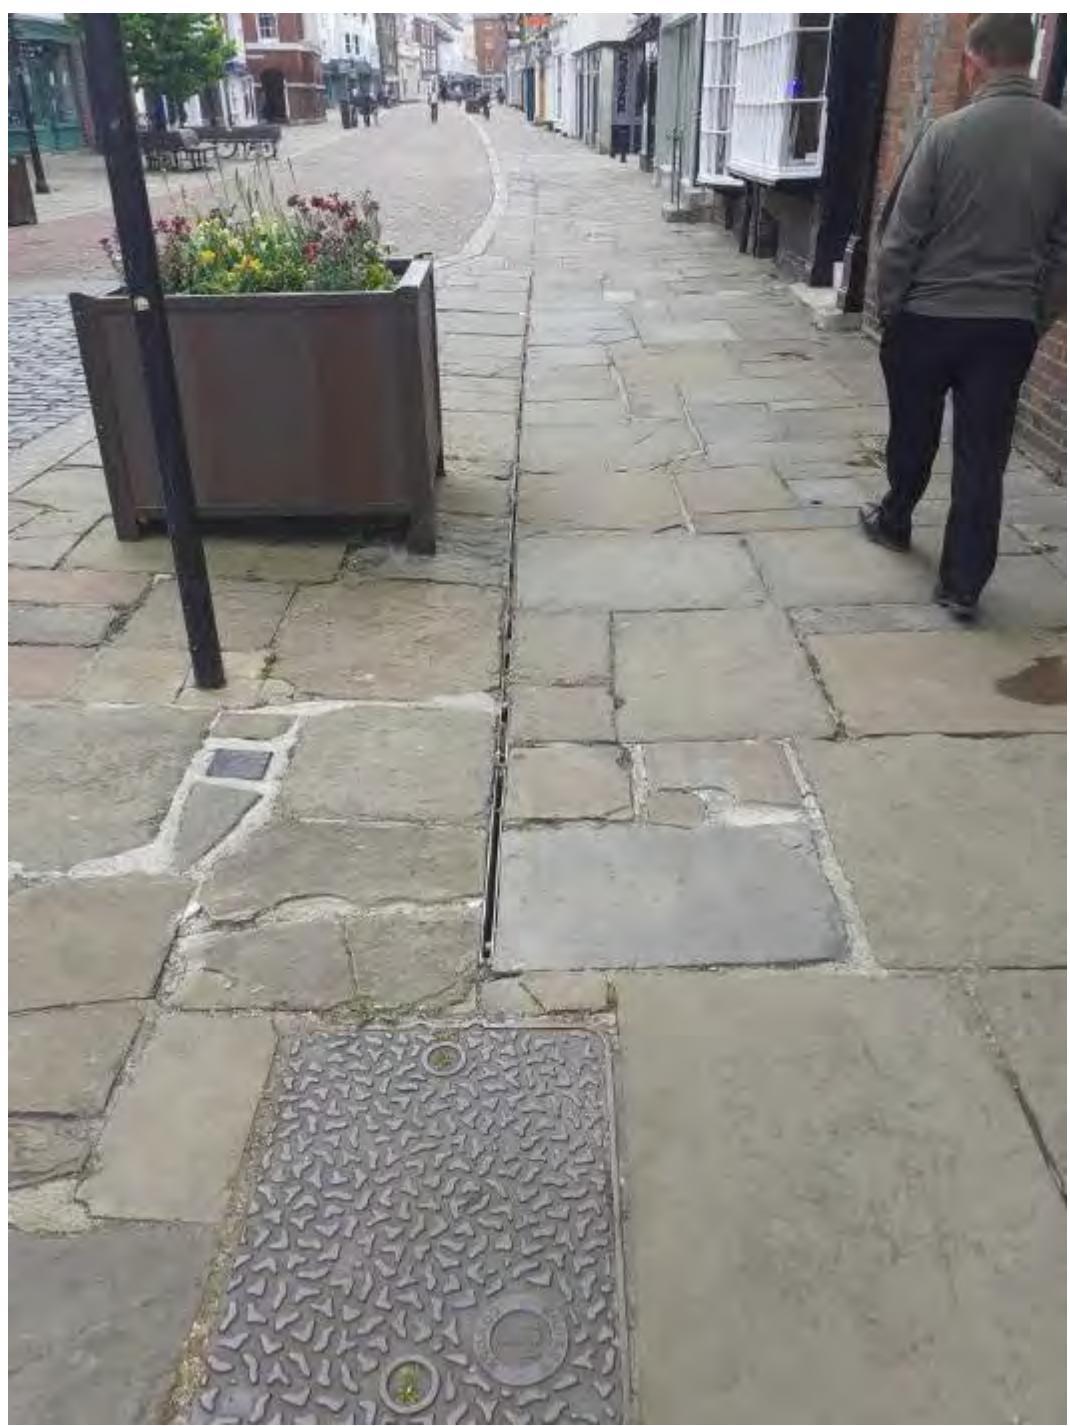
Slot drains blocking up, mortar failing, poor quality colour matching

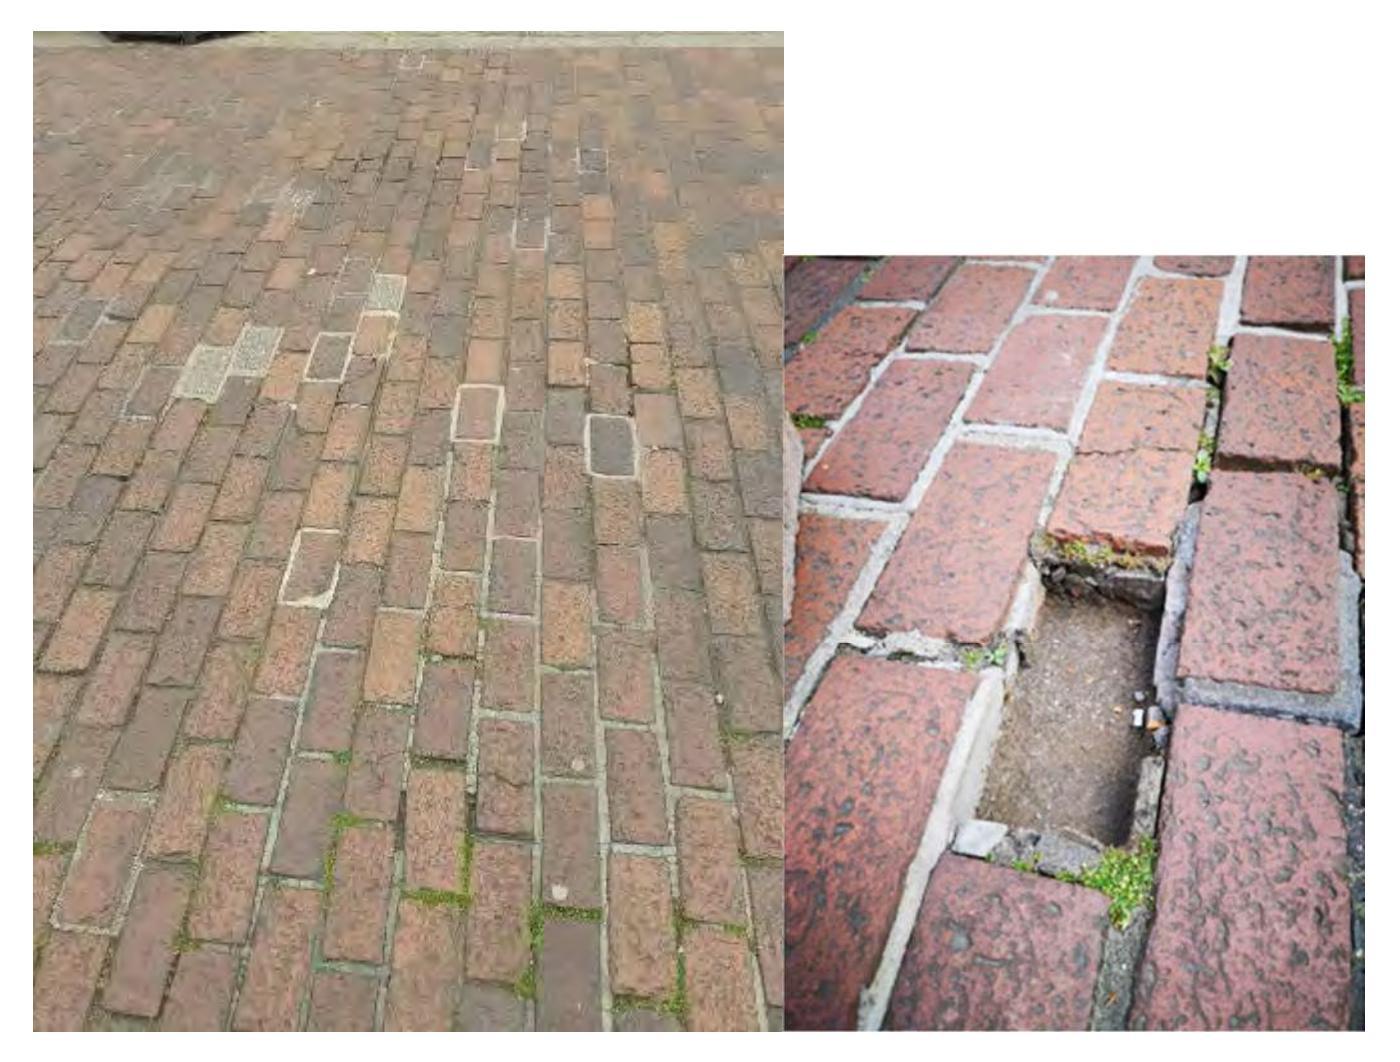
Clay / concrete paviors inappropriate in heart of conservation area. Mortar failing, poor quality matching in. It can be seen that temporary repairs have been undertaken using asphalt in some areas to backfill where the brick paviors have either been removed or have become dislodged.

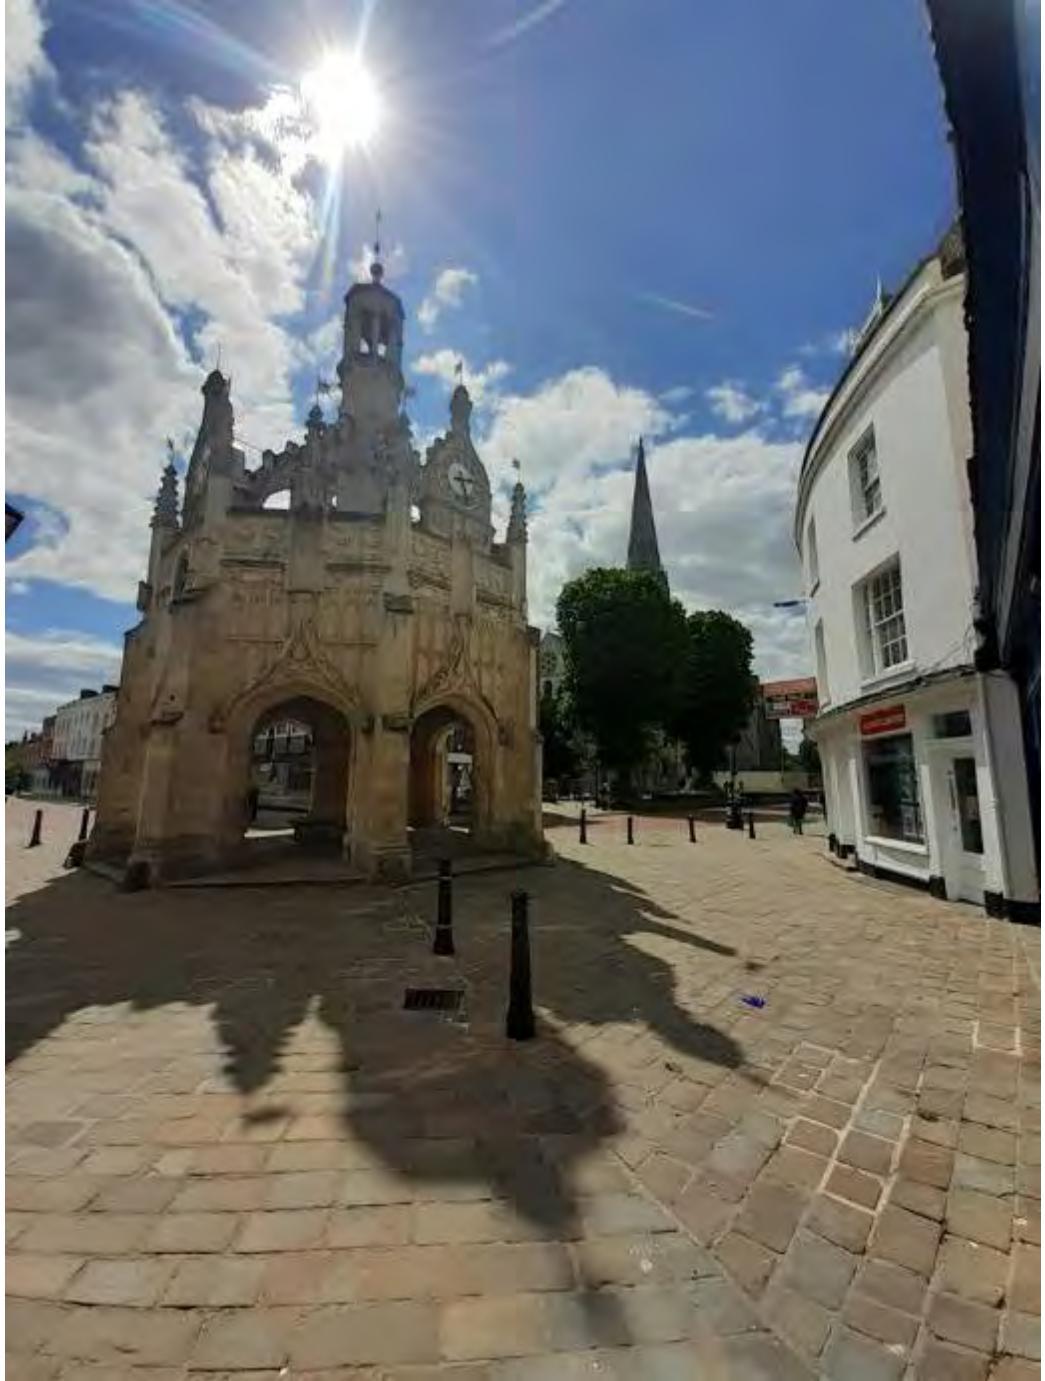
The market cross, this is a key heritage asset. Radiating Octagonal paving causing issues with cuts and maintenance. Contractors clearly struggling to re-lay the stone correctly following repairs.

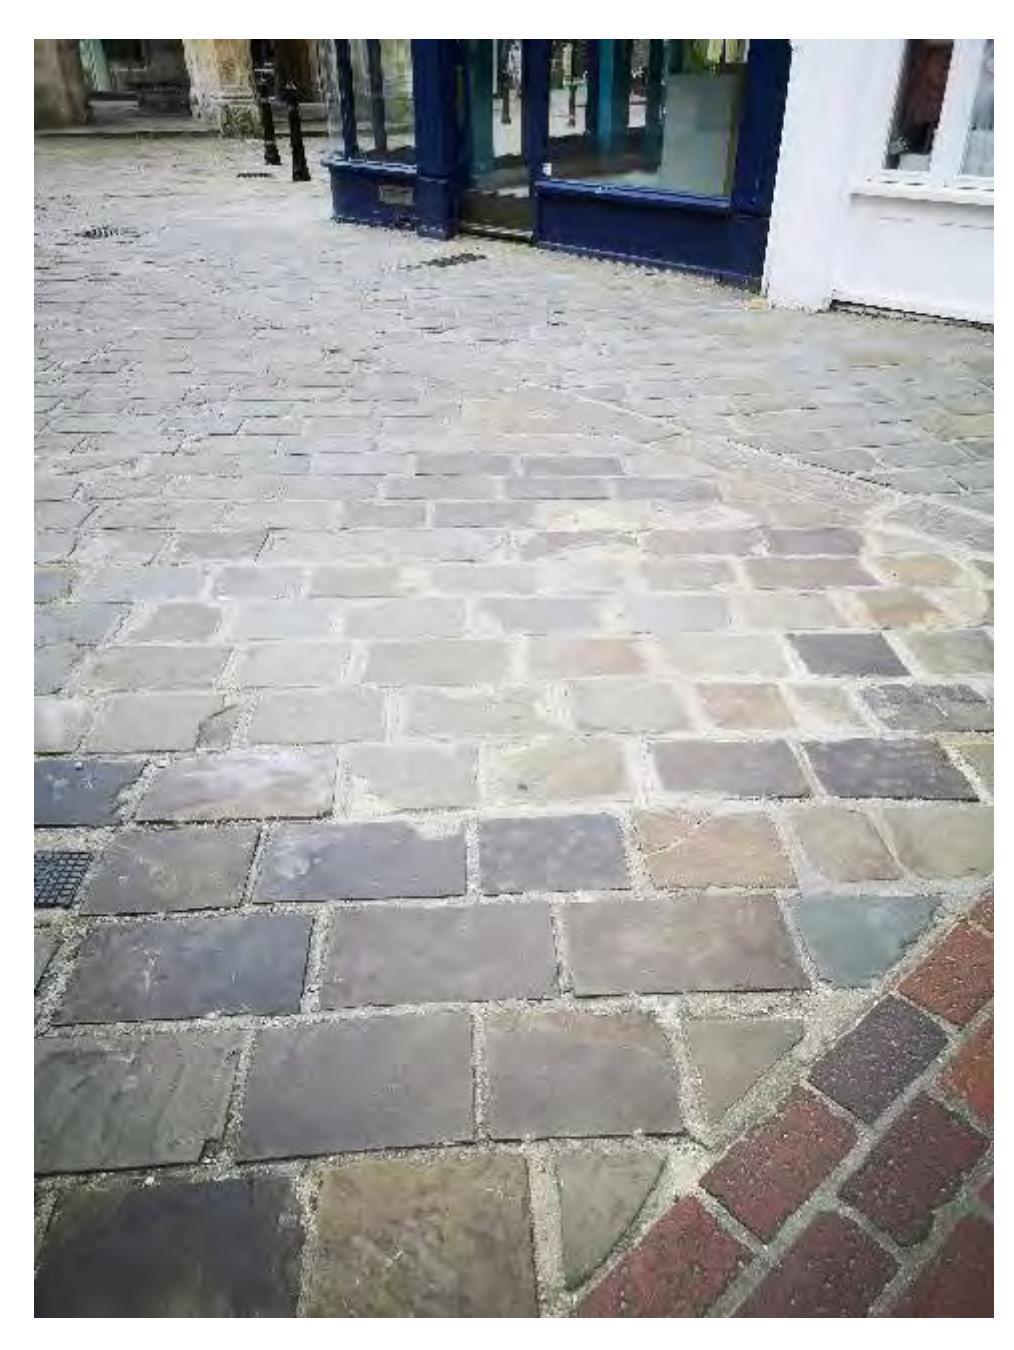
Where North Street meets East Street at the Cross, the paving type changes to a large element natural Purbeck limestone pavior laid in a radial pattern. Again, it is clear that reinstatement after street works have been undertaken is potentially causing issues (mortar width and colour matching). In general, the overall condition of the paving in this area is good.

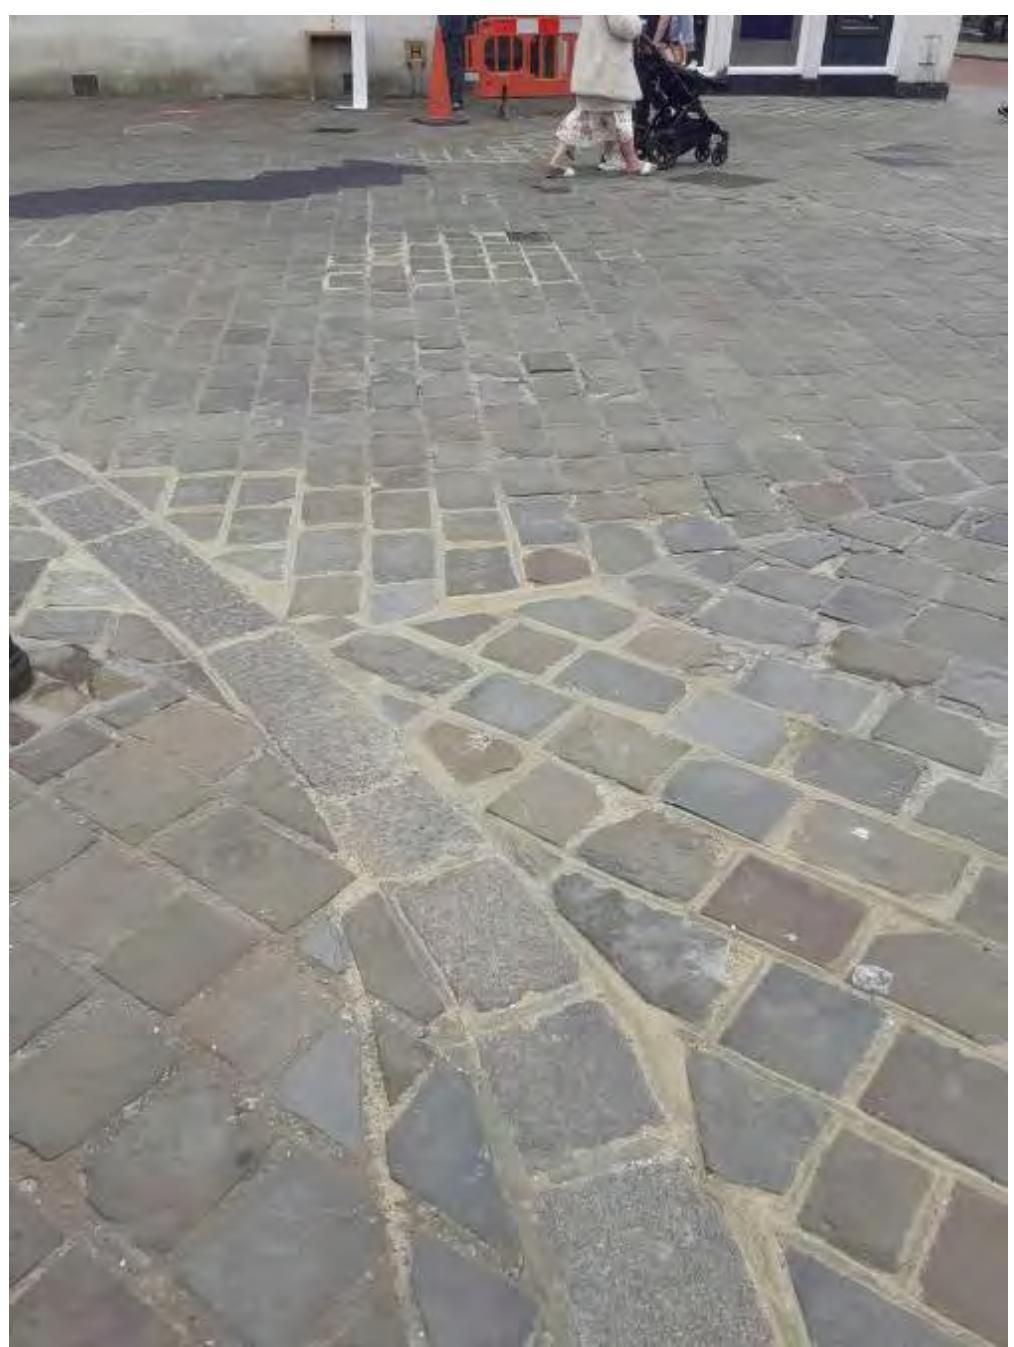
Lots of small cuts, awkward angles and large joints to compensate workmanship issues. Likely to always be a problem unless high quality stone masons are used. It can be seen that asphalt has been used as a temporary reinstatement, whilst awaiting the full repair. It is also clear in the foreground that where the direction of paving changes or the type of paving element changes, the potential for defects increases.

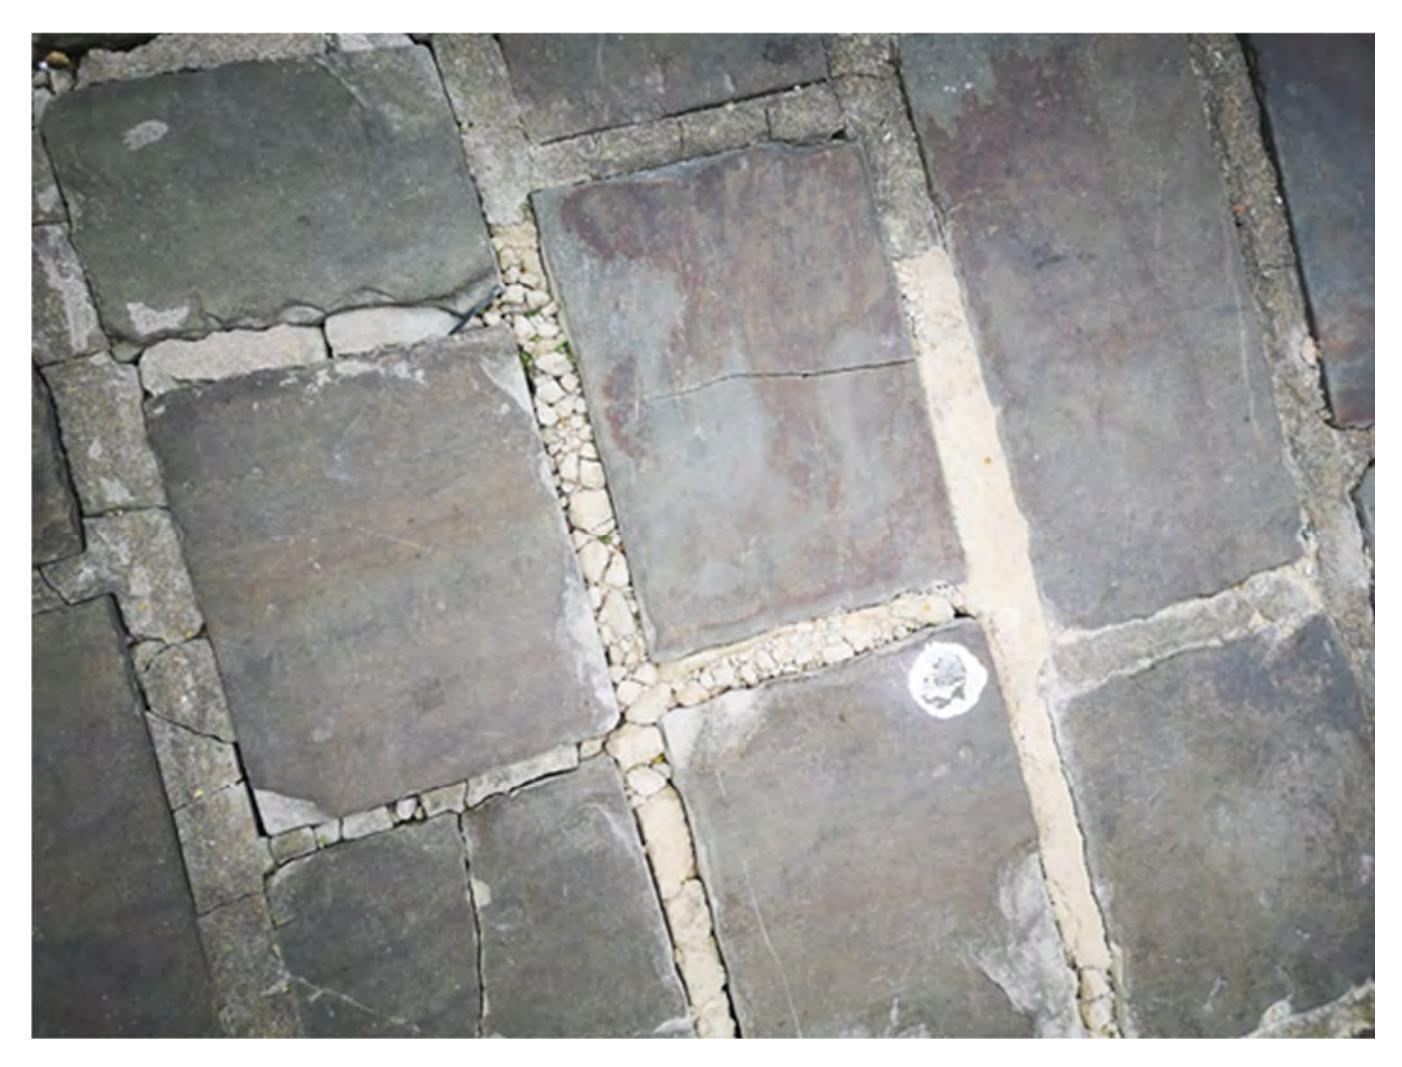
There have also been failures of the replacement mortar in this area. This has led to individual pavior units becoming loose with the risk of them being completely dislodged. The mortar was very friable. However, it is not possible to determine if the specification was inappropriate or if the material did not meet the specification.

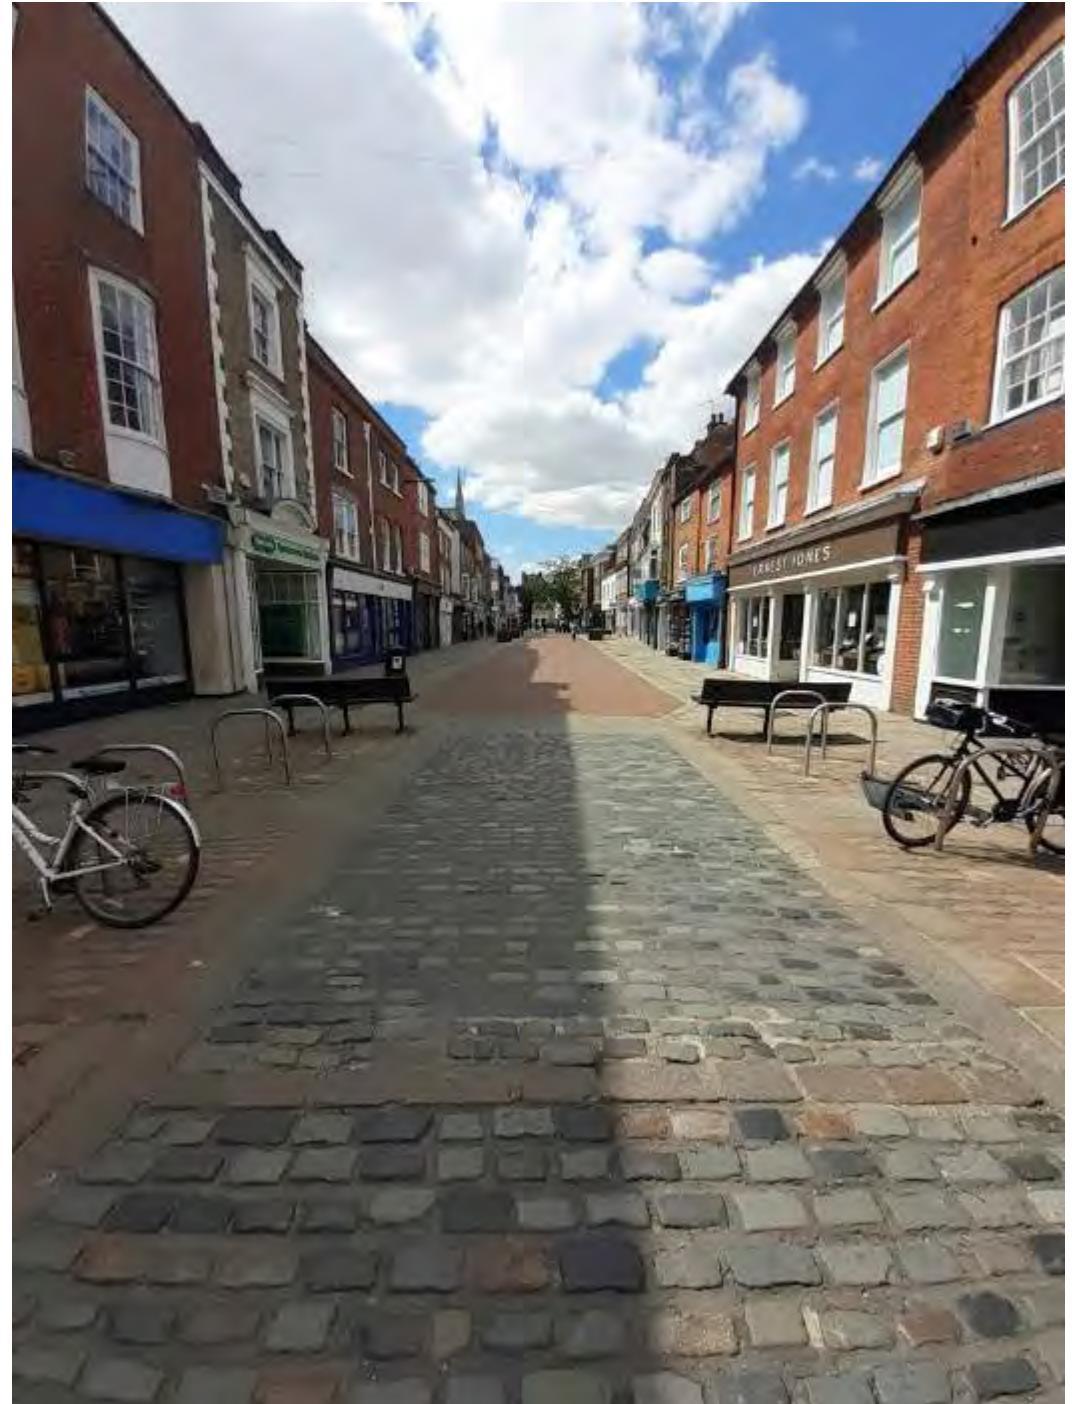
East Street street scene is lacking in interest and quality. It needs softening, greening and low quality materials should be replaced.

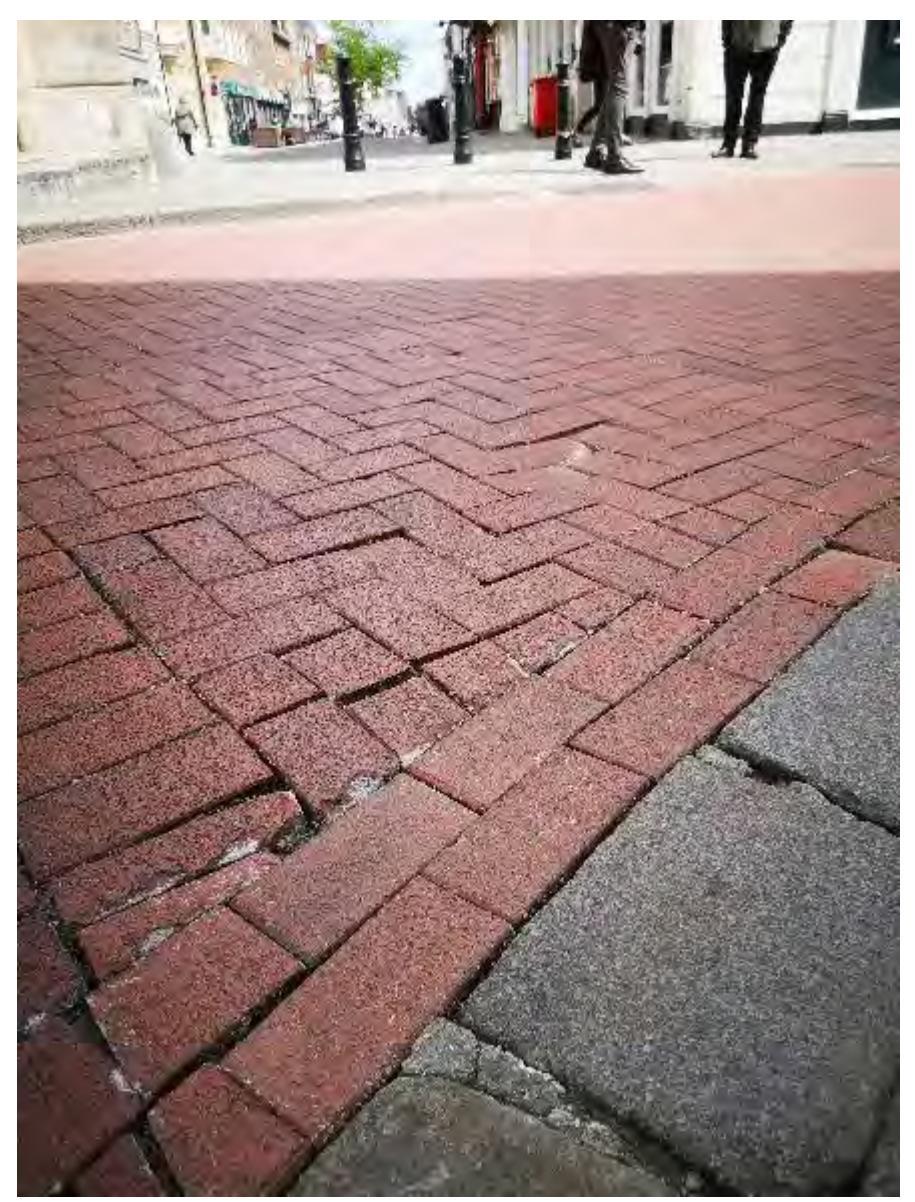
There are there specific areas in South/West Street that have existing defects. The least serious defect is adjacent to the kerb outside Russel and Bromley. It can be seen that an alternative bond pattern has been used in this area. It was also observed that this was regularly over-run by buses. It is unclear whether the laying pattern is to accommodate the alignment or was changed as a result of a previous defect. However, what can be seen is that further depressions and pavior movement has occurred. Where paviors are cut to fit the radius of the curve, they are more likely crack and become dislodged.

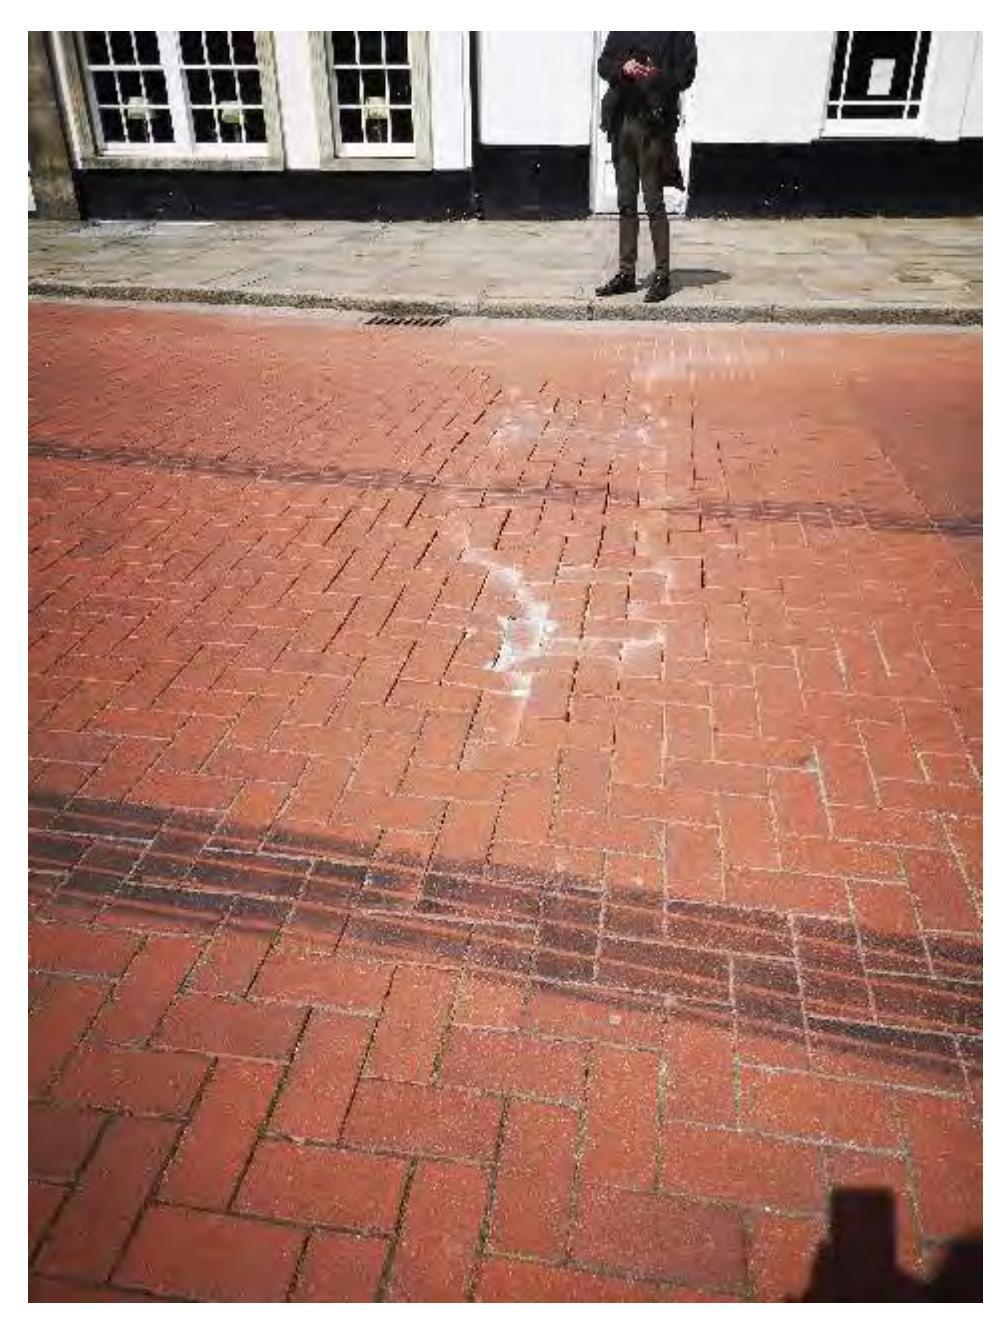
The second defect is on West Street, running transversely across the road pavement outside the Dolphin and Anchor Public House. This appears to be either an historic utility trench or a collapsed pipe beneath the road surface. The defect is not visible in the May 2018 Google Image. It can be seen that the paviors have moved and that bedding sand and other fine material has pumped to the surface.
