CHICHESTER CITY CENTRE PAVEMENTS

Options Study on Maintenance and Replacement

March 2021

TECHNICAL NOTE

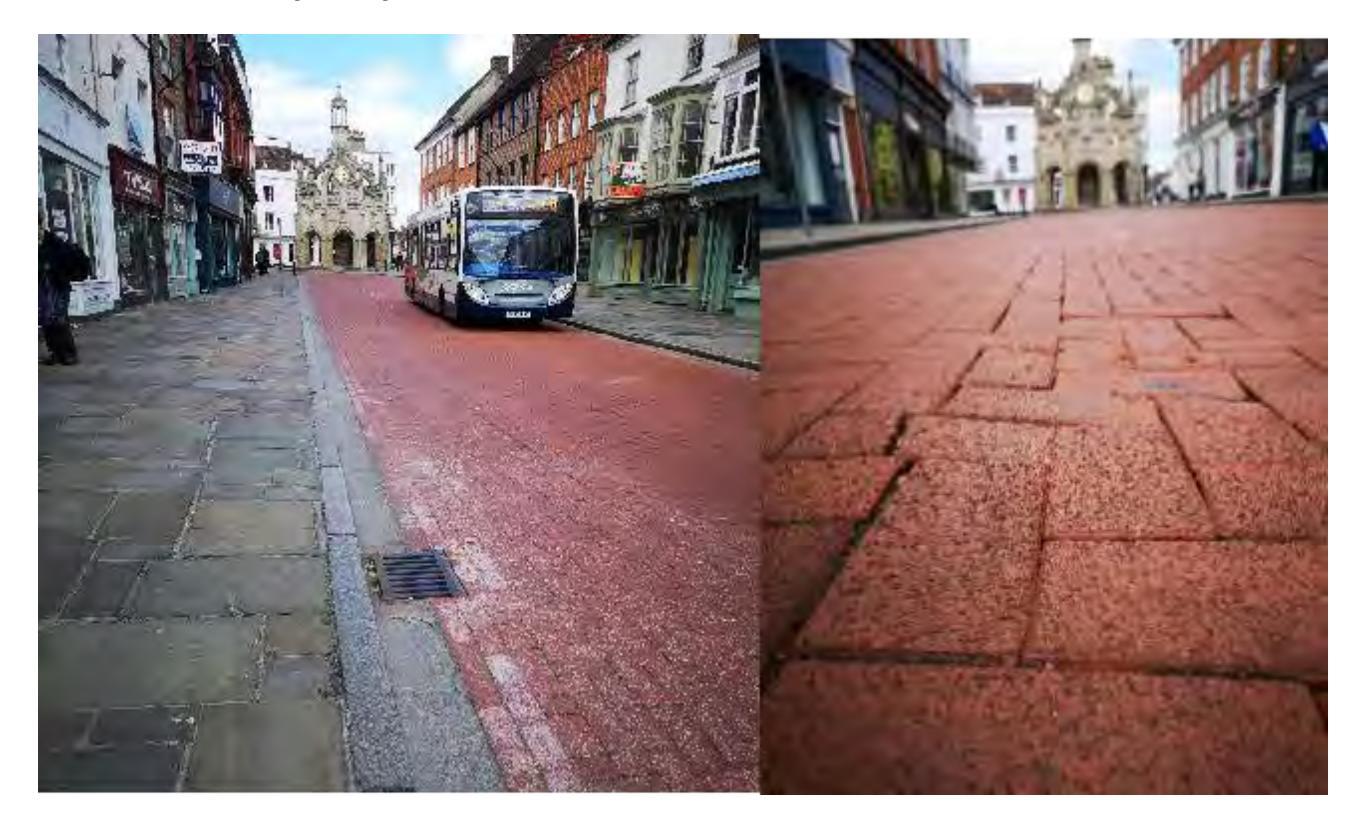
Lean concrete requires time to gain strength and if the buses were allowed to continue trafficking the reinstated area before sufficient strength gain has occurred, it is likely that the lean concrete has now reverted to behaving as a granular material.

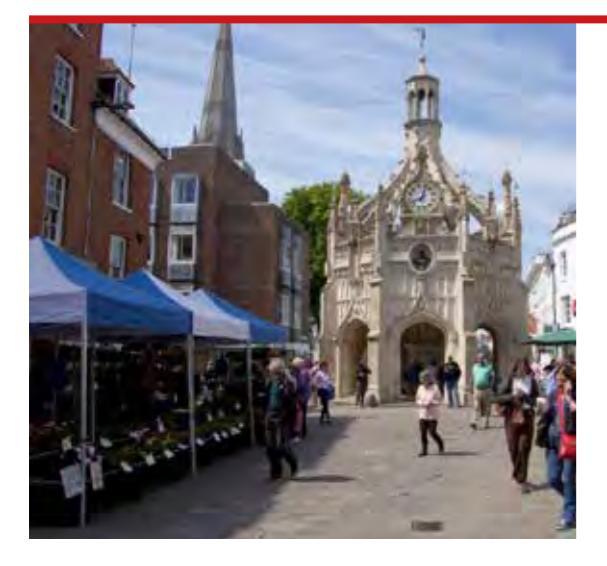
Heavy loading along the bus route contributes to failings in the construction make up for the clay paviours which are hard to maintain without causing disruption to traffic

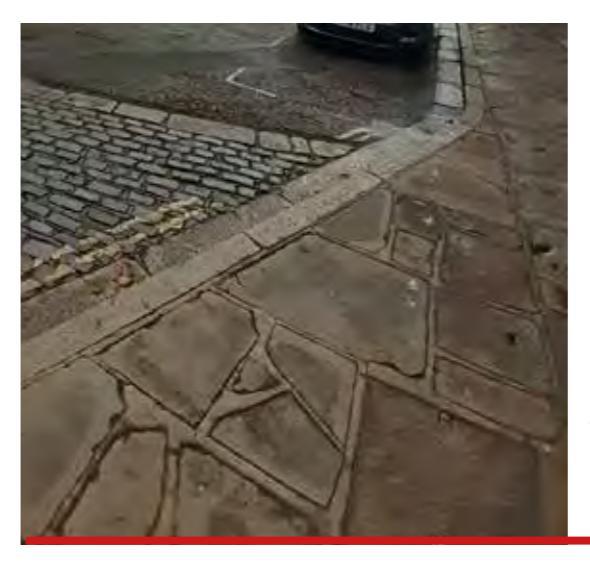
Areas used for the market are also exposed to heavier use / vehicle overun which should be considered in the design of the paving

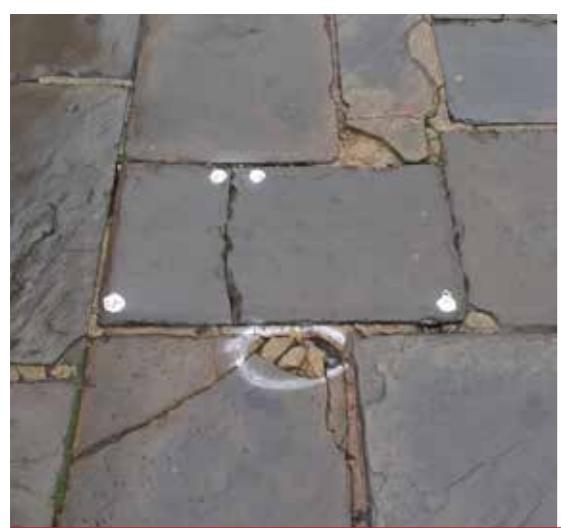
Cracking slabs are often evident in front of properties which require heavy deliveries eg in front of pubs

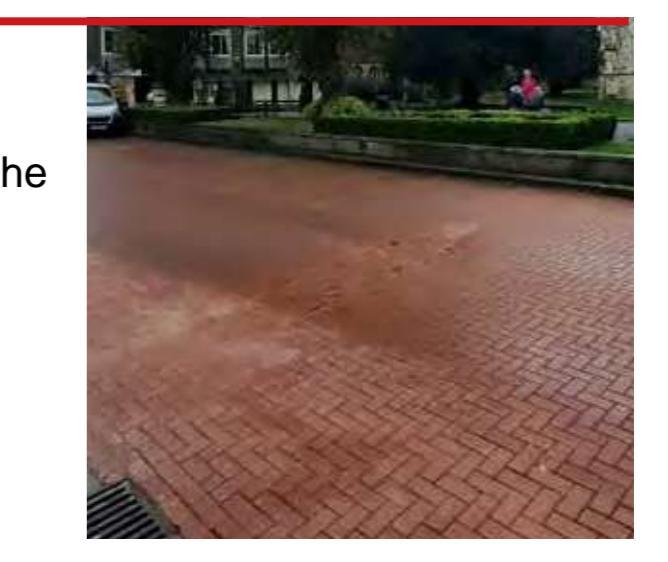
Vehicle overun to slab paving is causing cracked slabs, chipped edges, rocking slabs & trip hazards

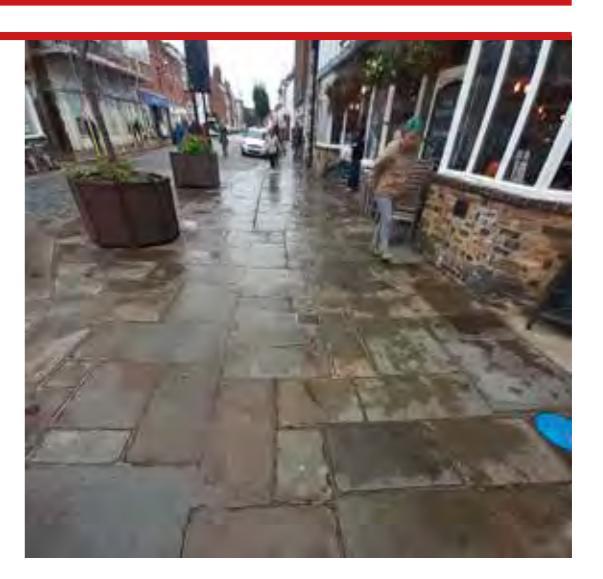
Bad patching & increasing joint widths have been caused by the numerous necessary repairs
