CHICHESTER CITY CENTRE PAVEMENTS

Options Study on Maintenance and Replacement

March 2021

TECHNICAL NOTE

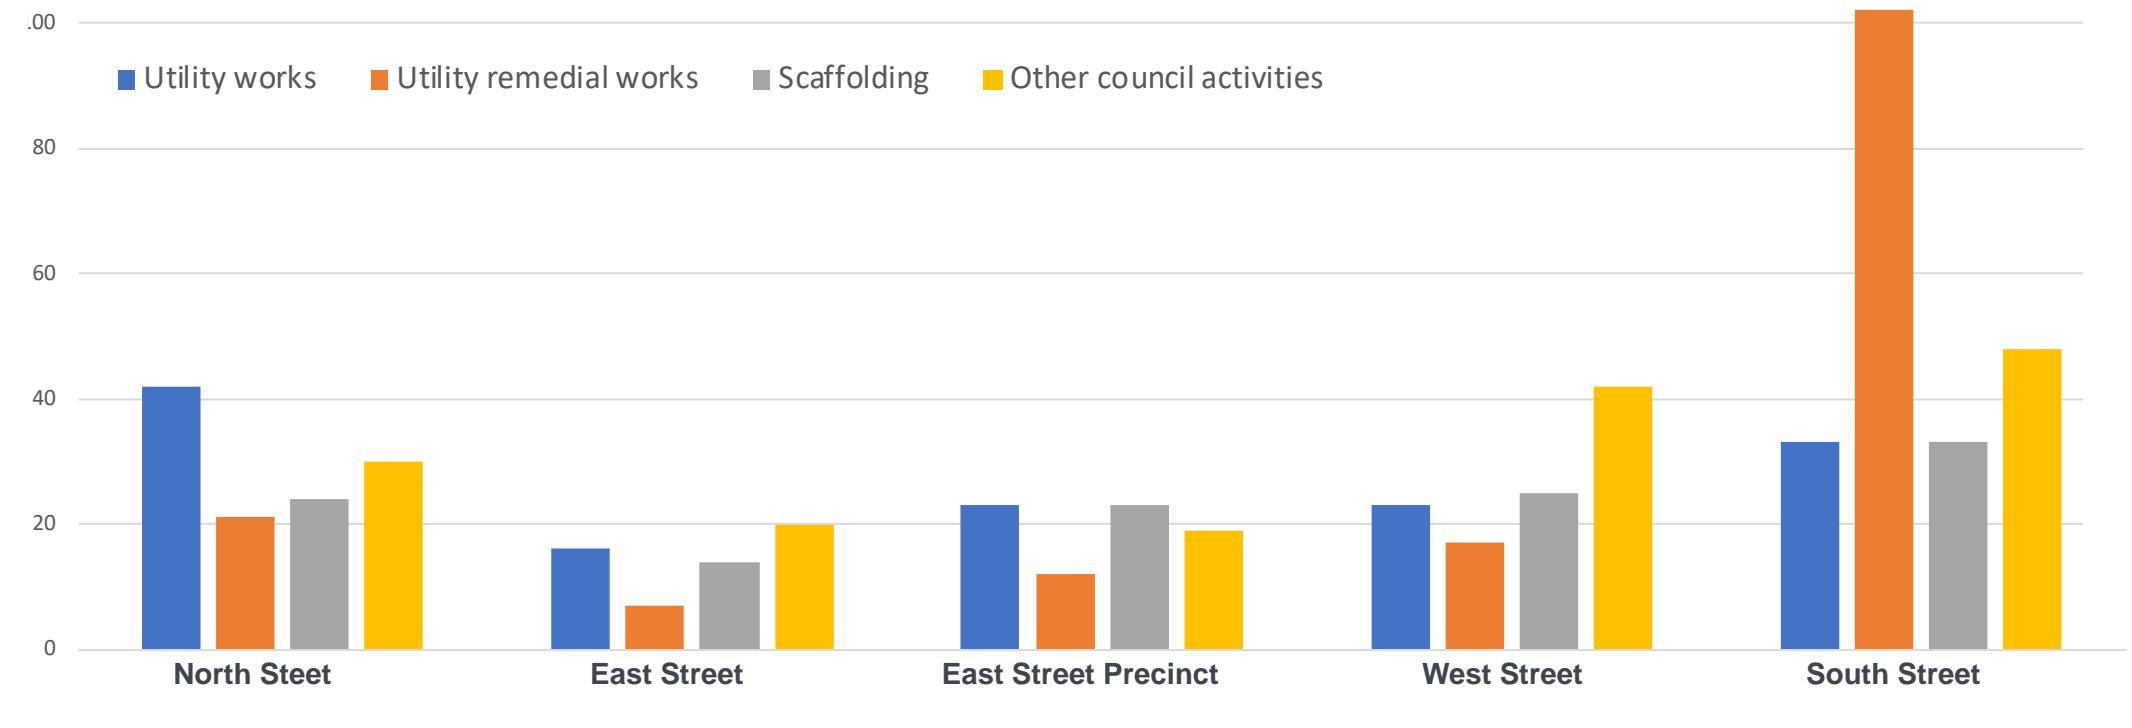
Figure 6. 5 Activity types for Utilities and Highways Permits

6.2.36 Of note were the number of permits for scaffolding lorries. Some "Other Council Activities" should probably be excluded from the analysis, as it is unlikely that they would influence pavement condition.

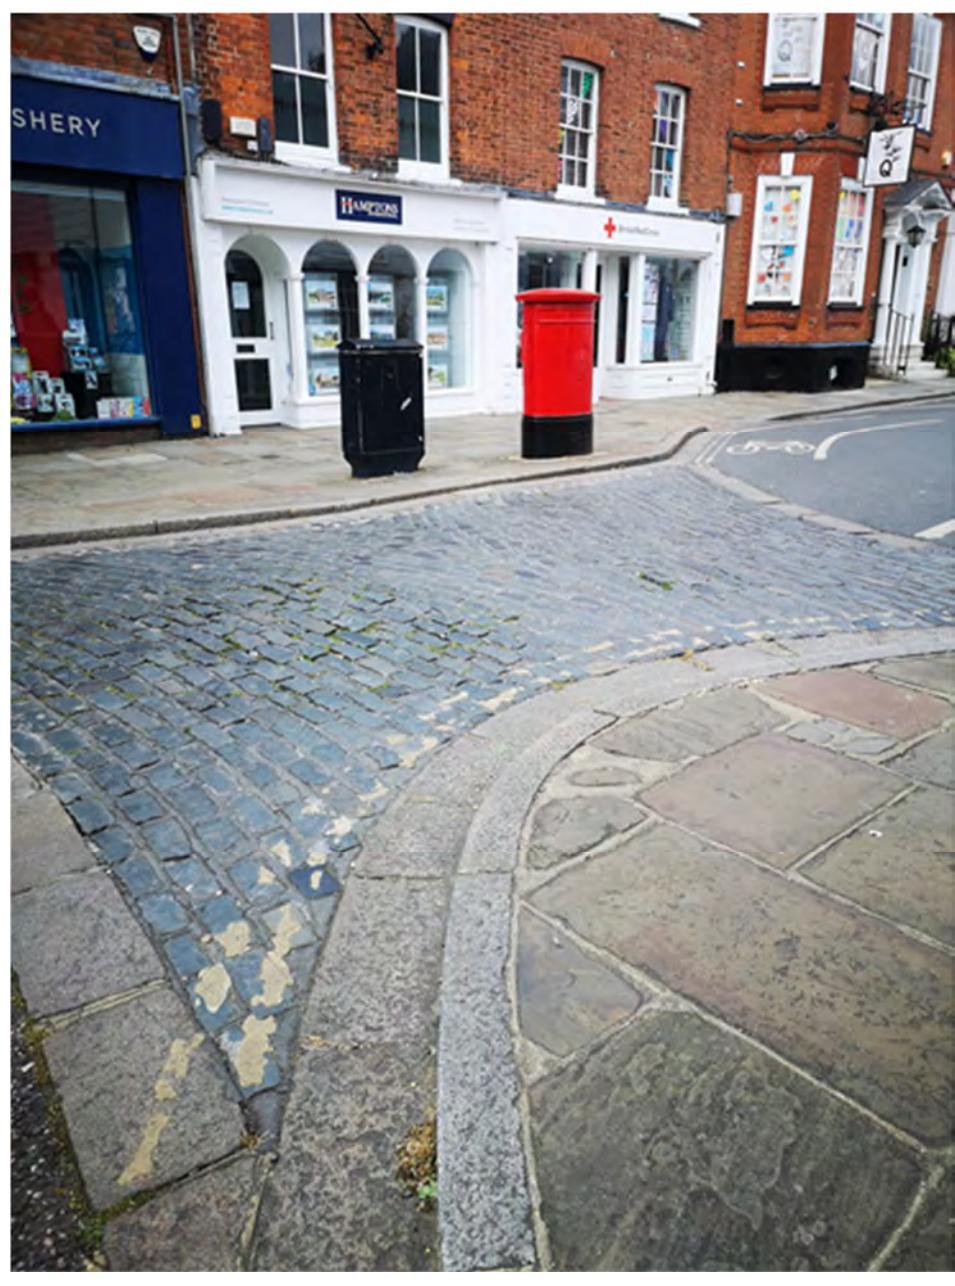
North Street from the junction of St Peters Street is the start of the pedestrian zone and is delimited by a gateway feature of natural stone paviors. The paviors appear well polished with some localised erosion of the jointing material. Flush granite kerbs are used to retain the paviors. The paviors are a rigid surface construction. The underlying construction is unknown.

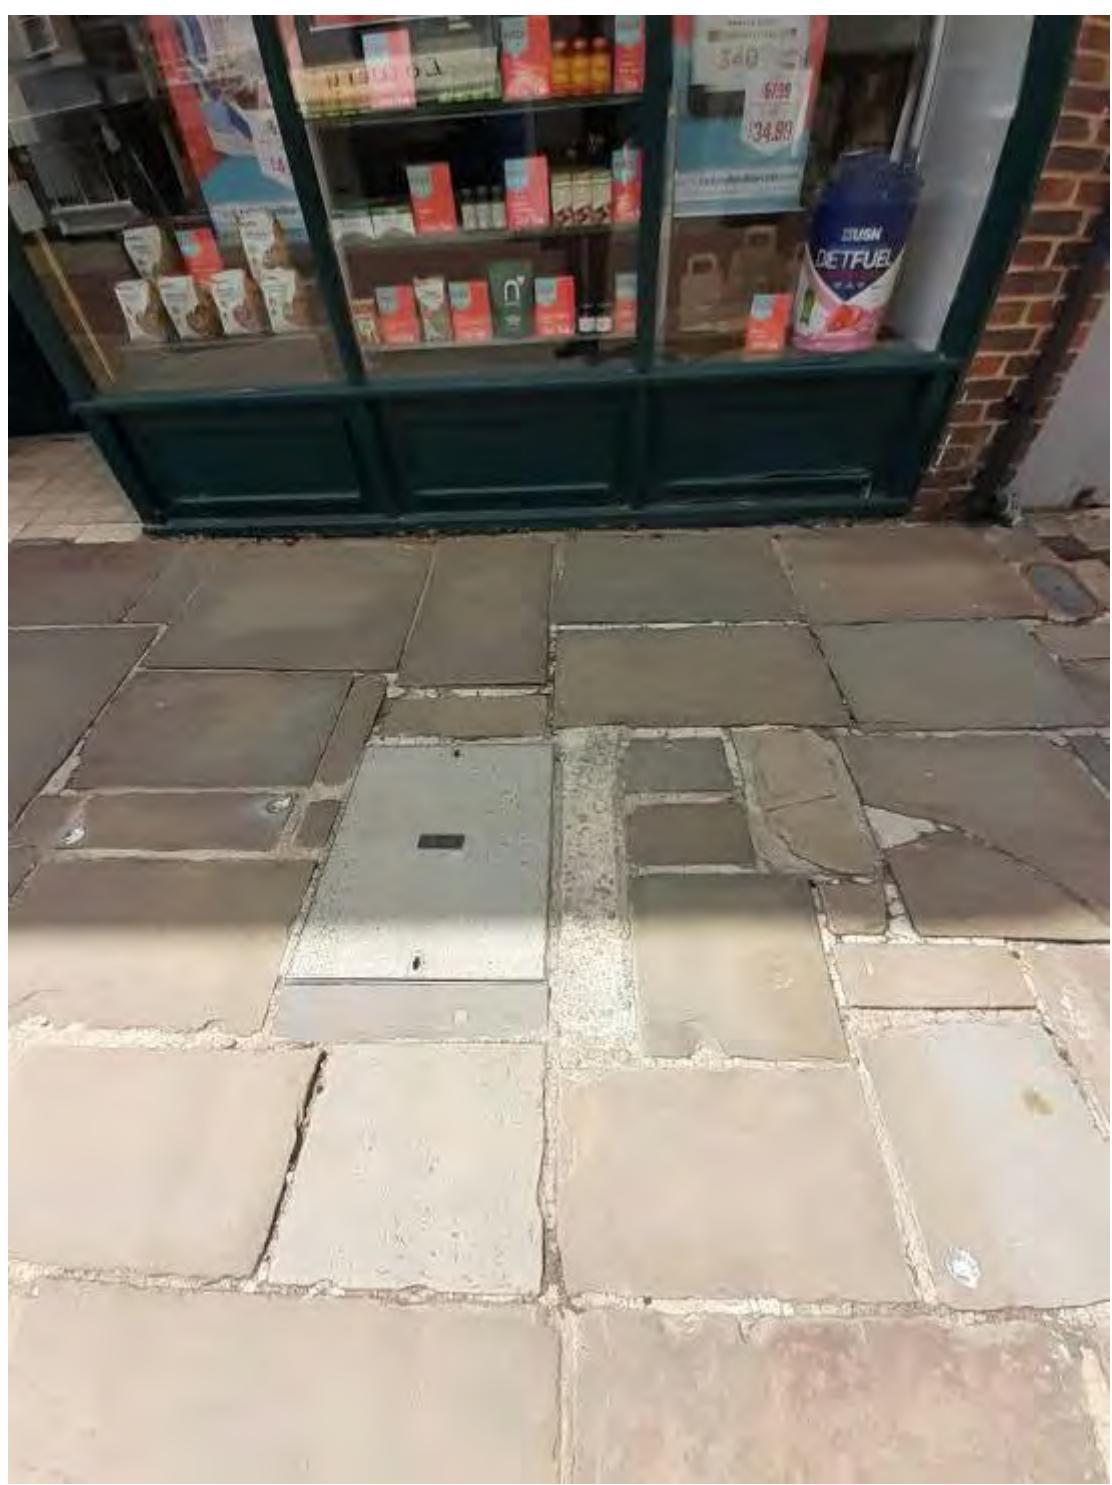
Unacceptable patching in

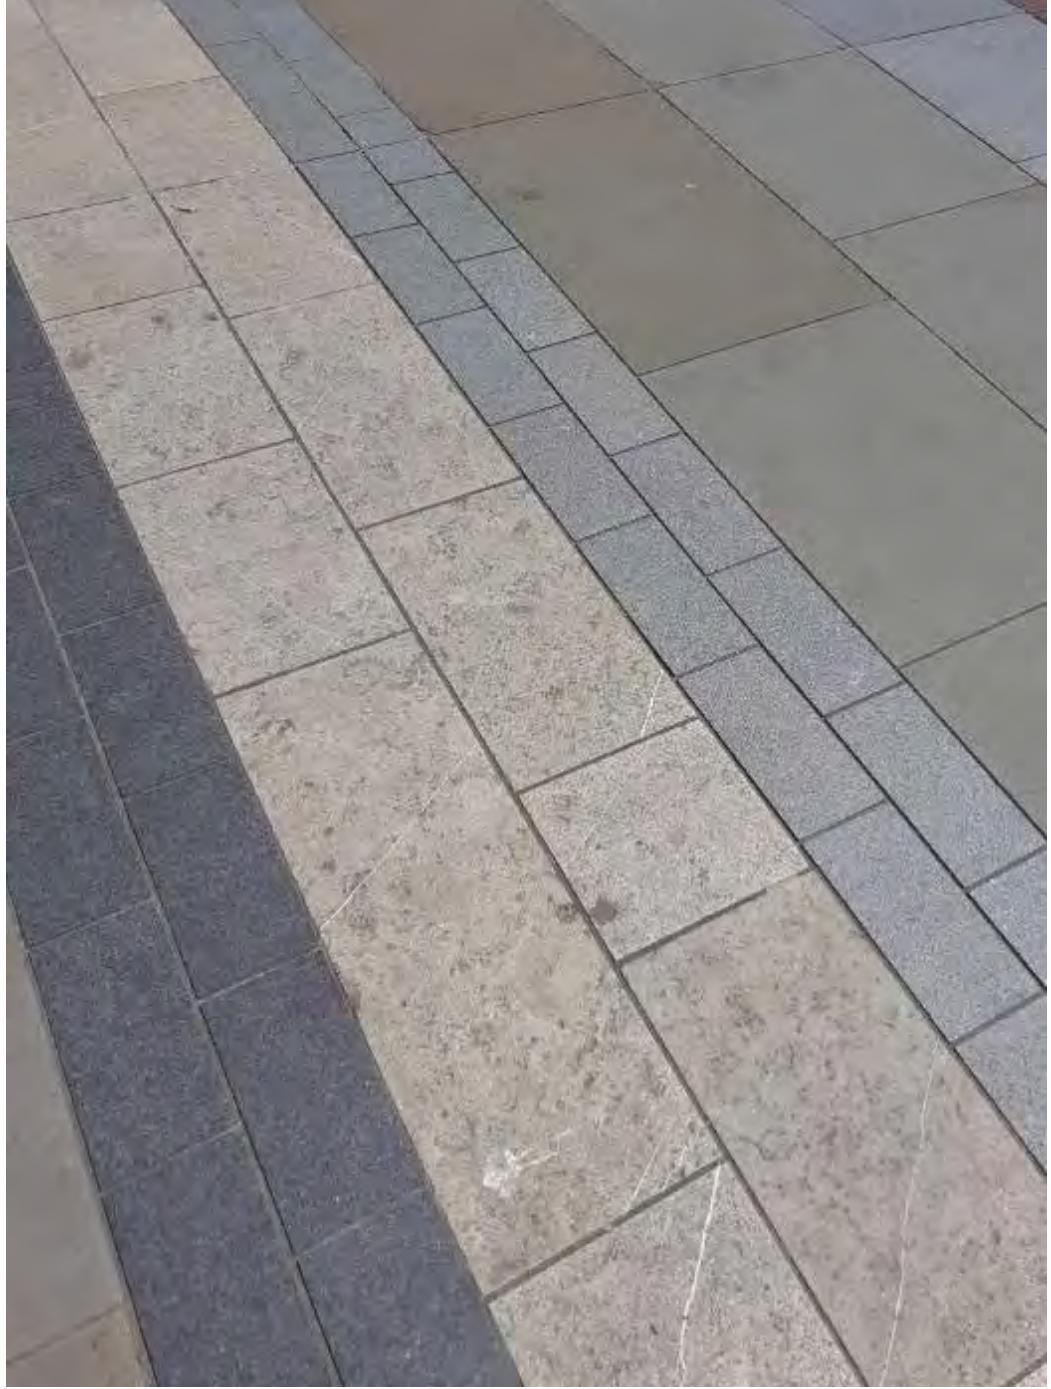
'Test Area' . It would be good to understand the thought process behind the material choices - no obvious connection to context.

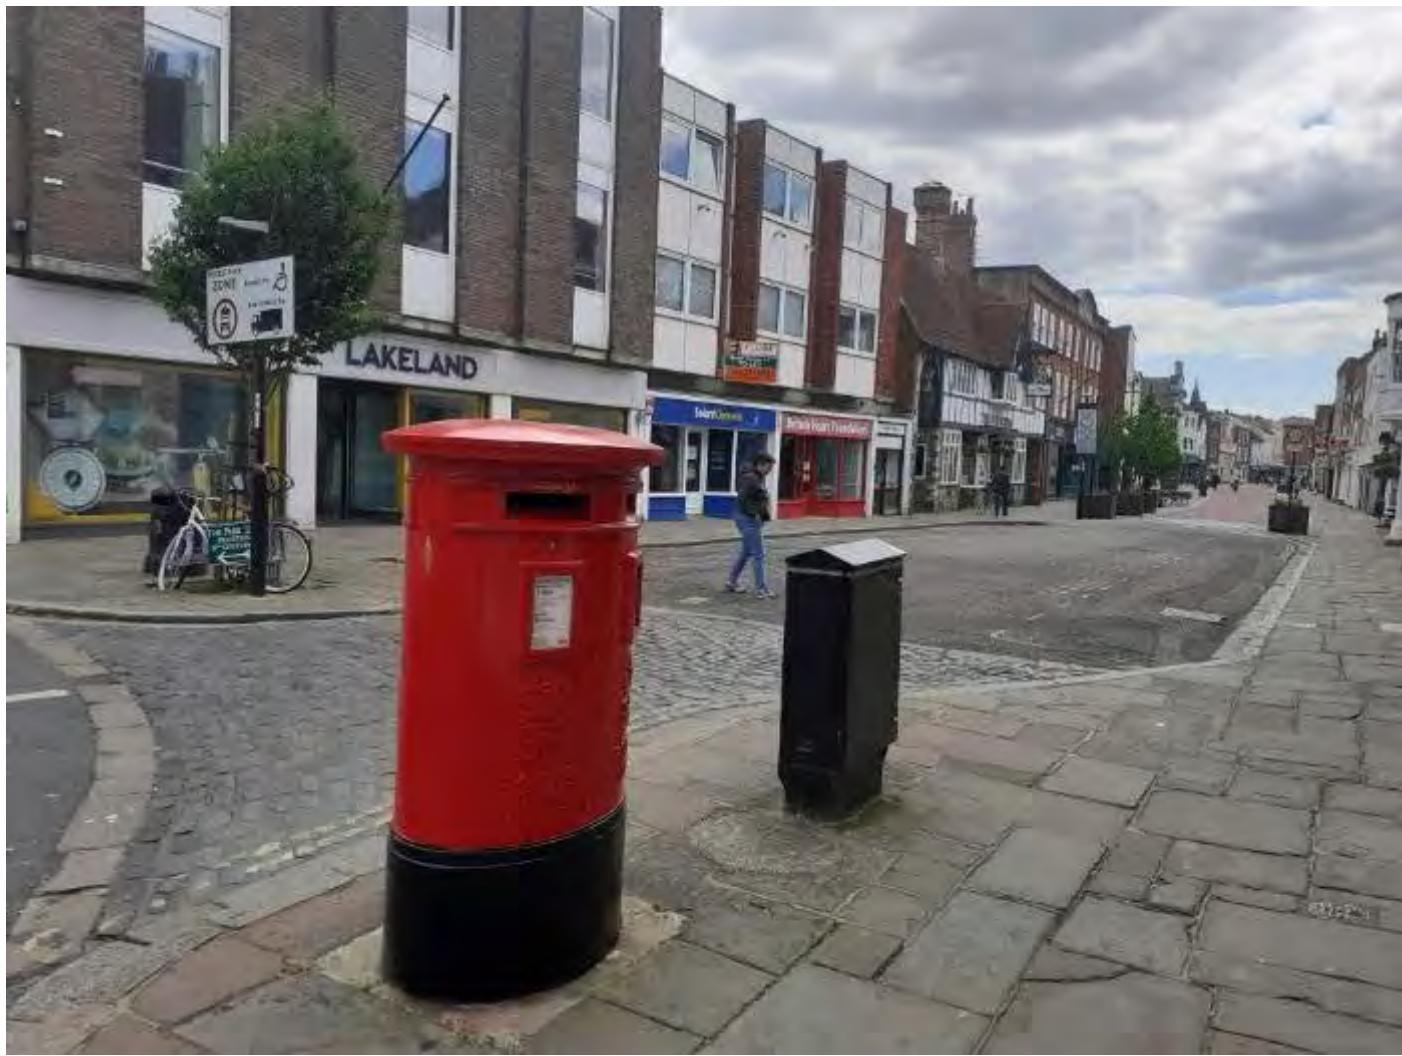
This is a poor gateway feature, especially with the tarmac disabled parking area beyond. There is nothing especially noteworthy about the architecture here - Consider moving the gateway to the next pinch point and returning to more traditional carriageway to focus spend on the areas that will have most impact.

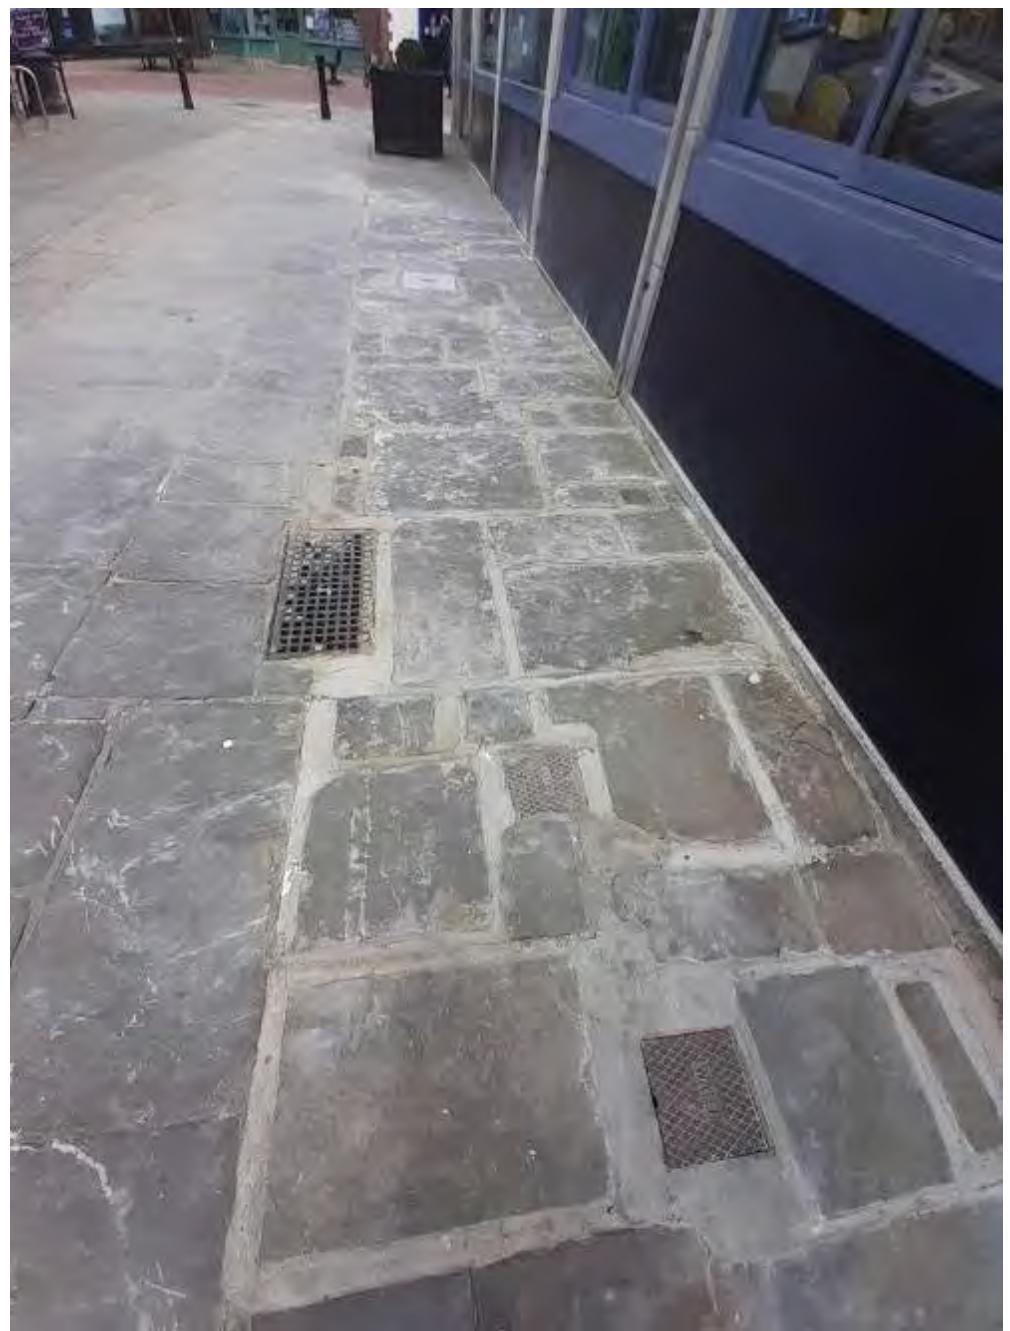
Crane Street leading off North Street is completely surfaced with York stone paving. It was evident in this area that reinstatement of the paving by Statutory Undertakers is not always completed to an acceptable standard. The mortar joints in this area are very wide and again there appears to be no colour matching of the mortar.

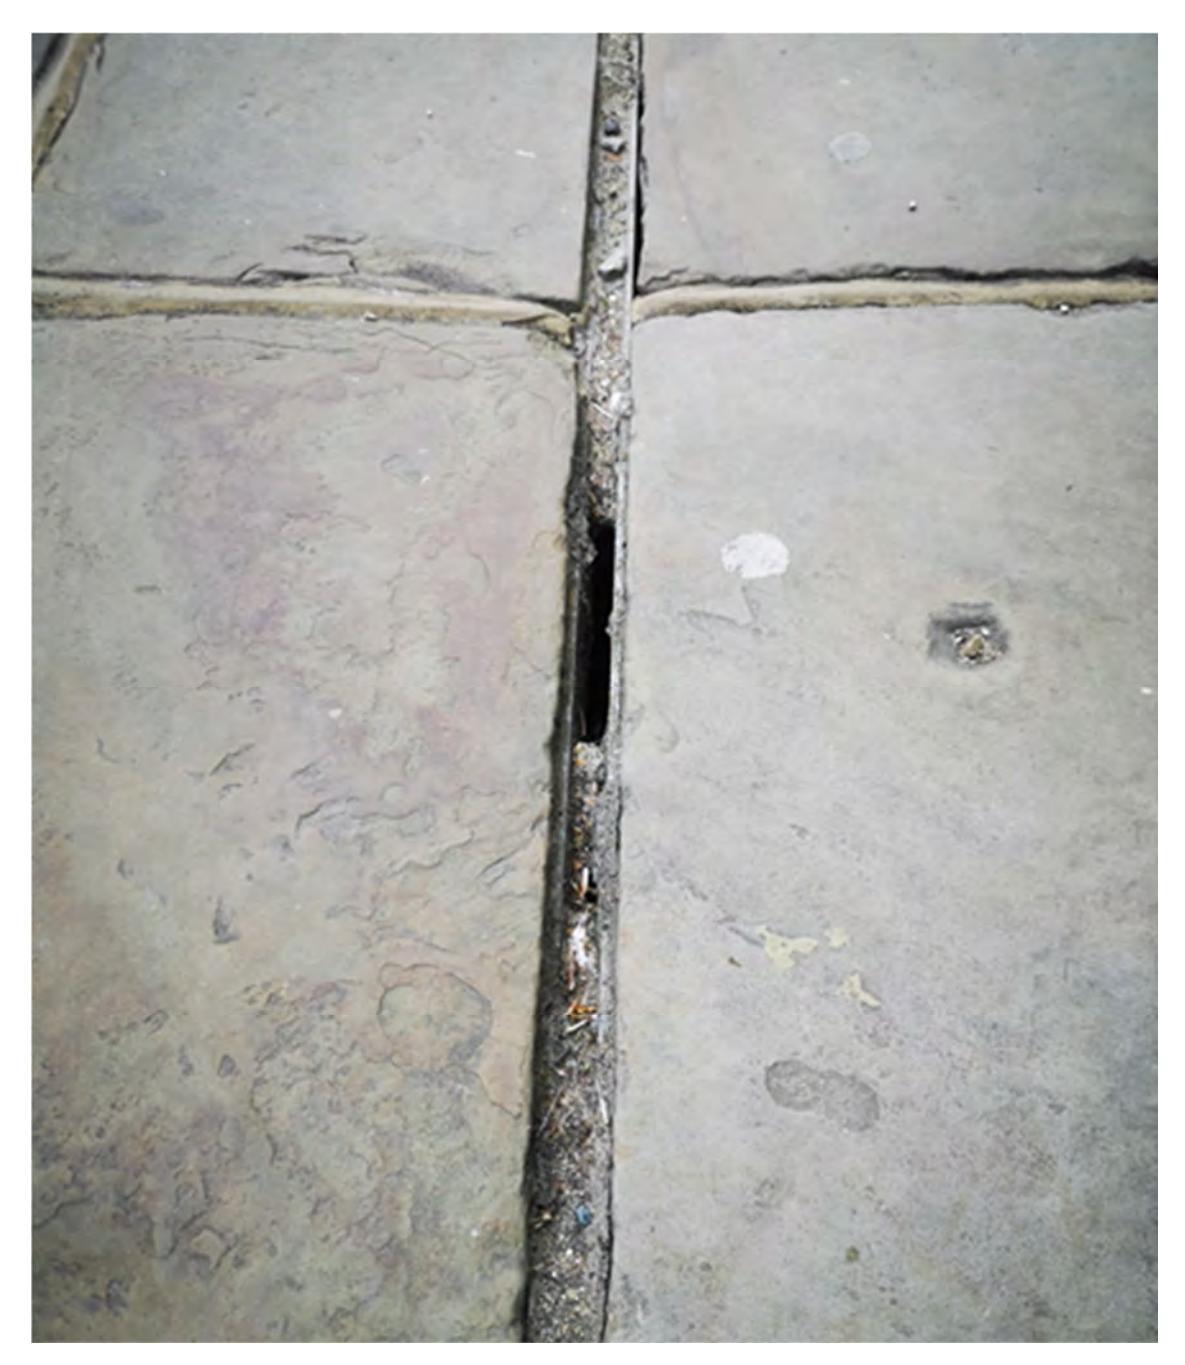
There is a slot drain present along the former footway for much of North Street. It can be seen from the photograph that there is significant collection of detritus in the slot which will prevent the drain from functioning as intended. It is understood that this is a significant maintenance liability that would benefit from a longer-term solution to minimise whole-life costs.

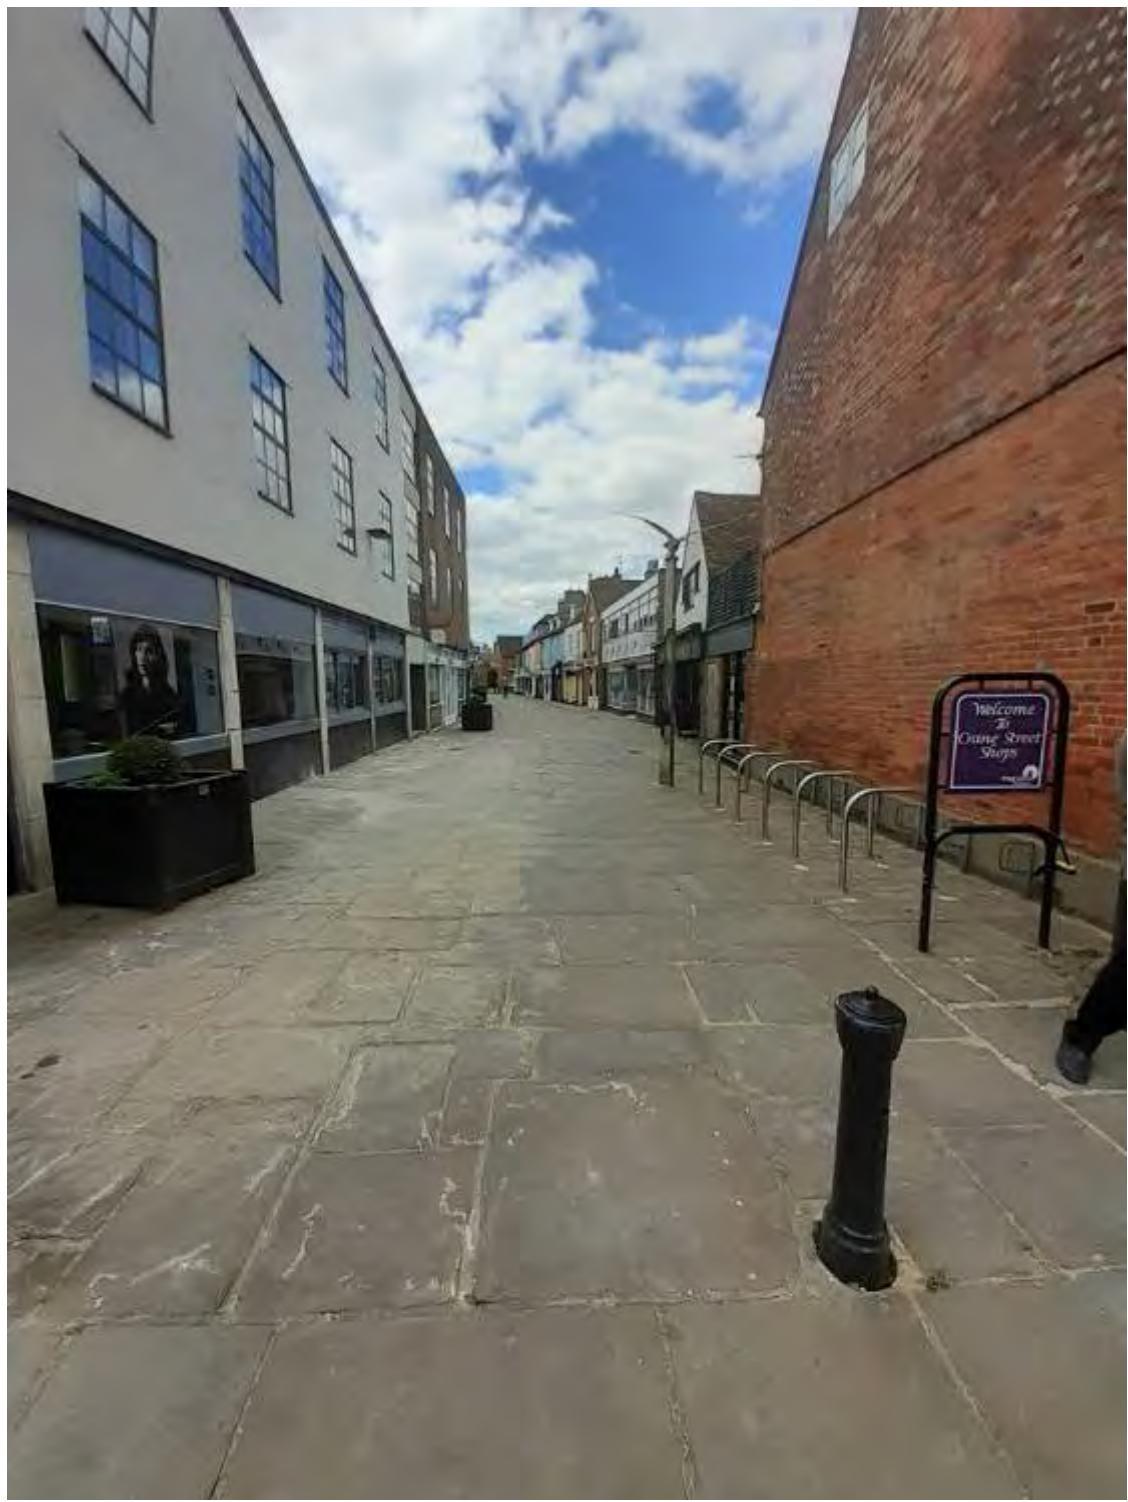
Uninteresting and poor-quality street scene along Crane Street

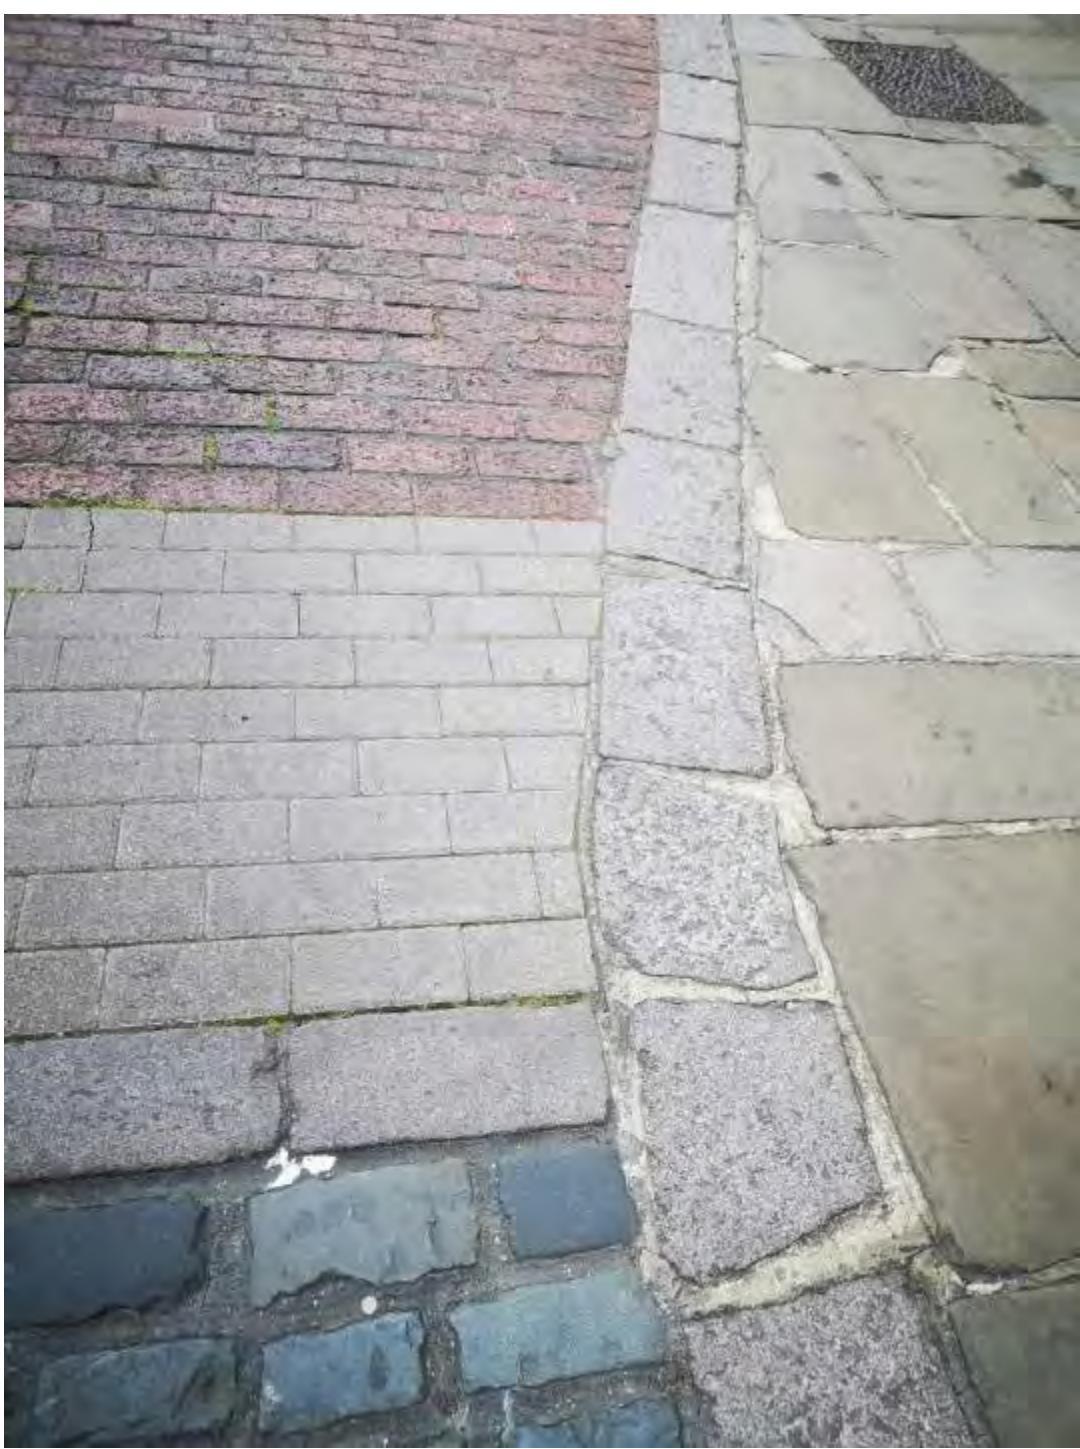
Poor material composition

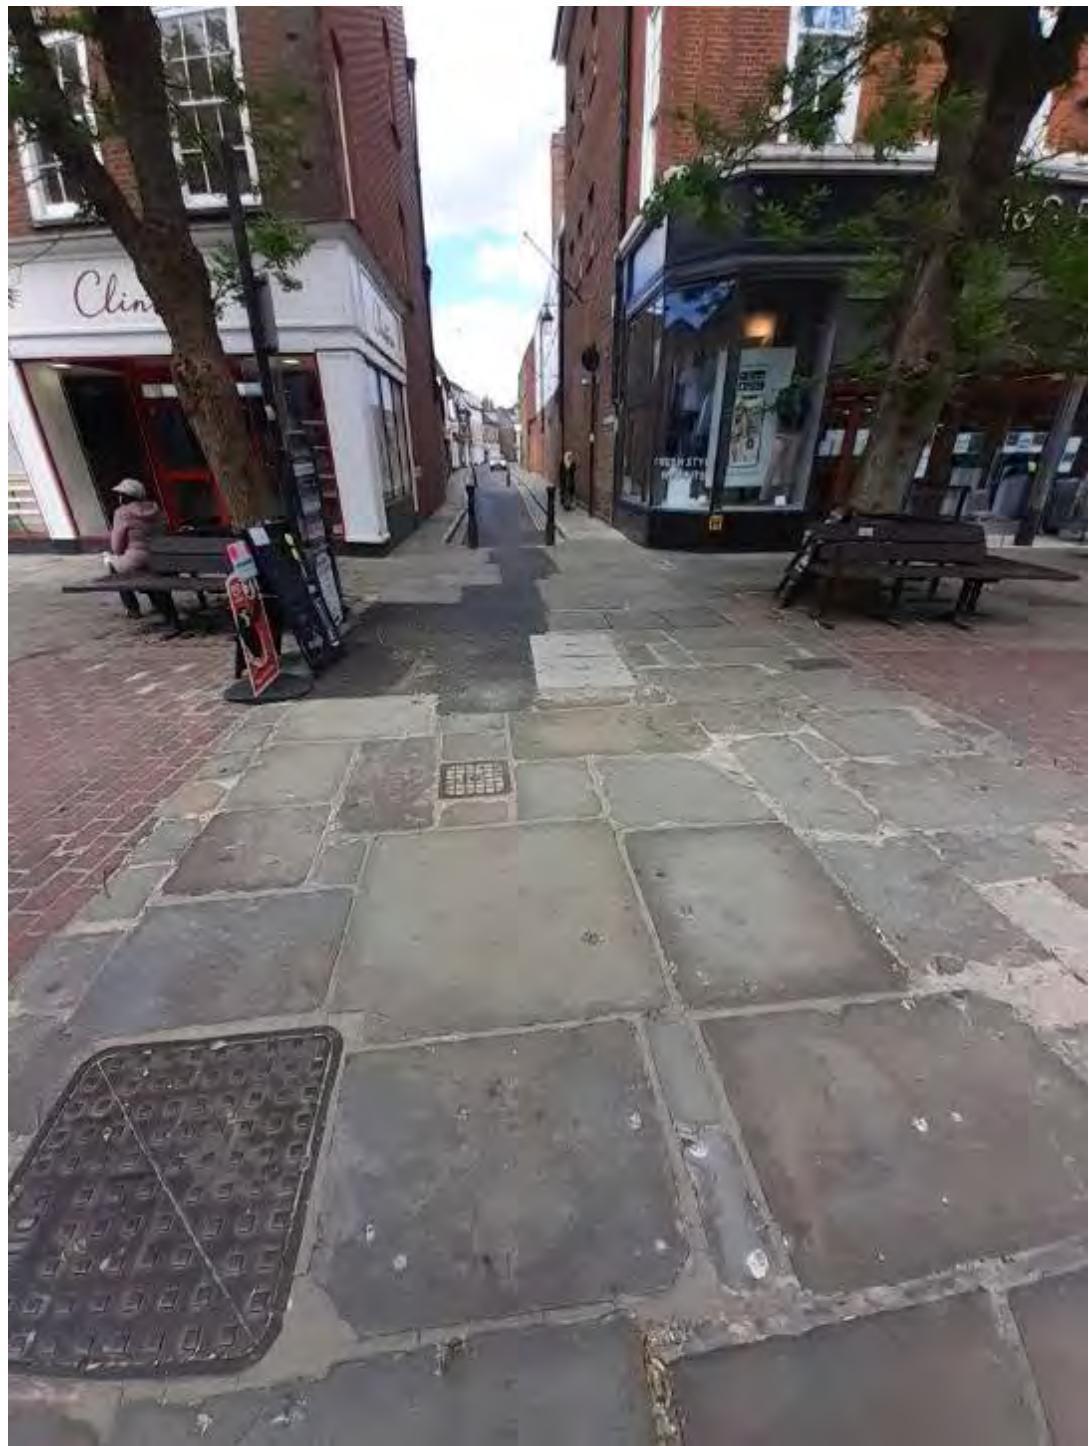
Strange emphasis given to the north south crossroads, when attention and importance should be given to the cross. Need to reconsider hierarchy of materials. Note the extensive tarmac patching.

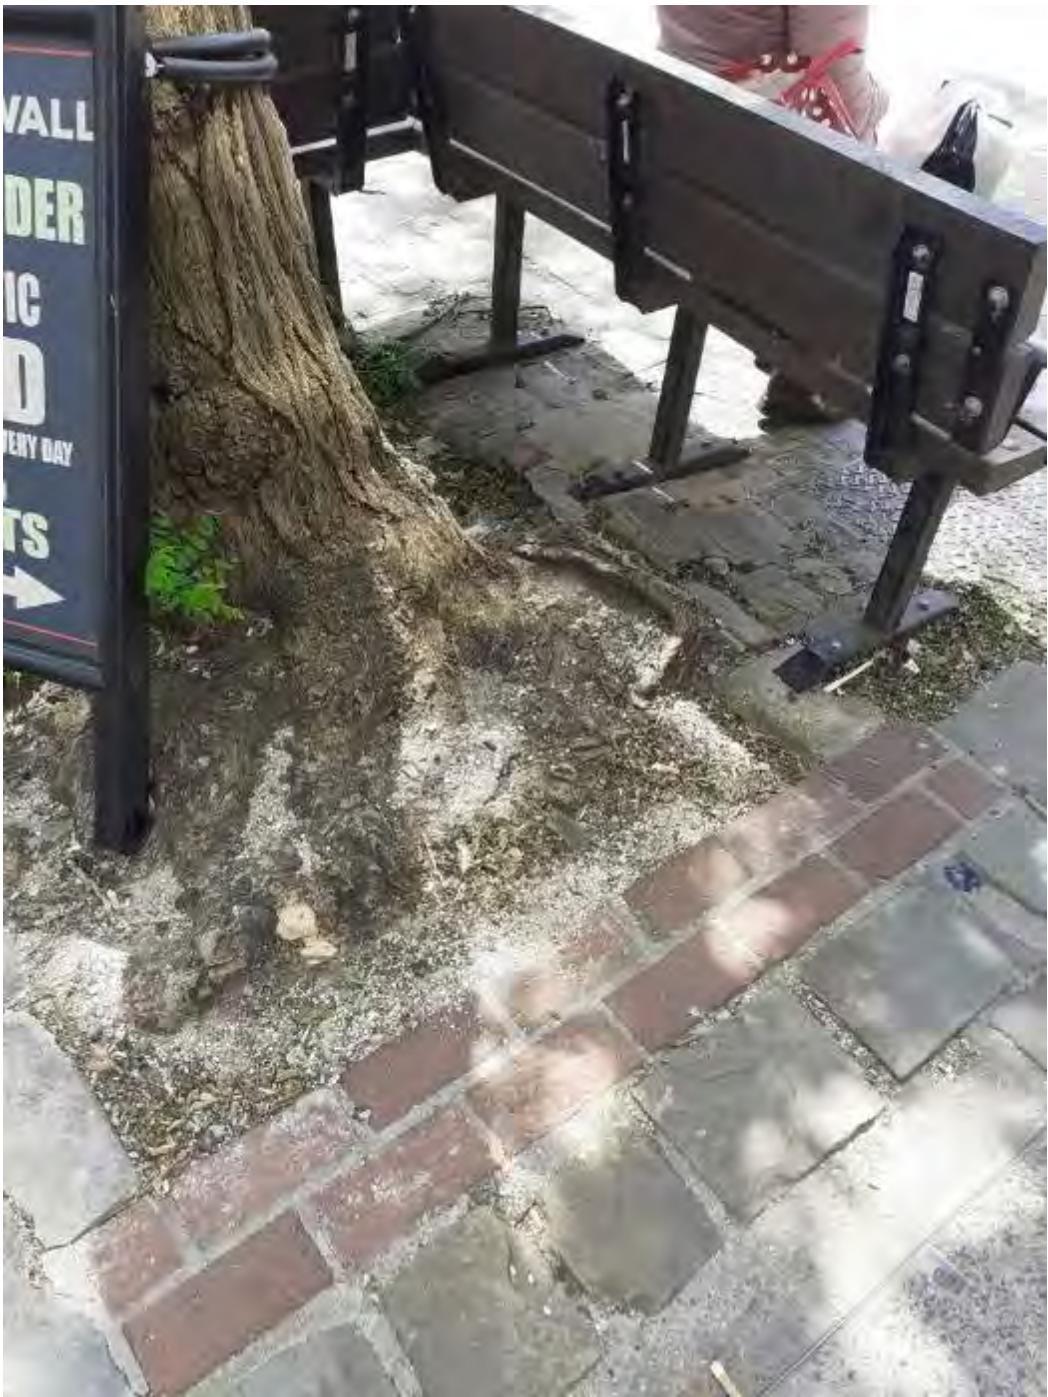
Tree health likely to suffer, eclectic use of materials. Tree roots pulling up paving due to insufficient rooting volume and medium. Lot of clutter. It would be good to understand how these trees were planted and scope for improving the rooting medium.

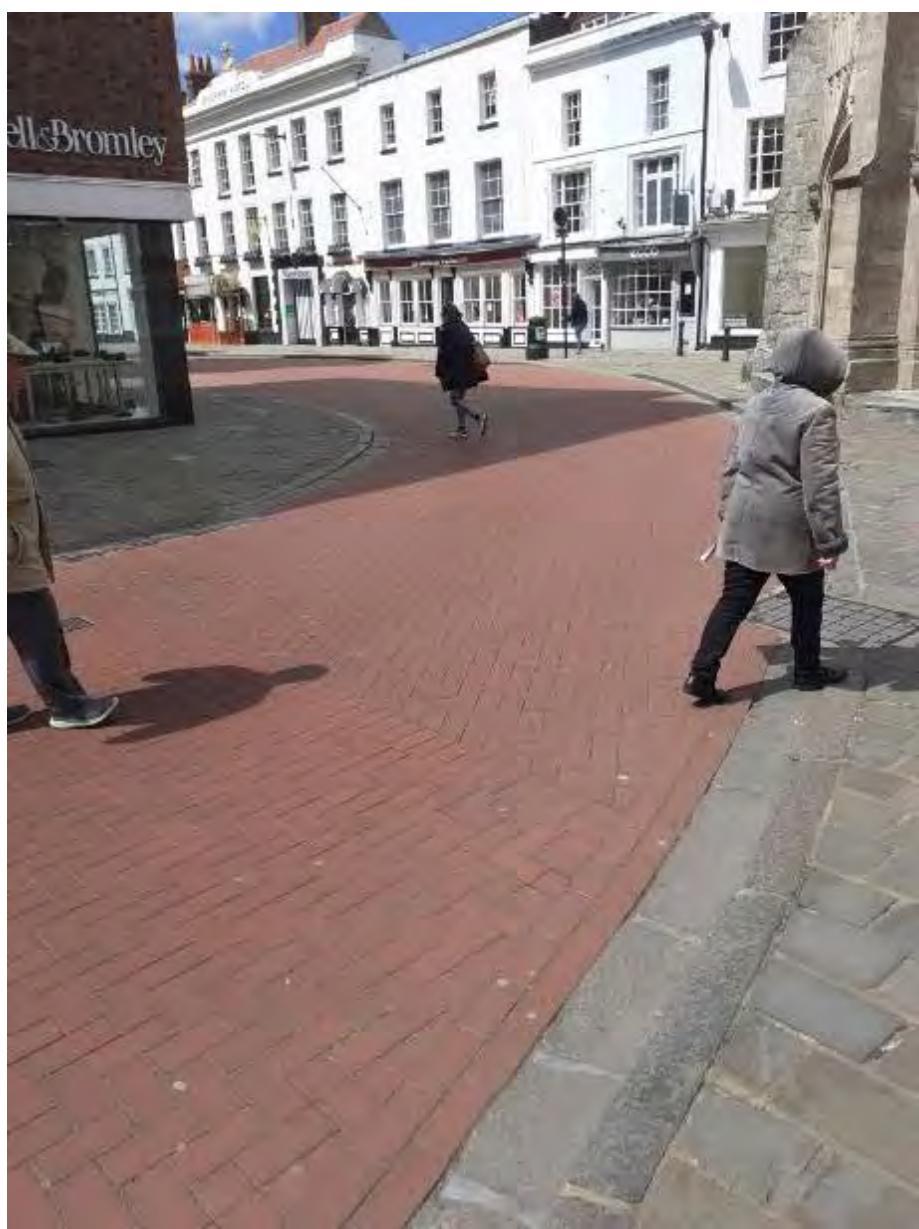
As noted in Section 4, the area of South Street and West Street covered by this study experience relatively high volumes of passenger service vehicle (PSV) traffic. The main carriageway area is surfaced a relatively modern clay pavior in a flexible type construction (i.e. no mortar). Although this construction type can be used for such higher trafficked areas, maintenance costs tend to be higher due to loss of jointing sand. There is no positive drainage below the paviors which allows the bedding sand to become saturated. This has resulted in the paviors moving in the past. That said, the paving is generally in reasonable condition apart from some isolated defects that are discussed in Section 6.

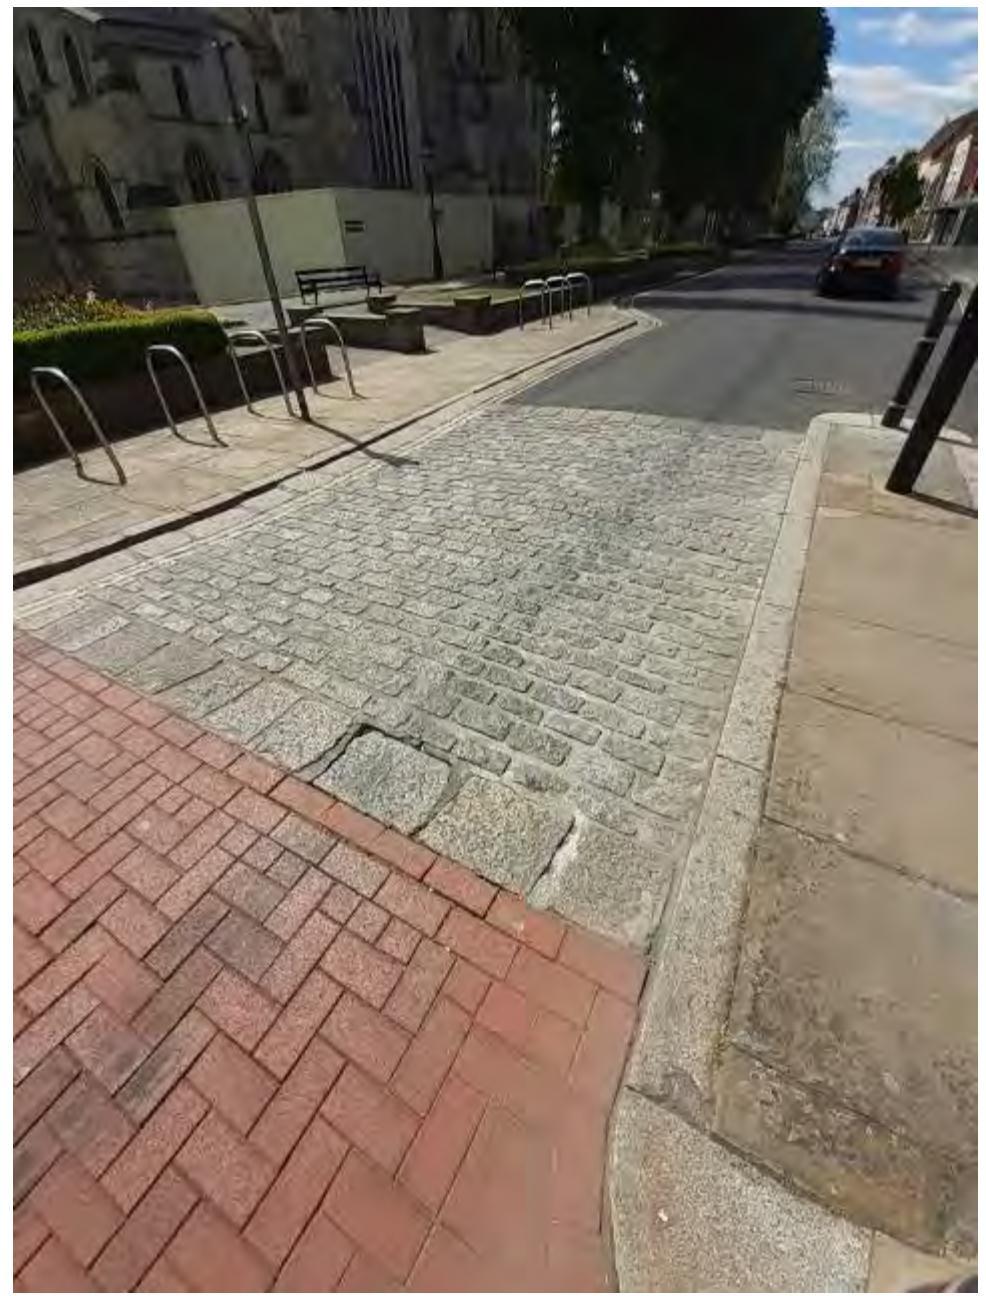
The heritage status and importance of the cathedral is not reflected at all in the street scene. A real placemaking opportunity is being missed here.

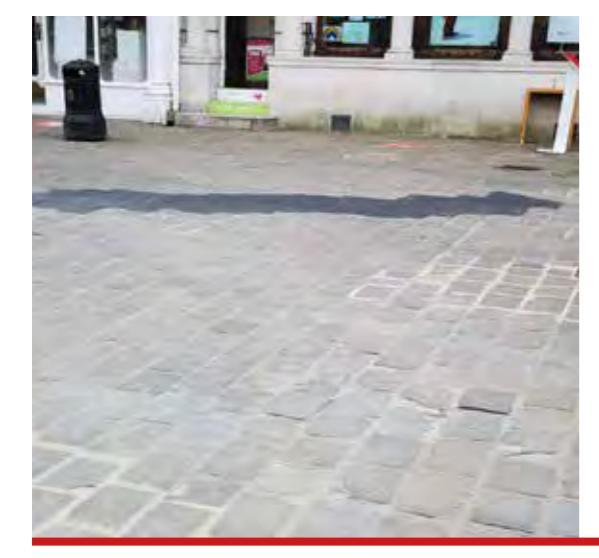
Relatively high number of interventions under Safety Plus inspections

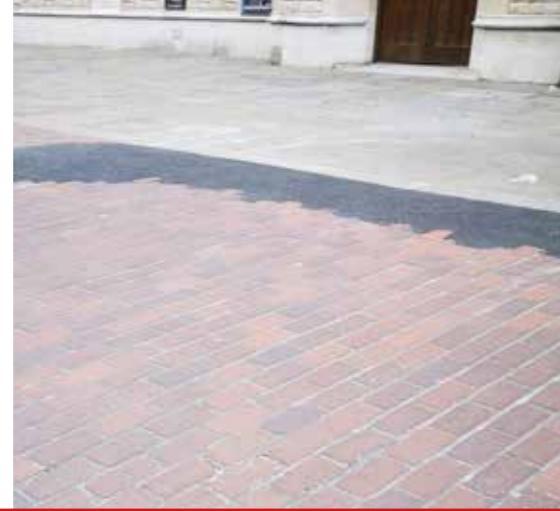
Reinstatements for utilities - Functional but not necessarily maintaining the aesthetics - Possibly leading to

disturbance and future defects

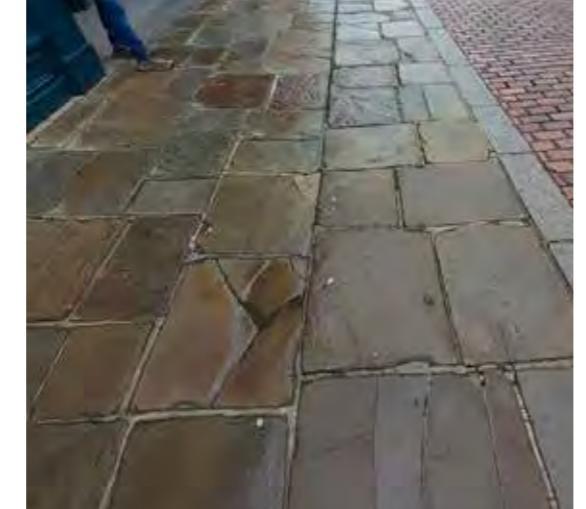
Vehicle overun to slab paving is causing cracked slabs, chipped edges, rocking slabs & trip hazards

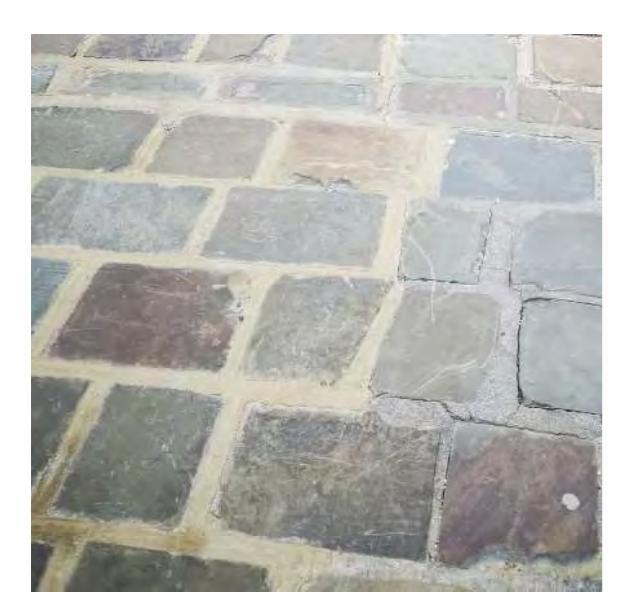
Purbeck setts would be a prime material to be lifted & relaid, in the existing location or elsewhere, on it's own or combined with new paving materials. Colour palette would work well combined with new porphyry or yorkstone / sandstone units

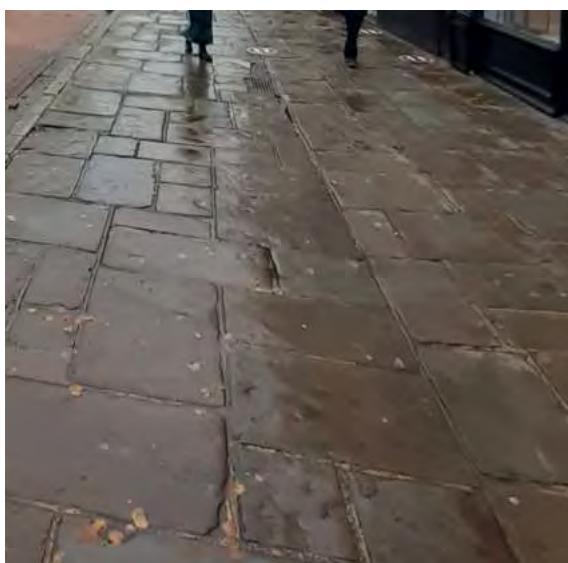
A number of the existing yorkstone slabs could also be lifted and relaid.

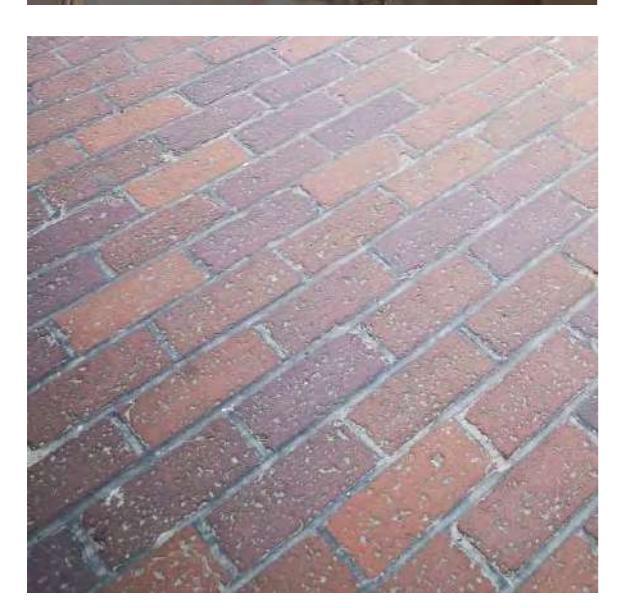
Red clay paviours could potentially be reused in areas of lesser heritage value
