CHICHESTER CITY CENTRE PAVEMENTS

Options Study on Maintenance and Replacement

March 2021

TECHNICAL NOTE

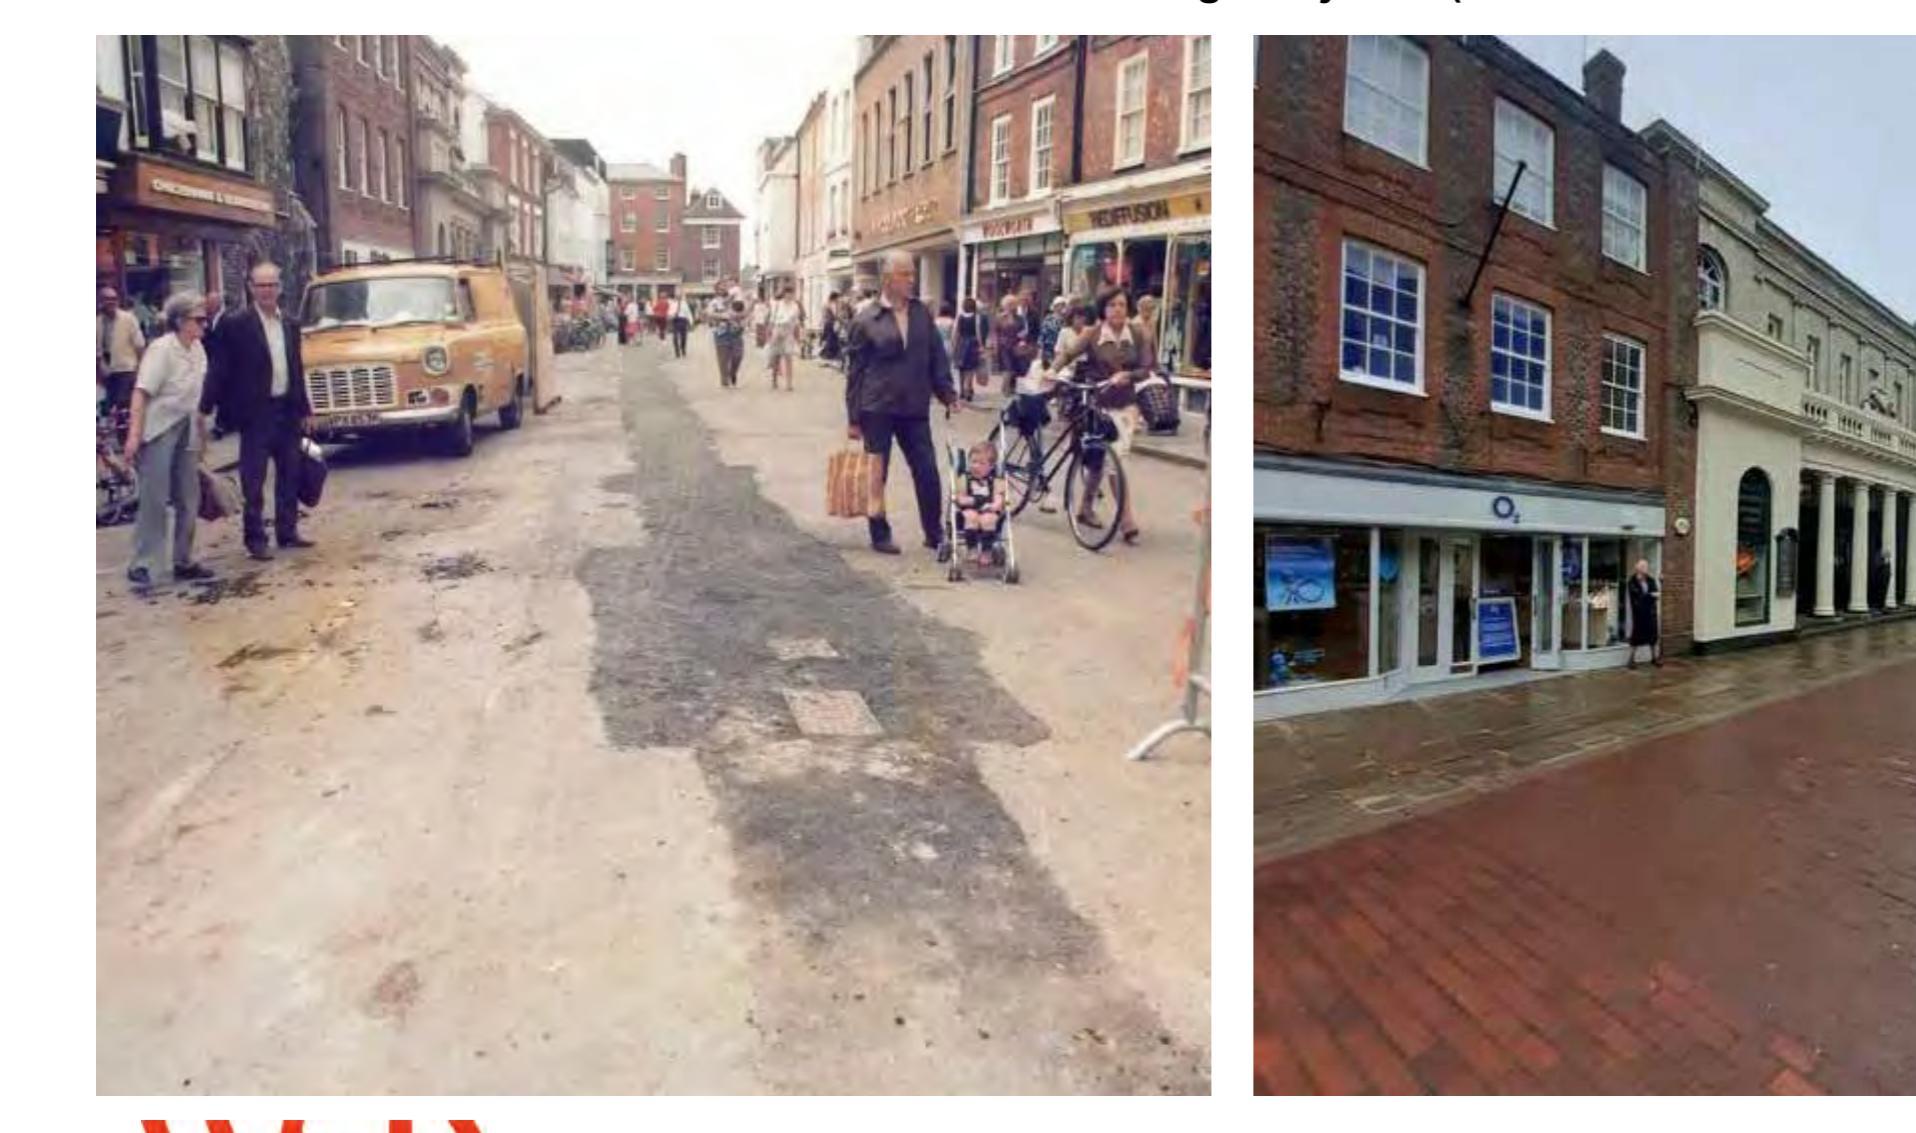
NORTH STREET HISTORIC PAVEMENT CONFIGURATION

- Historic footway areas likely to be very thin construction
 - More susceptible to damage from vehicles
 - York stone slab elements also more susceptible to damage from vehicles
- Main carriageway area likely to be a thicker construction
 - Better suited to vehicular traffic
 - Small element pavers also better at distributing traffic loads
 - Trade off between "rigid" construction with mortar bedding and joints (North Street and East Street) and "flexible" construction with sand bedding and joints (South Street and West Street)

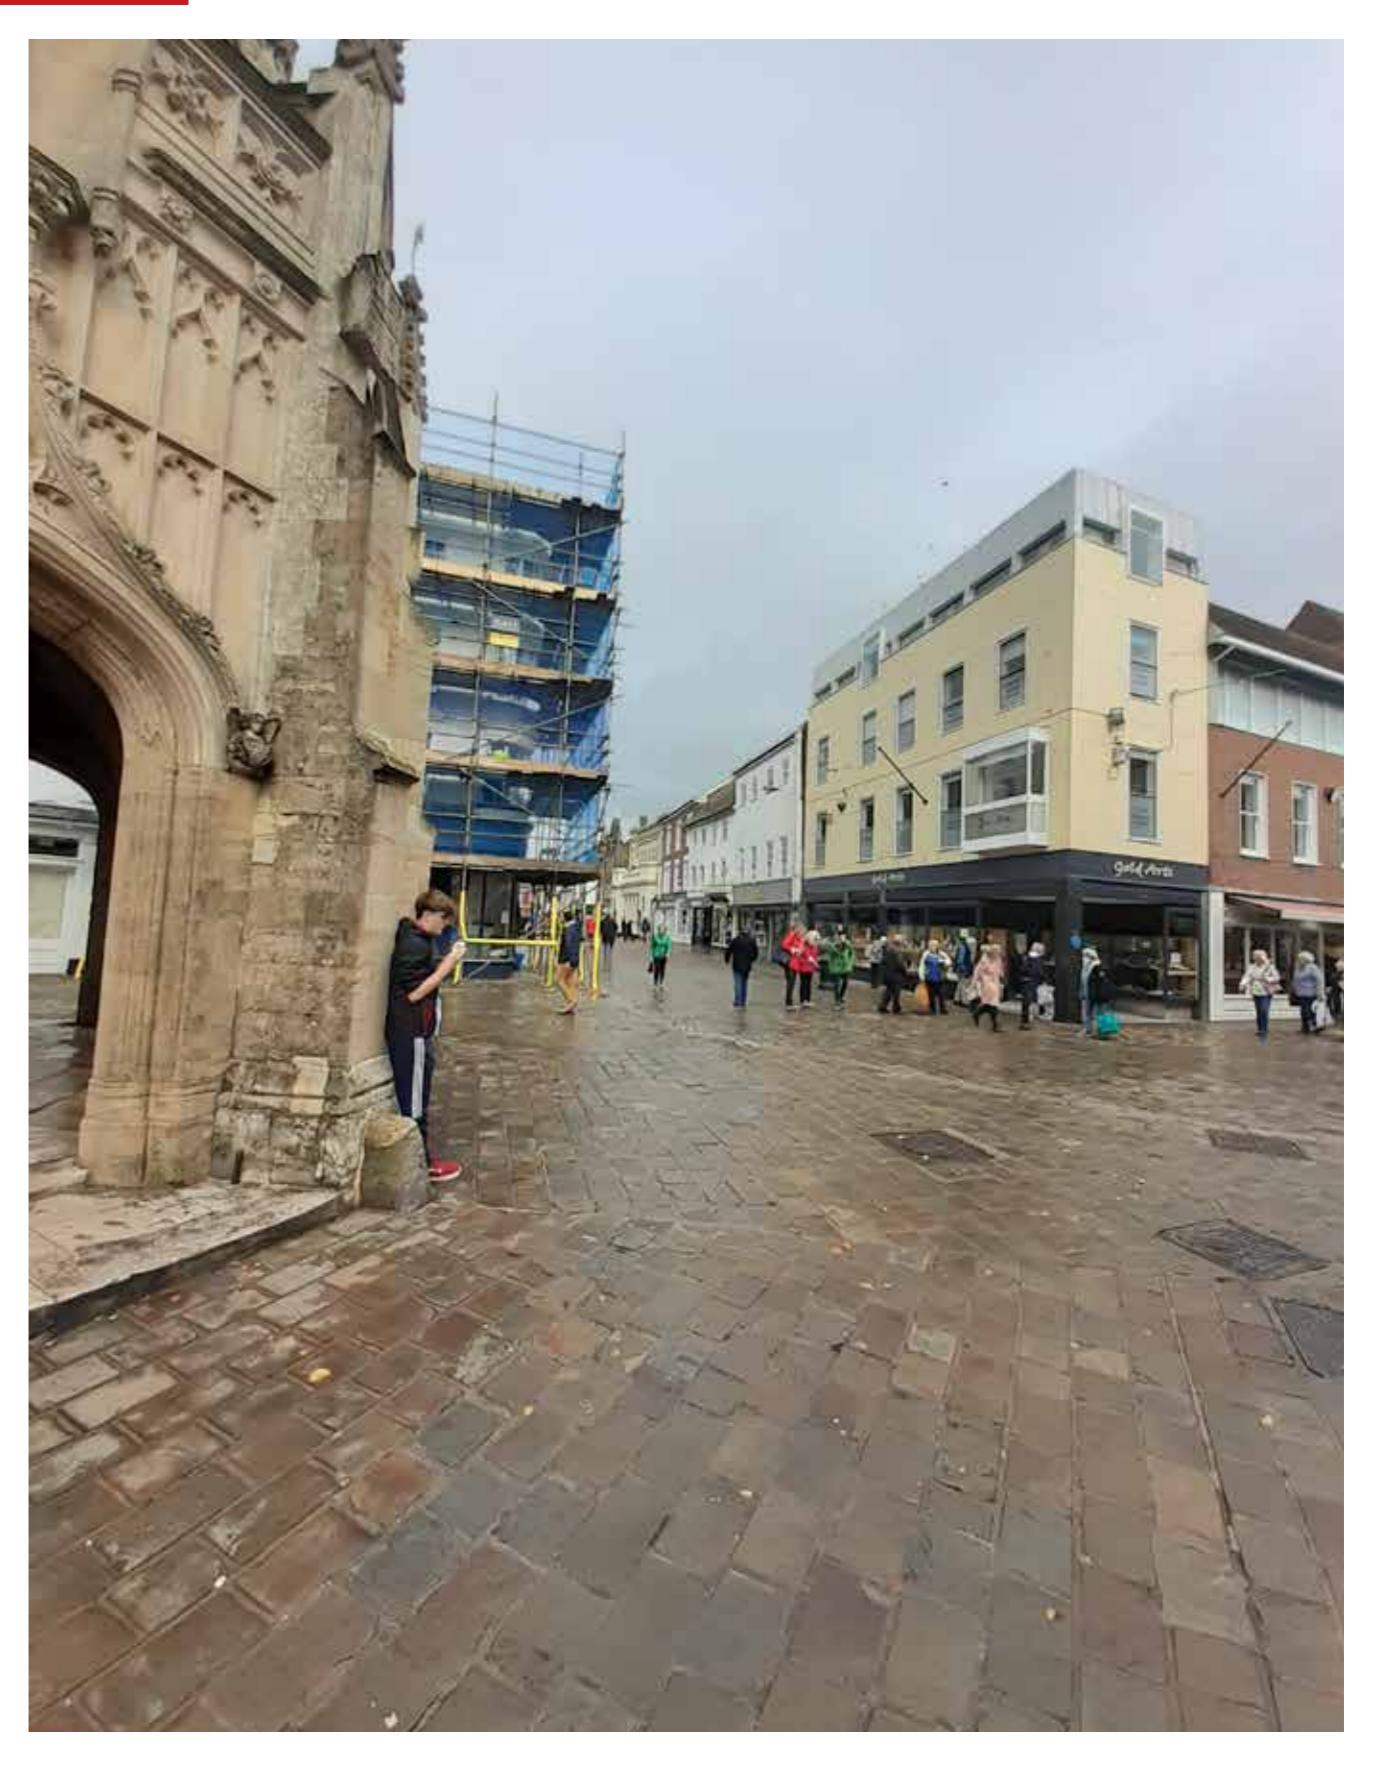
ANALYSIS OF SAFETY PLUS DATA

- Highest density around Market Cross and North Street
- Consistent pattern over time

Location information probably not accurate enough to determine whether vehicular traffic is contributory factor at Market Cross

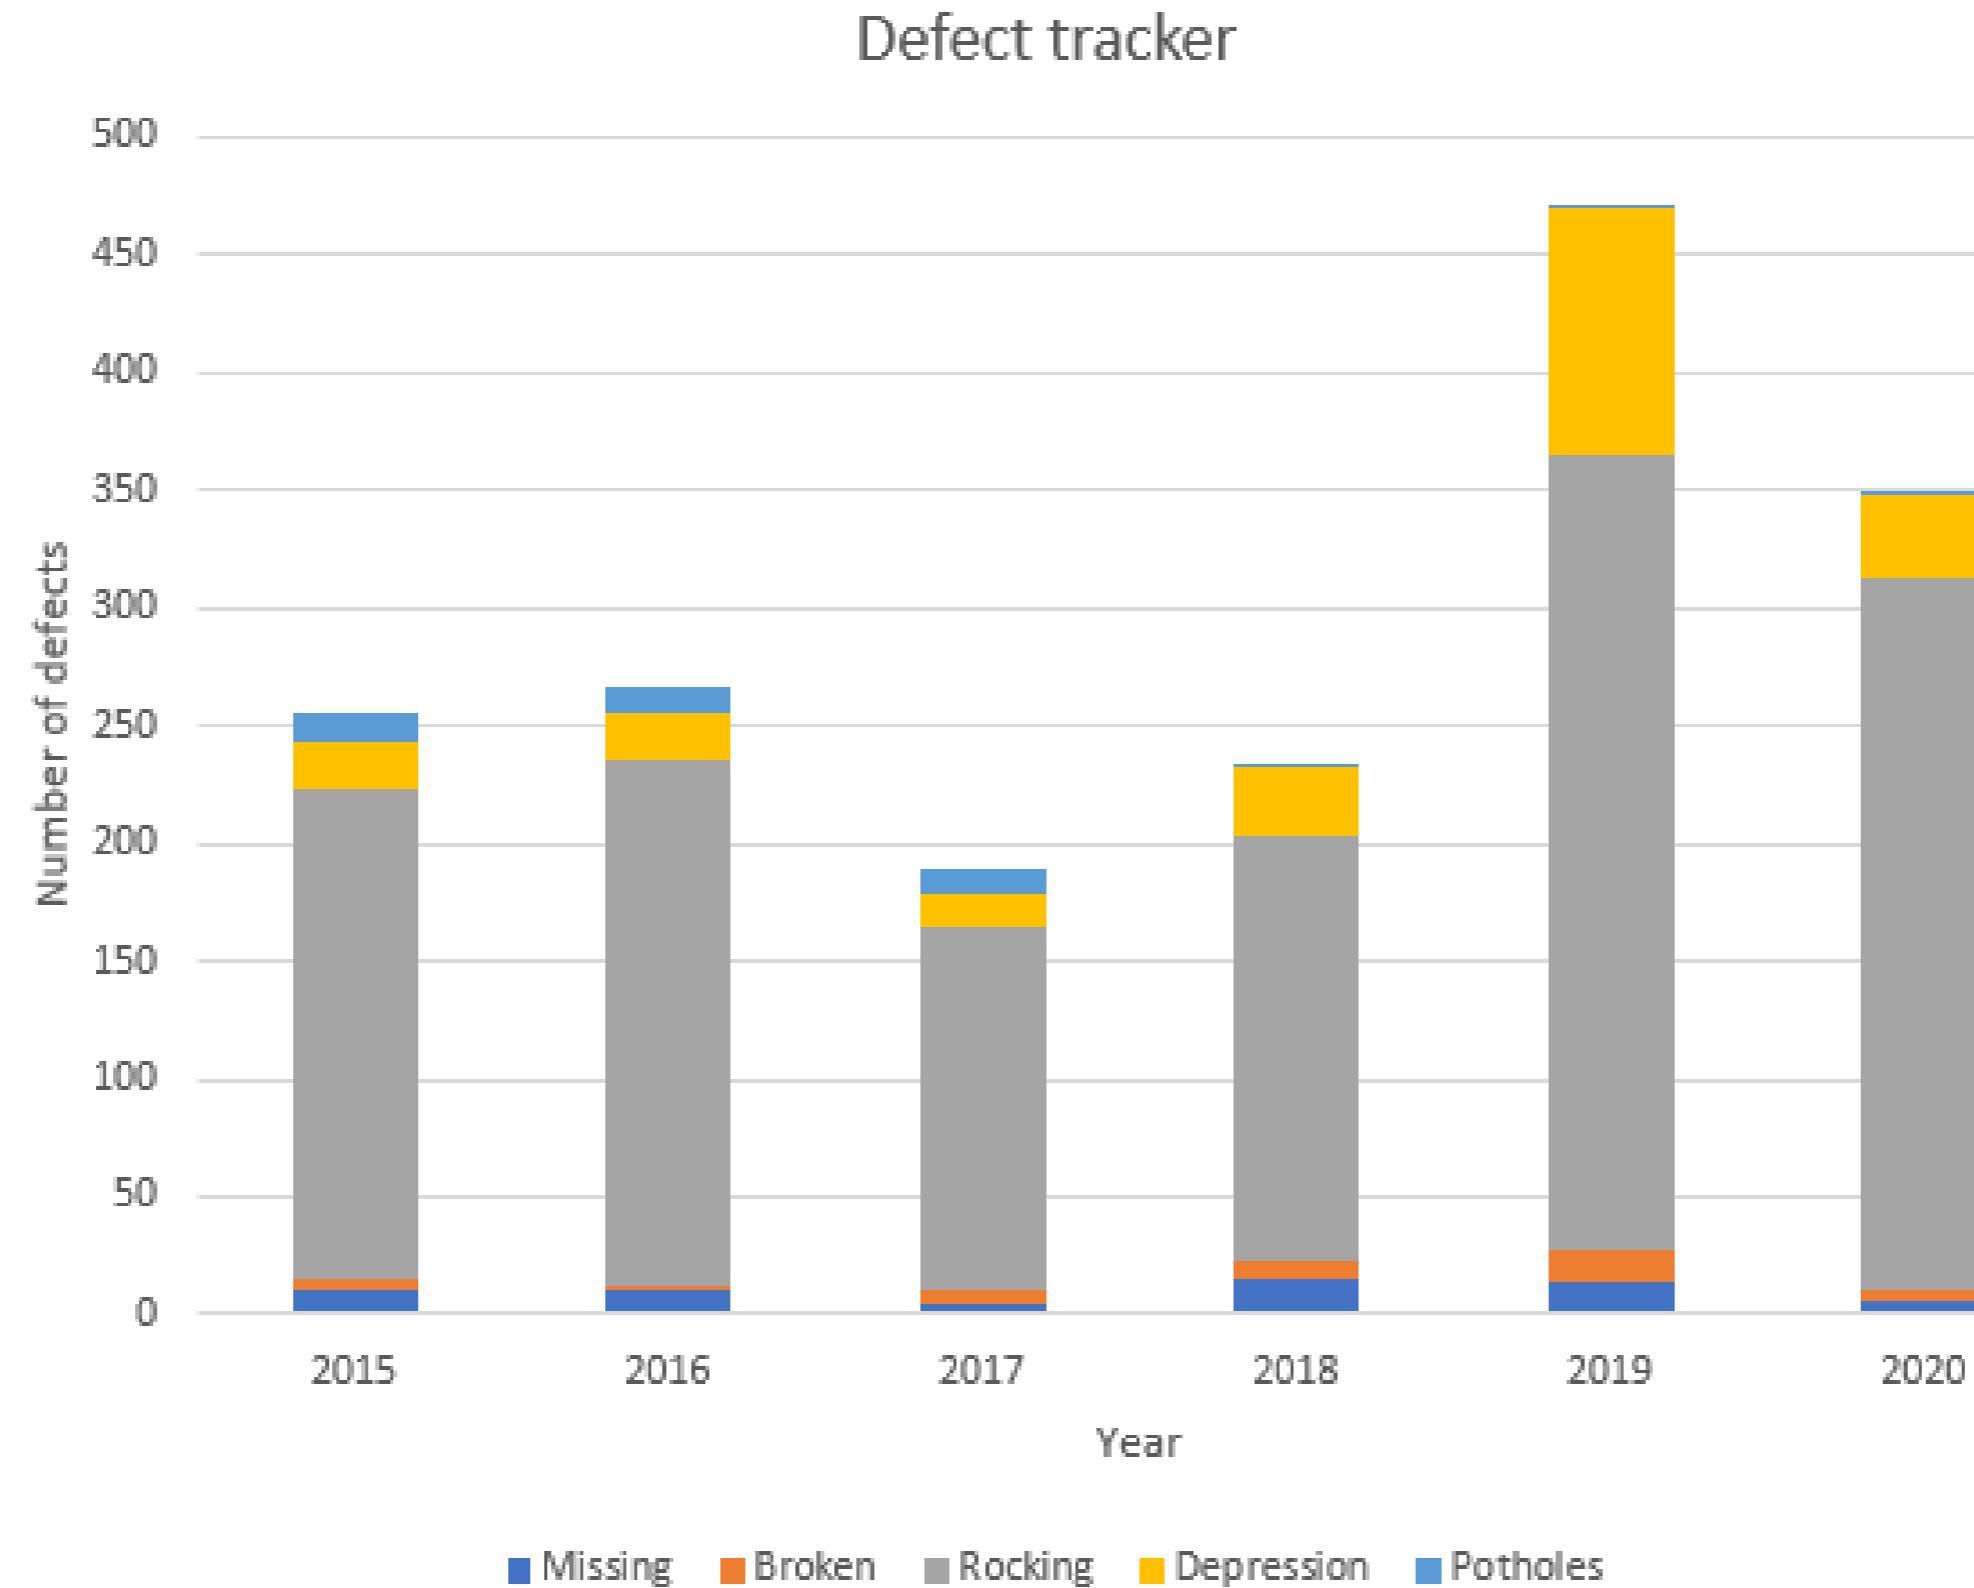
DEFECT TYPES FOR SAFETY PLUS REPAIRS

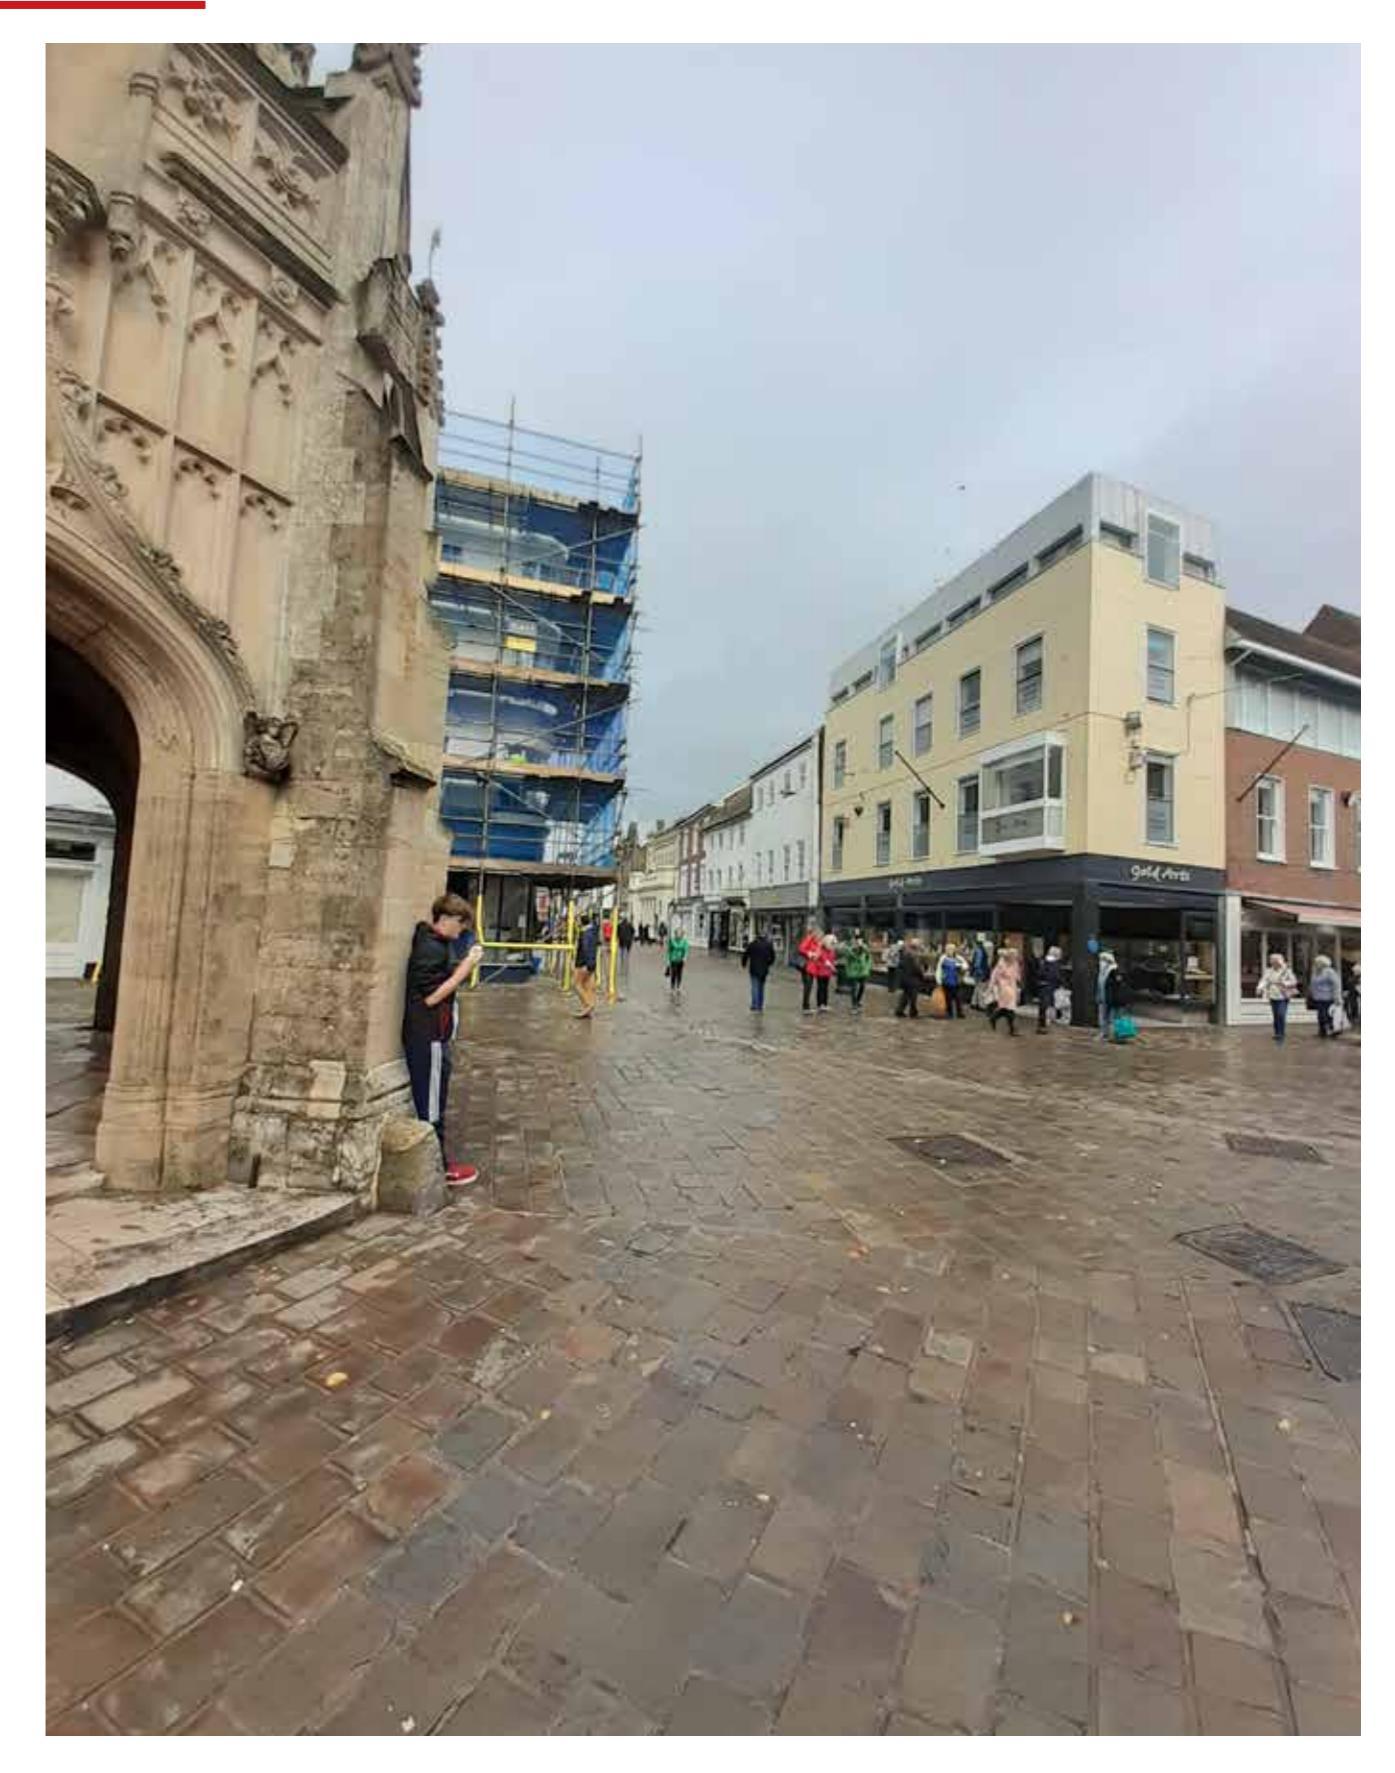
ANALYSIS OF UTILITIES AND HIGHWAYS PERMITS

• No definitive location data like Safety Plus – so currently not mapped

• Some "Other Council Activities" should probably be excluded

• Utilities vs utilities remedial works requires further investigation

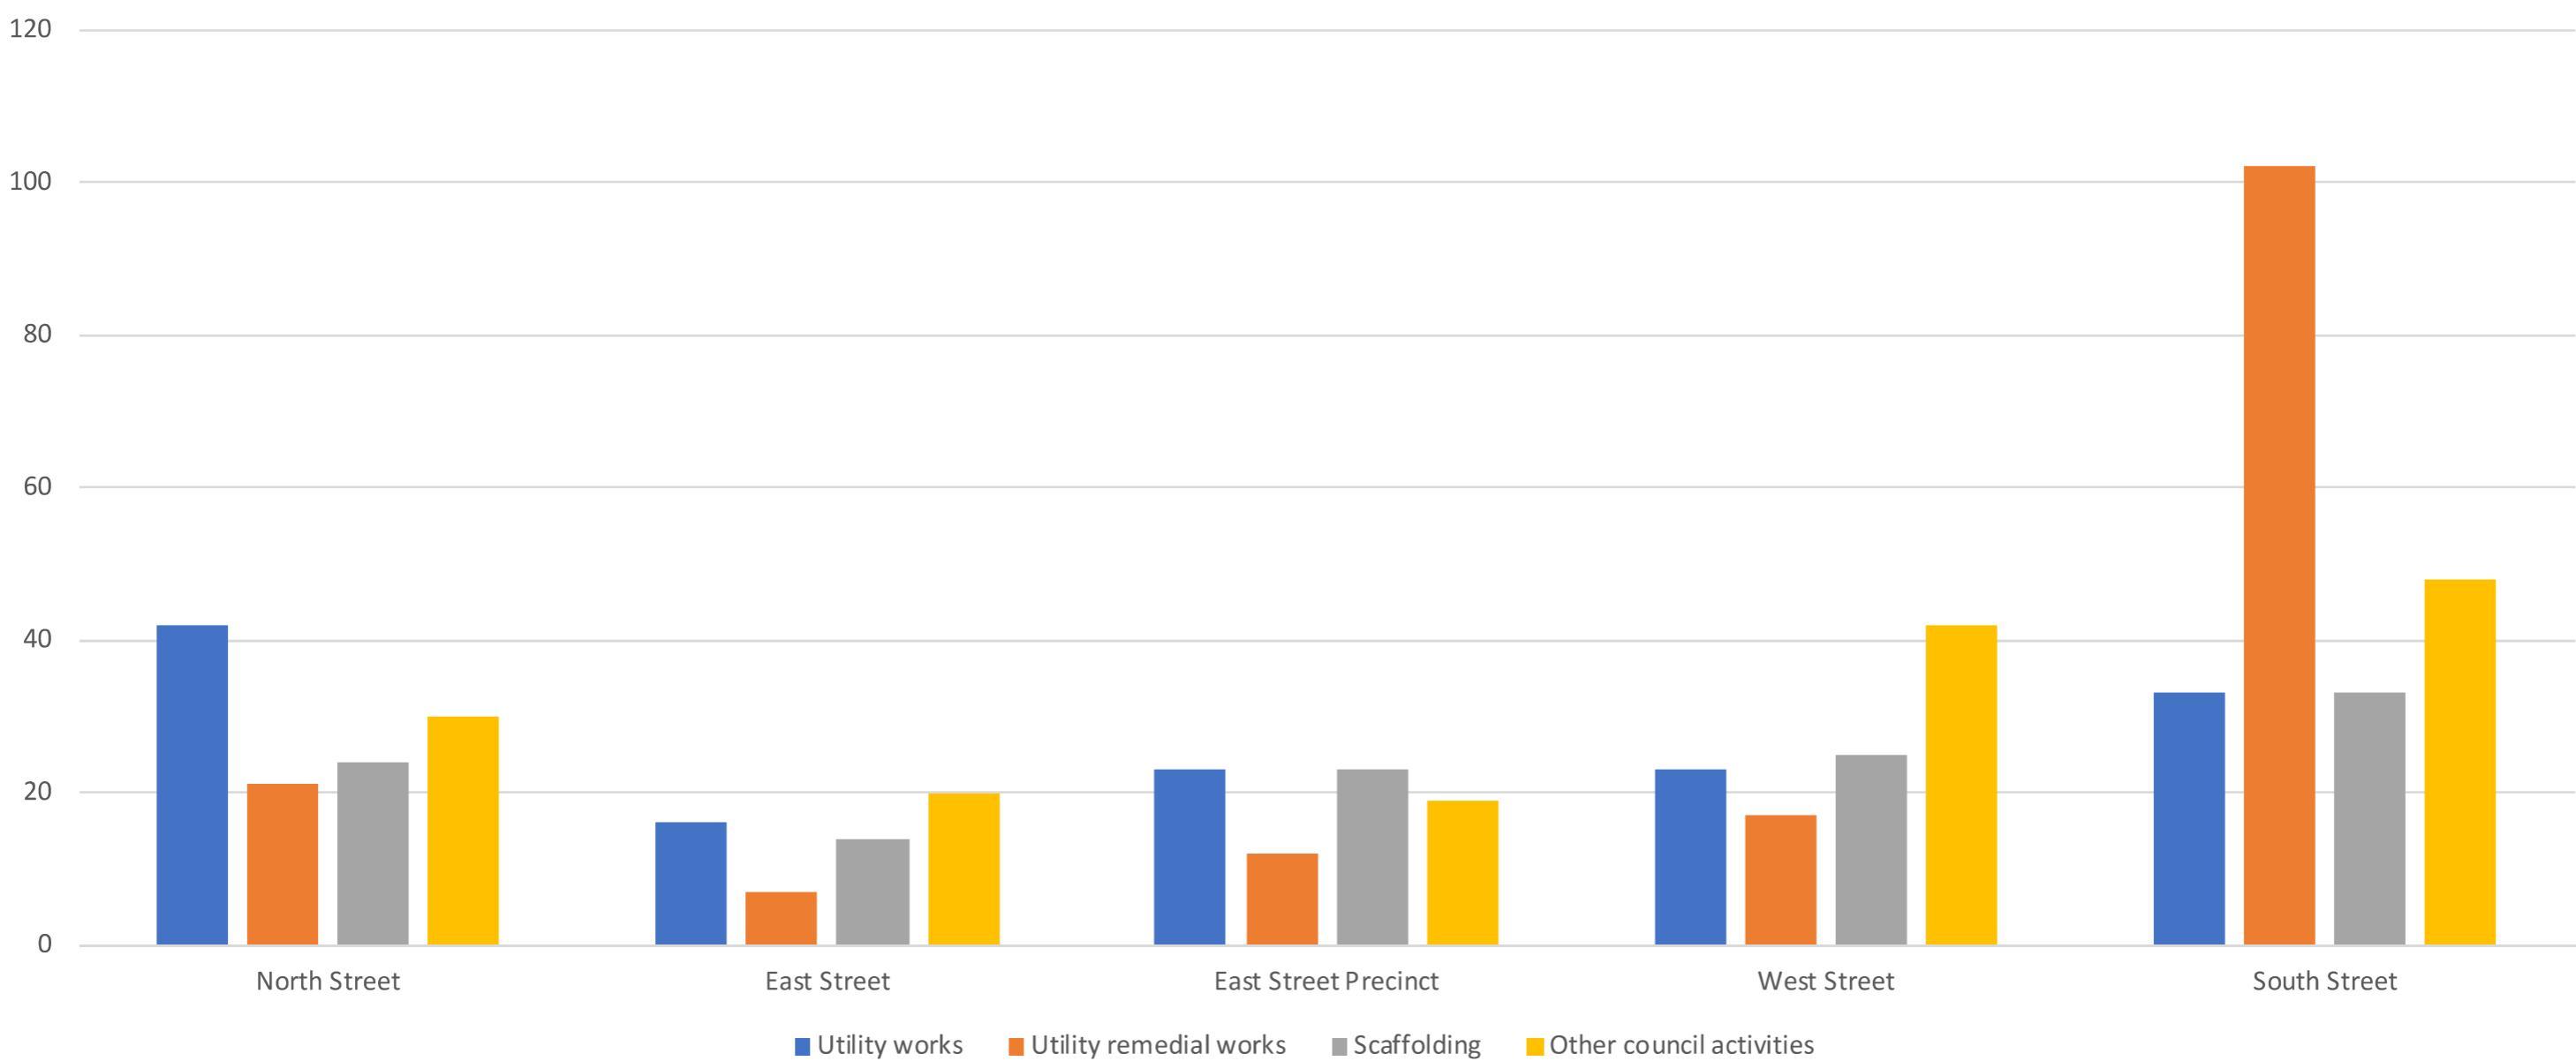
ACTIVITY TYPES FOR UTILITIES AND HIGHWAYS PERMITS (2015 - 2020)

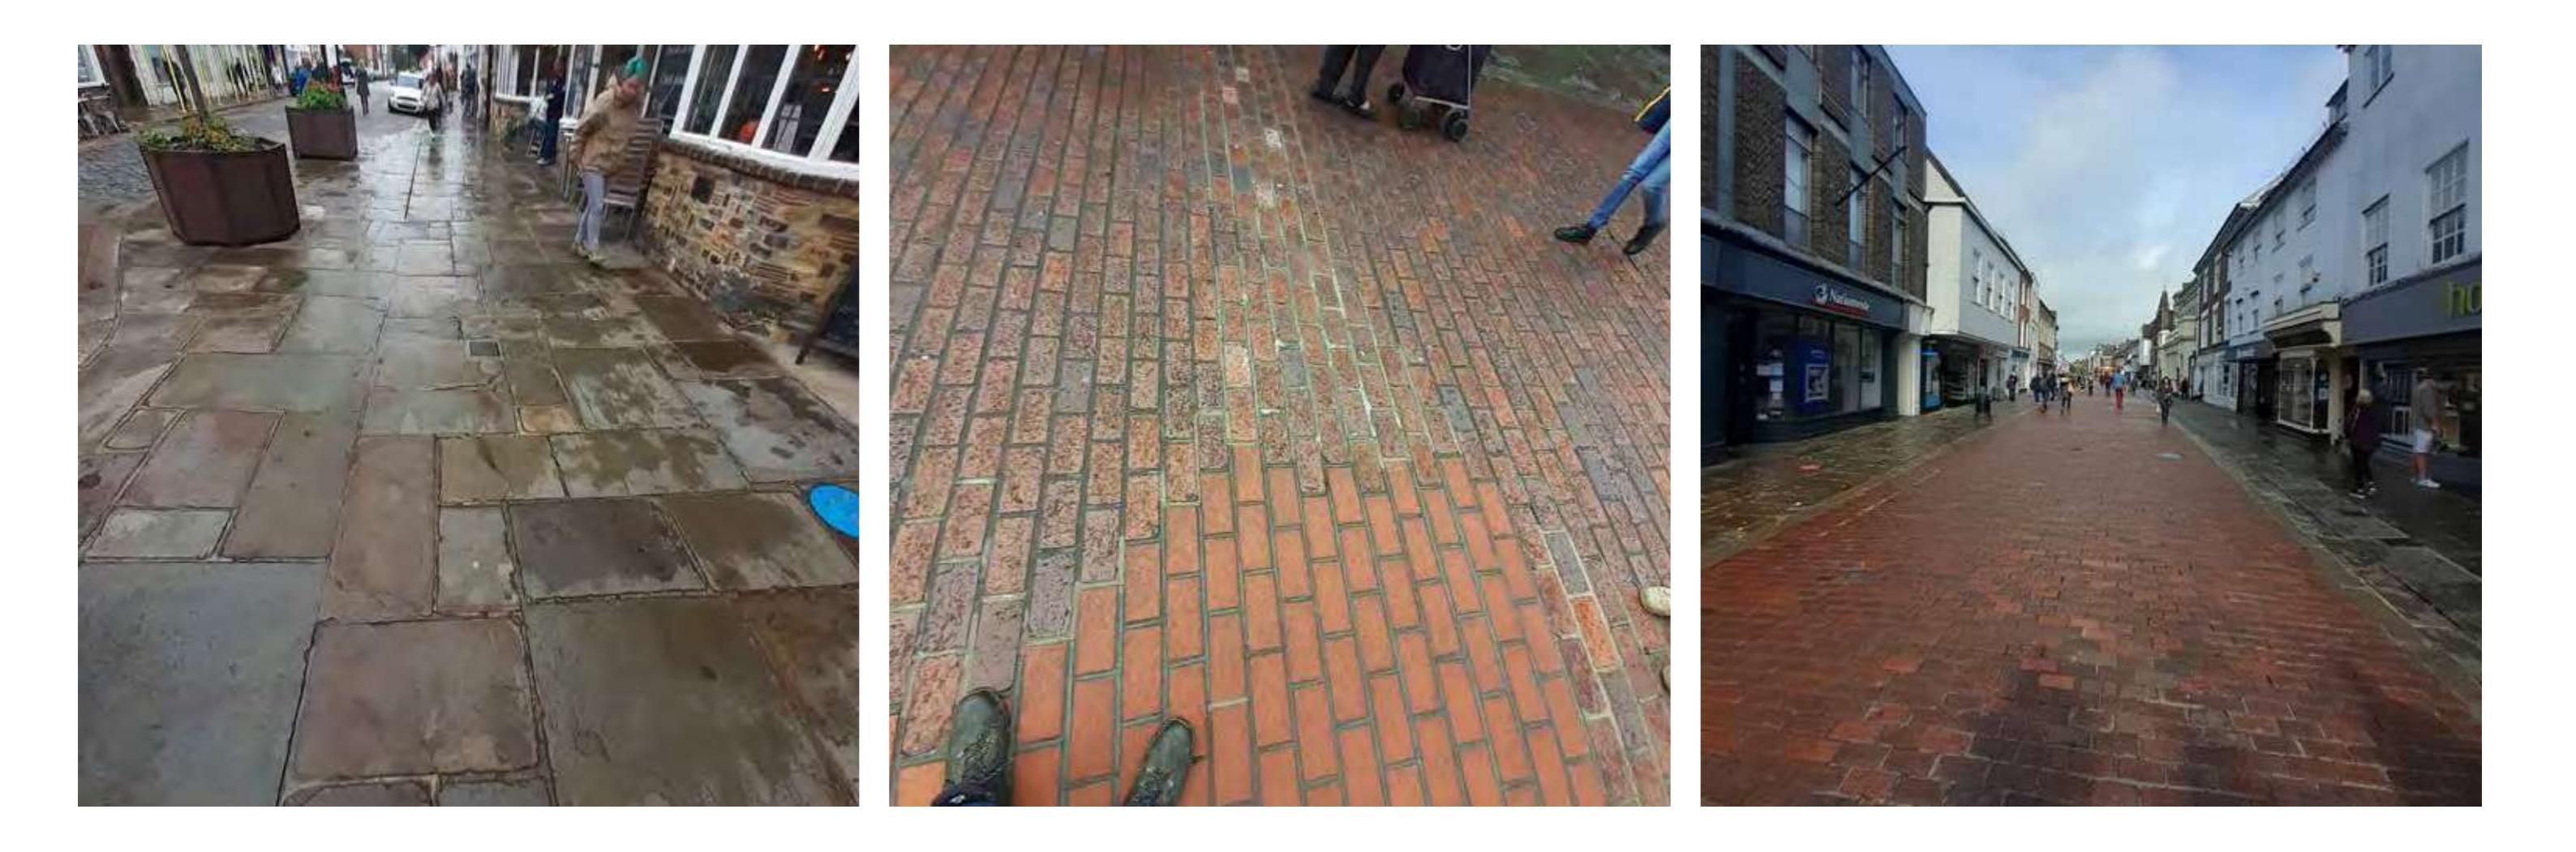
DISCUSSION POINTS - PAVEMENTS
